Berhampore to Newtown cycleway audit - safety and accessibility

90% design audit

April 2023

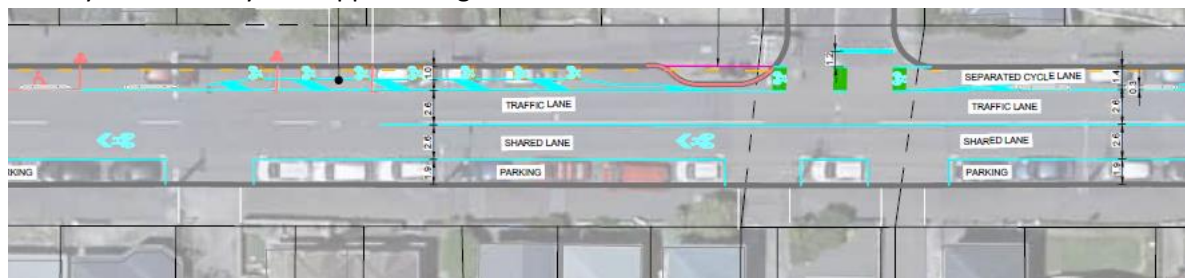
Figure 4-1: Shared lane on downhill with adjacent parking and driveways, Rintoul St

The design uses shared lanes in many locations, generally in the downhill direction. These sections generally involve on-street parking as well as driveways accessing properties. For example, see Figure 4-1

The safety issue is that drivers exiting the driveways may have limited visibility due to parked vehicles and may not notice cyclists approaching in the shared lane.

Probability of crash occurring	Likely
Expected crash severity	Serious injury
Primary treatment recommendations:	
4.2.1	Set parking further back from driveways on the approach (upstream) side.
Supporting treatment recommendations:	
4.2.2	Put sharrows on the upstream to (rather than the departure from) driveways, so that drivers exiting

<p>Designer</p>	<p>Agree with the recommended supporting treatment. The sharrow marking will be reallocated to upstream of major driveways.</p> <p>The client direction has been to generally maintain parking on the downhill side of the road. Parking has been removed in specific locations such as to improve lead in and out of bus stops, but otherwise is generally unchanged from the existing situation. We note that setting back of the parking spaces (similar to the guidance for separated cycleways, refer Waka Kotahi Technical note #2 - Separated cycleways at side roads and driveways, August 2020) would increase each setback from the current 1m to between 3m and 8m (depending on the length of parking) which would have a significant impact on the number of parking spaces removed.</p>
<p>Safety Engineer</p>	<p>Agree with the Designer to include the recommended supporting treatment with sharrow markings.</p>

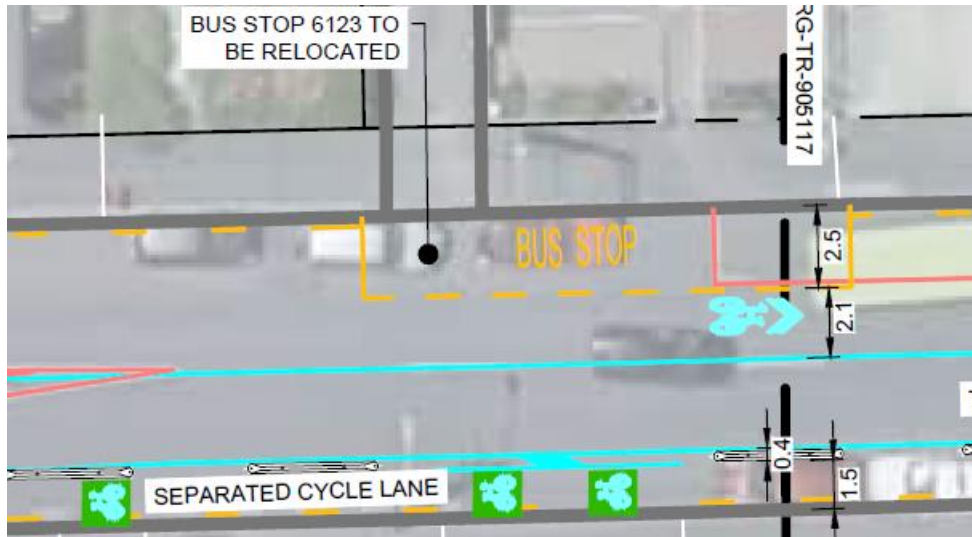
Figure 4-2: Bus stop 6123

Bus stop	Location	Sheet	Lane width	Comment
7120	76 Rintoul Street (northbound)	905113	1.9	Acceptable – too narrow for a car
7121	130 Rintoul Street (northbound)	905114	2.3	
6121	133 Rintoul Street (southbound)	905115	2.2	School stop?
6122	143 Rintoul Street (southbound)	905115	2.1	School stop?
6123	187 Rintoul Street (southbound)	905116	2.1	see Figure 4-2

Probability of crash occurring	Unlikely
Expected crash severity	Minor injury
Primary treatment recommendations:	
4.3.1	Table 4-2 outlines the possible treatments; the selection will depend on the particular stop. Option 1 is preferred for non-school bus stops, Option 4 is the only one considered suitable for school bus stops.
Supporting treatment recommendations:	
4.3.2	N/A

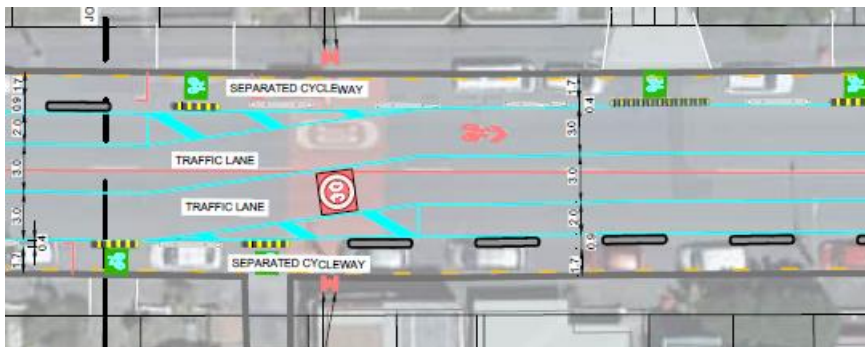
Figure 4-3: Sharp lateral shift on Luxford Street

There are several locations where the traffic lanes undergo a sharp lateral shift. For example, on Luxford Street at the 30 km/h threshold:

The lateral shift appears to be approximately 2.25 m (this should be confirmed via CAD). In a 30 km/h zone, the taper length should therefore be approximately 31 m, as per the TCD Manual under “edge lines at abrupt changes in width” (see Equation 1); however, only 17 m is provided.

Designer	Agree with CASA findings. It has been noted that the implementation of shorter tapers has a beneficial impact on calming the traffic.
-----------------	--

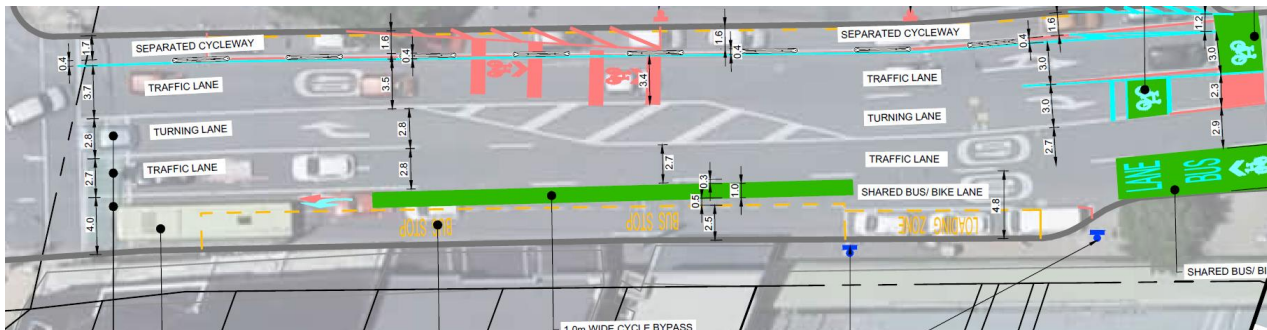
Figure 4-4: Riddiford bus stop / loading zone / cycle lane arrangement

4.7 Riddiford bus stop / loading zone / cycle lane arrangement (905110) – **C E M**

The arrangement shown in Figure 4-4 is an improvement on the previous design; however, there are still some safety issues:

4.7.3	Mark the cycle trajectory from the end of the bus-cycle lane to the cycle lane beside the bus stop.
Supporting treatment recommendations:	
4.7.4	Relocate the loading zone, e.g. to 14 Rintoul Street.
4.7.5	An alternative option would be to reduce the length of the loading zone so that it only accommodates one van. This would be an improvement on the current proposal, but not as effective as the combination of the other mitigation measures proposed above.

Designer	<p>Agree with CASA findings and recommendations.</p> <p>The relocation of the bus stop box to a more southerly position is supported in order to provide adequate space for both cyclists and motorists between the limit line and the end of the bus stop box. This adjustment aims to enhance the safety of the left turn lane, facilitating its use by both vehicles and cyclists. This repositioning would result in a reduction in the length of the loading zone so it can accommodate one vehicle.</p> <p>It has been observed that a vehicle occupying the loading zone may impede bus access to the start of the bus stop, thereby decreasing its overall effectiveness. However, it has been noted that the loading zone is scheduled to be time-restricted from 9:30 am to 3 pm, thereby avoiding potential issues during peak periods. During off peak periods the full bus stop length will not be required and there is sufficient lead in to the head of the stop.</p> <p>Additionally, the green paint marking will be extended from the loading zone to the end of the bus stop box.</p>

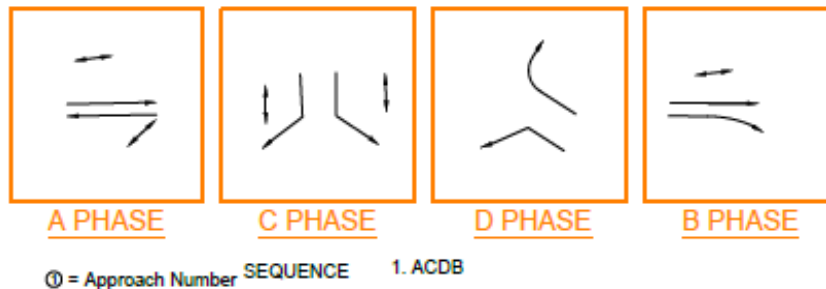
Figure 4-5: Phasing diagram for Riddiford / Rintoul

Figure 4-5 shows the phasing for Riddiford / Rintoul; there is no partial pedestrian protection provided at the intersection. The 10-year crash history includes three crashes involving pedestrians, but these all appear to be due to pedestrians attempting to cross during the wrong phase.

The safety issue is that turning motorists may not realise they have to give way to crossing pedestrians, due to the unusual angle of some legs.

Given the lack of crash history involving pedestrians at this intersection, crashes are expected to be very unlikely. Given the geometry that ensures vehicle turning speeds below the safe system threshold for pedestrians, those that do occur are not expected to cause more than minor injury.

Designer	<p>These crossings are outside of the current project scope.</p> <p>We note that the LGWM City Streets Newtown to Berhampore project includes this intersection and recommend this feedback is passed on to be considered in that design.</p>
Safety Engineer	Noted.
Proposed client action	Team to pass feedback on to LGWM team
Action taken

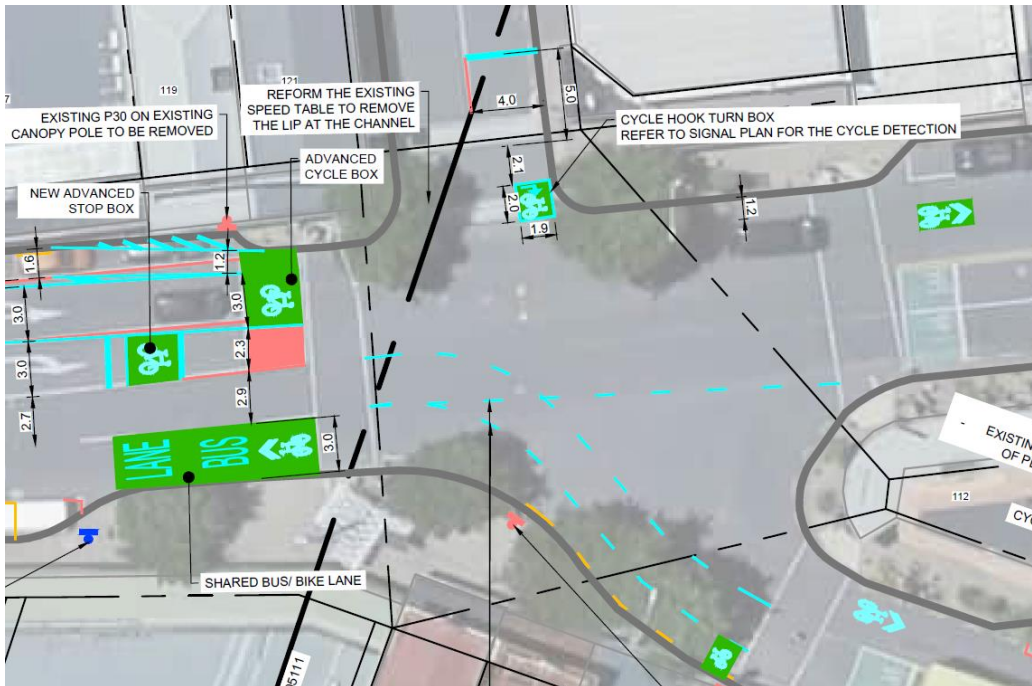
Figure 4-6: Emmet / Riddiford / Rintoul intersection

4.9 Rintoul Street approach to Riddiford Street (905110) – **C E**

Figure 4-6 shows continuity lines to guide drivers turning from Rintoul Street into Riddiford Street towards the general traffic lane, rather than the bus-cycle lane.

within signalised intersections. The design team have conveyed that they have been instructed by Waka Kotahi that it is not possible to use anything more than continuity lines within a signalised intersection. However, the CAT recommends that a treatment using colour and/or cycle symbols in the cycle lane (either for the full area, or in blocks as per a side road crossing) would be a stronger guide to motorists to stay out and cyclists to stay in the lane. Another possible option could be some flexi-posts with low kerb bases in the last section of Rintoul St prior to reaching Riddiford St.

Safety Engineer	<p>Agree with CASA findings and supporting treatment recommendation. The designer should consider realigning the northwestern kerblines to ease the left turn from Rintoul St to Riddiford St to mitigate the risk identified by the CASA. I disagree with the Designer to remove the pedestrian crosswalk lines as pedestrians need guidance just like cyclists and drivers.</p>
Proposed client action	<p>It is out of scope for the transitional programme to move the kerblines here – the City Streets team at LGWM may do this as part of the permanent project (Pass on to LGWM). We are not suggesting removing pedestrian crosswalk lines - only green box on the intersection side. We also propose adding an advance cycle light to give cyclists a head start in front of traffic.</p>
Action taken

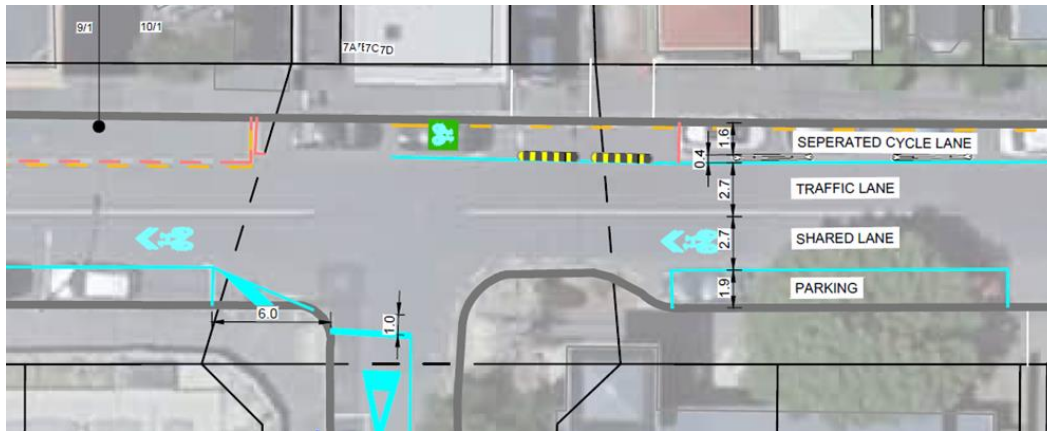
Figure 4-7: Start of southbound cycleway on Rintoul Street

The safety issue is insufficient indication to cyclists regarding the commencement of the southbound separated cycleway on Rintoul Street (see Figure 4-7) – cyclists may not realise they are expected to use the cycleway and instead continue sharing the narrow general traffic lane in the uphill direction.

The crash types expected are cyclist vs motor vehicle or cyclist v bus.

Probability of crash occurring	Unlikely
Expected crash severity	Serious injury
Primary treatment recommendations:	
4.10.1	Use a longer block of green at the start of the separated cycleway, plus across the adjacent high-risk driveways.
Supporting treatment recommendations:	
4.10.2	N/A

Designer	We agree with the CASA recommendation. Longer green boxes, 3.0m long, with cycle symbols painted at the beginning of the box should be utilised to
-----------------	---

emphasise the commencement of a separated cycle lane. To improve the visibility of the cycle lane and increase the awareness of drivers we also consider implementation of two standard green boxes with cycle symbols at entrances of high-risk / high-use driveways.
Safety Engineer	Agree with the CASA primary treatment recommendation.
Proposed client action	Agree with designer proposal for longer green box
Action taken

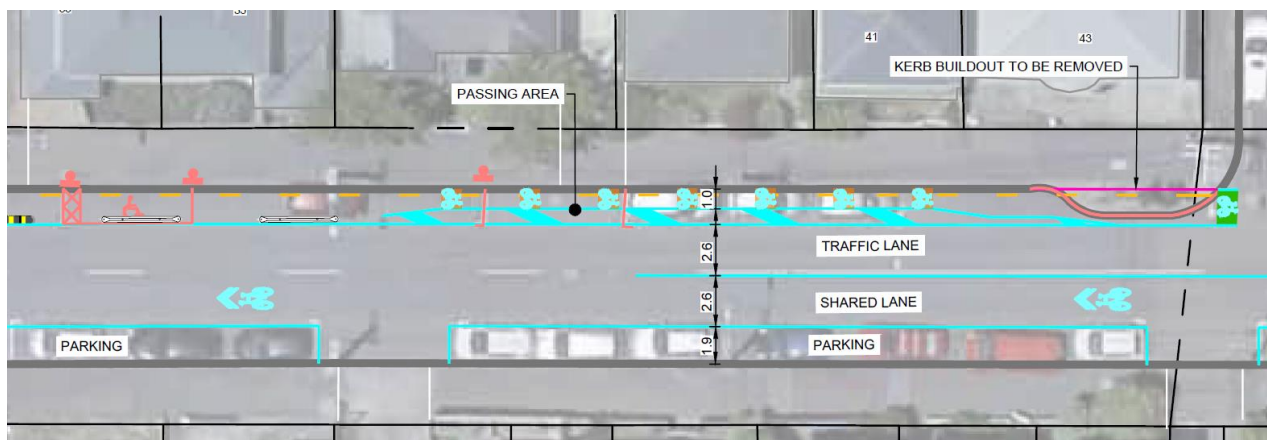
Figure 4-9: Rintoul Street passing area

Figure 4-9 shows an example of one of the passing areas planned on the north (uphill) side of Rintoul Street. The design decisions report indicates that this is to provide space on the narrow carriageway when there is a bus (or other large vehicle) travelling in either direction.

The safety issue is that the passing area creates a cycle lane of 1.0 m, which is too narrow for cyclists travelling immediately adjacent to buses. It is also noted that the 1.0 m is measured to the kerb face, i.e. it includes the gutter, which is not always in cyclable condition along the route. The chevron area (0.8–0.9 m) is not dedicated cycling space and will not be physically available to cyclists if being used by a bus (or any

Probability of crash occurring	Unlikely
Expected crash severity	Serious injury
Primary treatment recommendations:	
4.13.1	Provide localised lane widening by removing parking on the other side of the road.
Supporting treatment recommendations:	
At the very least, if the passing areas in the cycleway are to be retained:	
4.13.2	Confirm treatment style with Waka Kotahi. In particular,

<p>Responses:</p>	
<p>Designer</p>	<p>Agree with CASA findings.</p> <p>Based on the bus frequency, it is expected that buses will meet once along Rintoul Street. However, due to the horizontal and vertical geometry and the surrounding conditions of the corridor, visibility along Rintoul Street is restricted. Therefore, a few passing areas are necessary to allow bus drivers to see oncoming buses with sufficient</p>

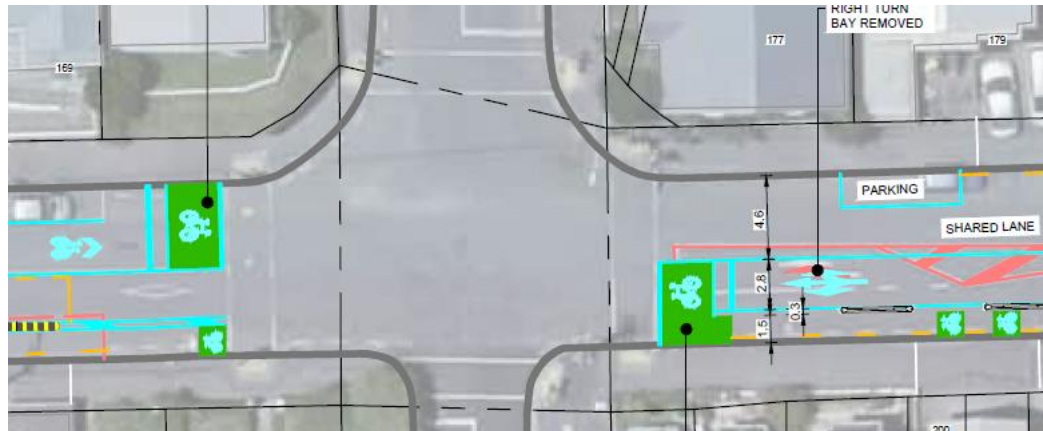
Figure 4-10: Rintoul / Te Wharepouri intersection layout

Probability of crash occurring	Likely
Expected crash severity	Serious injury

There several safety issues, depending on the vehicle movements involved:

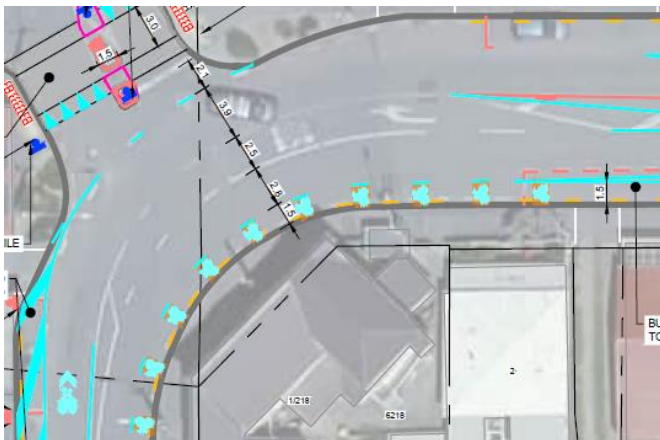
Figure 4-11: Cycle lane on inside of bend at Luxford / Rintoul

Figure 4-11 shows the cycle lane on the inside of the bend at Luxford / Rintoul Street. Since the 30% plans, the width of the cycle lane has been narrowed and red coloured surfacing (see also issue 4.4) has been added under the cycle symbols.

The safety issue is motor vehicles are expected to cut the corner and encroach on the cycle lane.

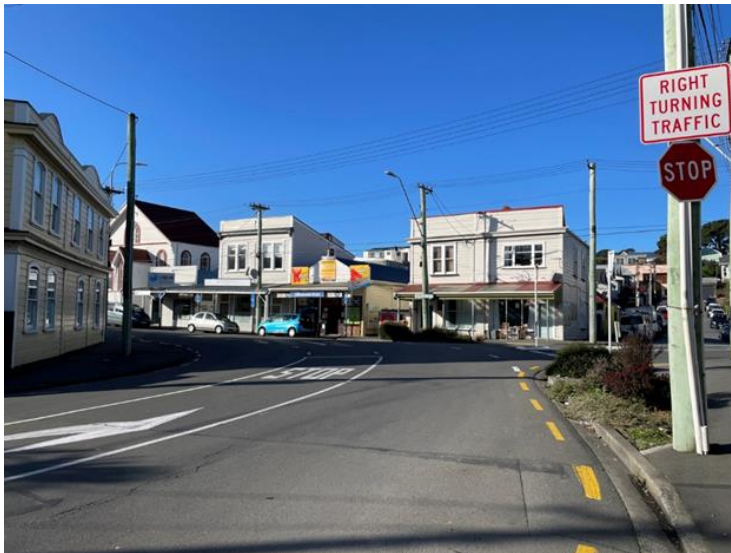
Figure 4-12: Stop applied to right turn bay on Luxford Street into Rintoul Street

Figure 4-12 shows the right turn from Luxford Street to Rintoul Street, which has a stop control applied. The safety issue is this situation is ambiguous, which can lead to unintended or unexpected behaviours. The main / priority route continuous around the bend between Luxford Street and Rintoul Street south of the intersection. Normally drivers turning from a main road would give way to opposing traffic, but not the side street traffic. In this case, however, right turning drivers faced with the stop control would be expected to give way to side street traffic (who have a GIVE WAY control). Some drivers coming from the side street may not be aware of the stop control placed against the right turn bay and therefore assume they have to wait for the right turners. It is also unusual to apply a stop sign in this configuration, where the rest of the approach traffic has no form of control.

The crash types expected are any combination between the intersection users – bus, motor vehicle, bike, and pedestrian.

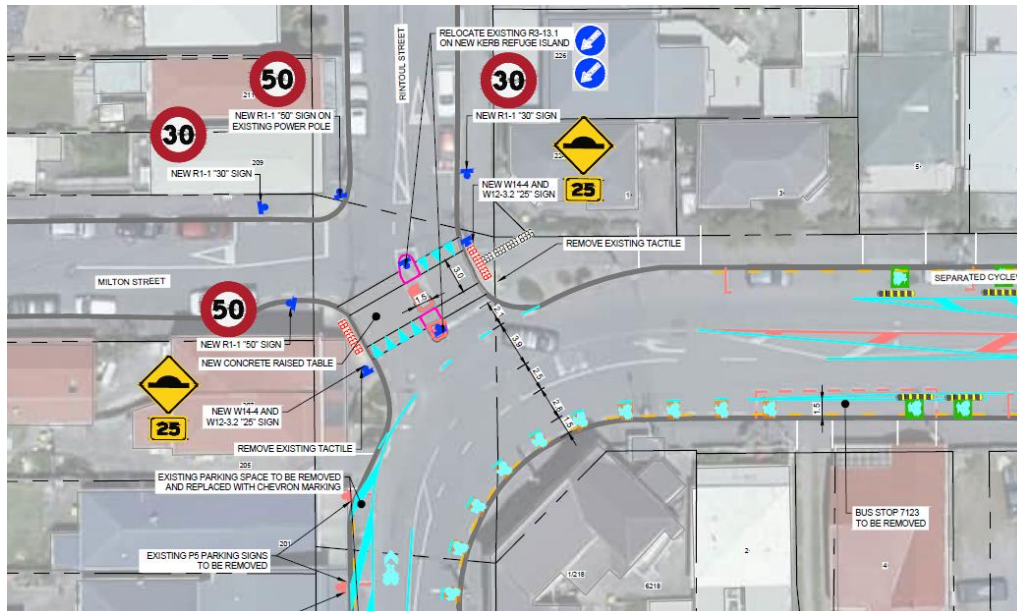
Figure 4-13: Luxford / Milton / Rintoul intersection

Probability of crash occurring	Unlikely
Expected crash severity	Minor injury
Primary treatment recommendations:	
4.17.1	Mark a zebra crossing on the raised safety platform, to minimise confusion.

The raised safety platform at the Luxford / Milton / Rintoul intersection (see Figure 4-13) has been designed as a pedestrian courtesy crossing. The safety issue is this will create ambiguity - most drivers are likely to wait for pedestrians, but some will not.

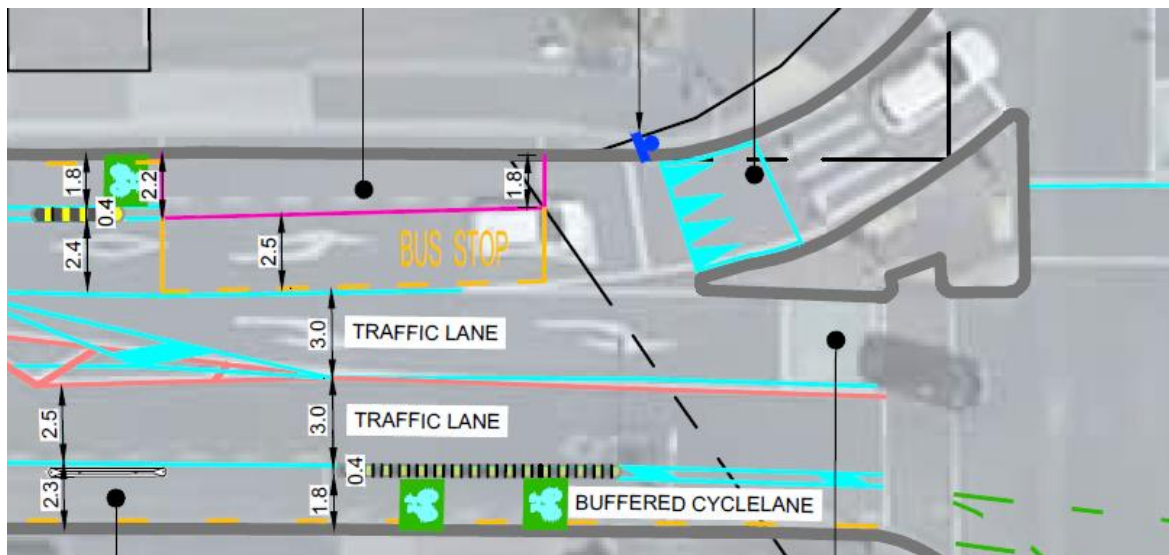
Figure 4-14: Slip lane onto Adelaide Road

4.19 Transition to shared lane between bus stop and slip lane at Adelaide / Luxford (905118) – **C E** Serious

The safety issue is westbound cyclists on Luxford Street will traverse the bus stop platform then immediately have to merge with general traffic prior to or on the slip lane to Adelaide Road (see Figure 4-14).

The crash type expected is motor vehicle vs cyclist or bus vs cyclist.

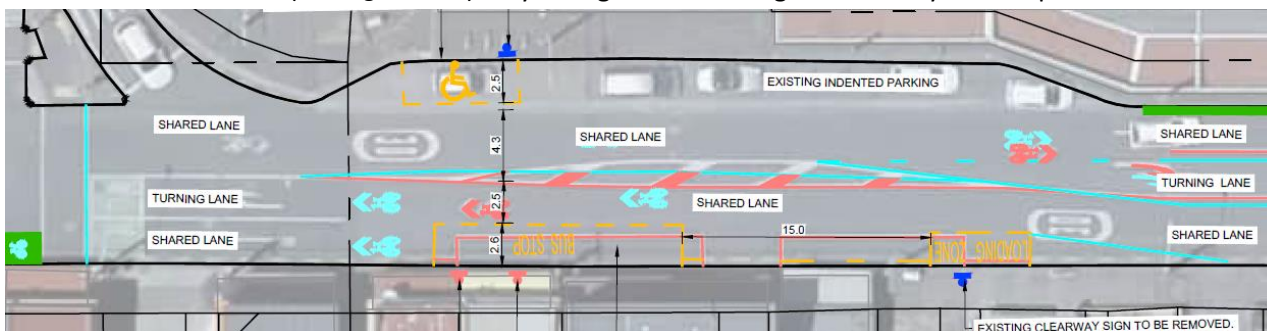
Figure 4-15: Bus stops on Adelaide Road between Luxford Street and Britomart Street

We are aware that the locations of the bus stops in the vicinity of the Adelaide / Luxford and Adelaide / Britomart intersections (see Figure 4-15) may change due to changes in the City Streets plans.

As currently proposed, the bus stops on Adelaide Road between the two intersections are shown as being right against the existing kerb; in reality, it will not be possible for buses to park right up against the kerb as they would hit the adjacent power pole and verandas.

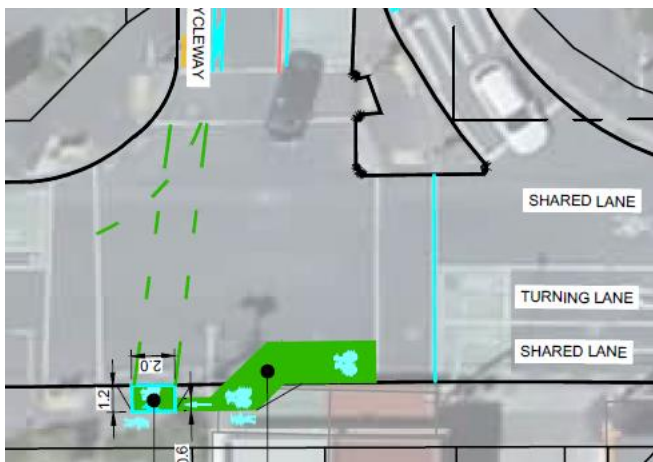
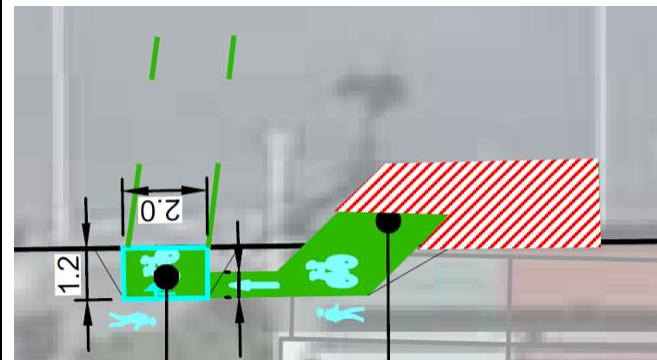
Figure 4-16: Jug handle (hook turn box on footpath) provision for Adelaide Road to Luxford Street

Figure 4-16 shows the jug handle (hook turn box on footpath) provision for cyclists turning right from Adelaide Road to Luxford Street; there are three associated safety issues:

4.21.1 Remove most of the section of green on-road that looks like a marked cycle lane – leave a short on-road section leading to the footpath section.

4.21.2 Consider means of increasing the size of the hook turn box, without further disadvantaging pedestrians, possibly by means of a small kerb extension.

4.21.3 Fix the continuity lines from the Adelaide Road left turn.

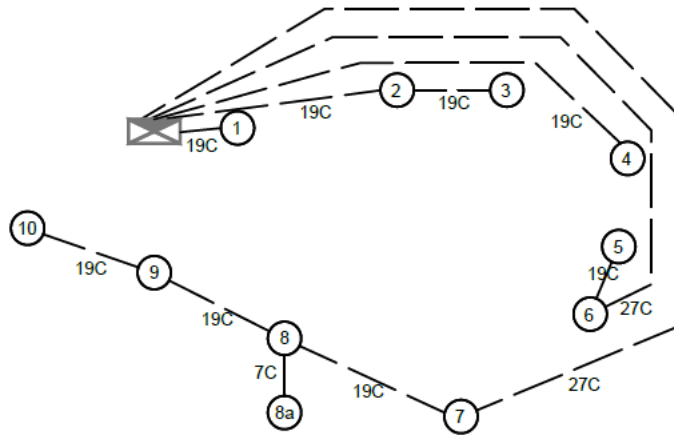
Figure 4-17: Riddiford / Rintoul traffic signal cable run

Probability of crash occurring	Very unlikely
Expected crash severity	Serious injury
Primary treatment recommendations:	
4.22.1	Introduce redundancy to the cable runs

The crash types expected are any combination between the intersection users – bus, motor vehicle, bike, and pedestrian.
