POST CONSTRUCTION ROAD SAFETY AUDIT Island Bay Cycleway

Prepared for Wellington City Council

11 May 2016

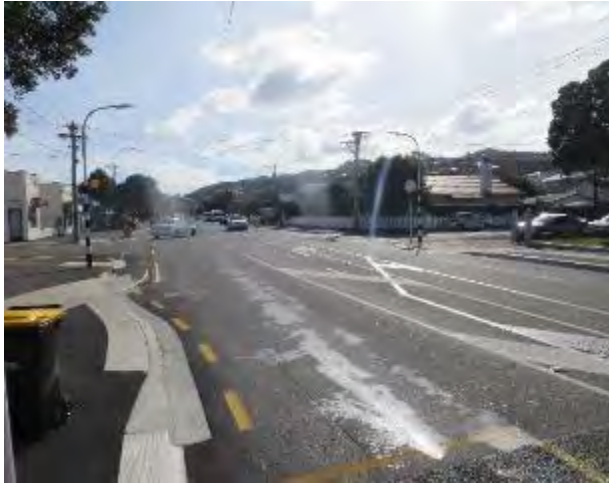
There are numerous locations throughout the project site where the previous markings have been blacked out using paint as opposed to other forms of removal. This causes confusion to the approaching motorist as it is not clear as to which markings are the correct markings as the blacked out markings can be clearly seen by approaching motorists (refer Figure 2-1 to Figure 2-4).

Figure 2-1 below shows that the right turn bay has been blacked out, but this is not immediately apparent from the approaching driver's perspective especially during the middle of the day when the sun shines along The Parade and at night with street light reflection off both the old and new road markings.

Figure 2-1: Photo showing ghost right turn bay markings

Remove redundant markings by a method that does not cause ghost marking such as a full width resurfacing.

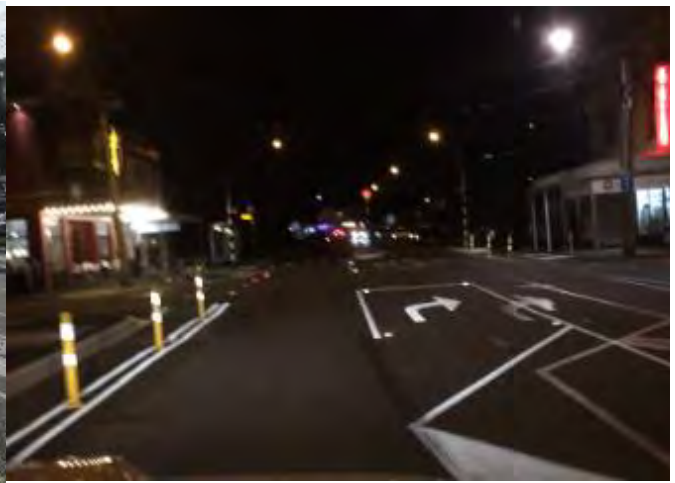
Figure 2-2: Photo showing an additional ghost right turn bay marking

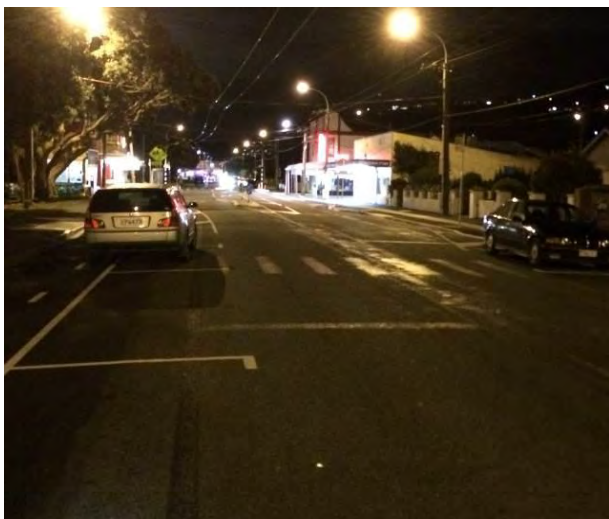
Figure 2-3: Photo showing former pedestrian zebra crossing markings

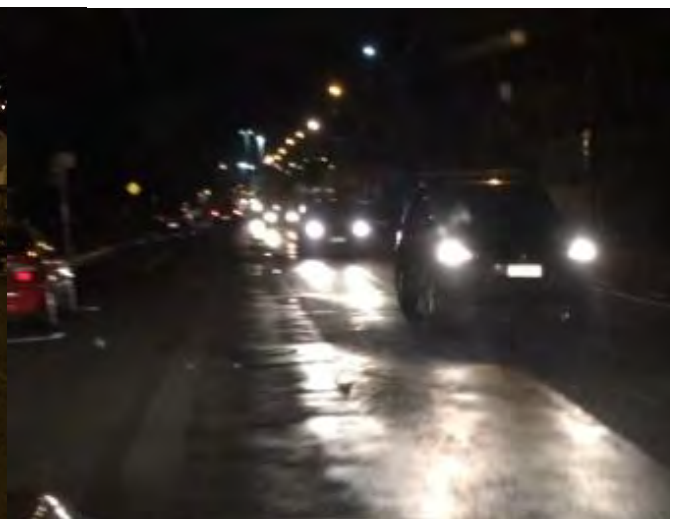
Figure 2-4: Photo showing removal of flush median markings, on a flushed surface, minimises centreline visibility

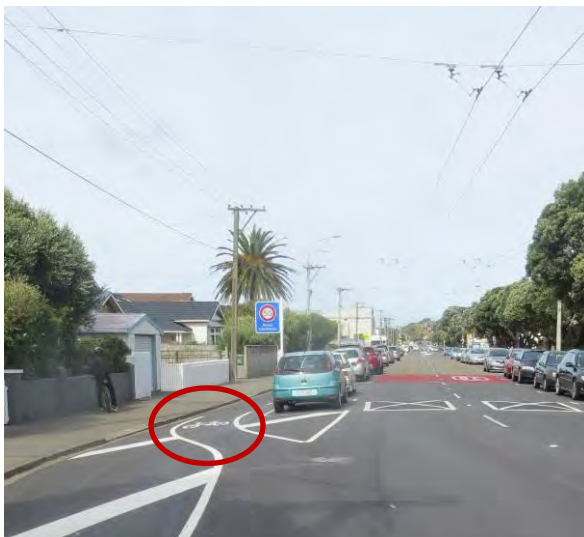
The SAT observed inconsistent application of both green coloured cycleway markings and cycle symbols along the bus stop cycle bypasses and across intersections, as shown in Figure 2-5 to Figure 2-8.

Figure 2-5: Photo showing a lack of green coloured cycleway markings on diverge from the "sharrow" lane into the cycleway

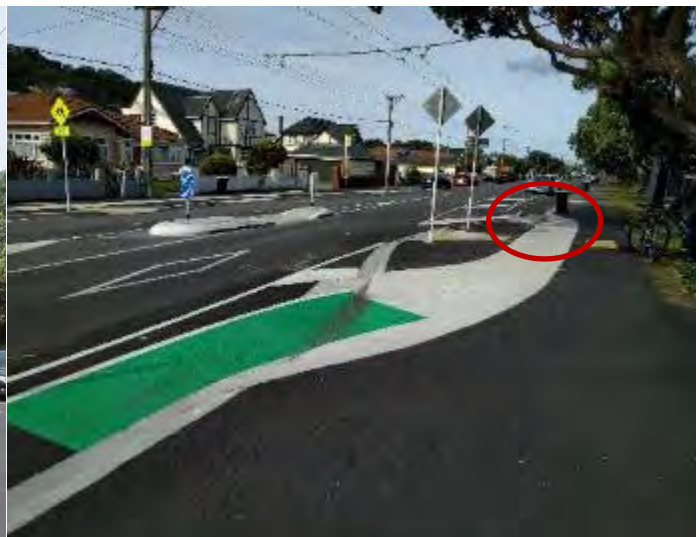
Figure 2-6: Photo showing green coloured cycleway markings provided on departure only. Note also the cycle symbol in advance of the green surfacing blending into the concrete surface

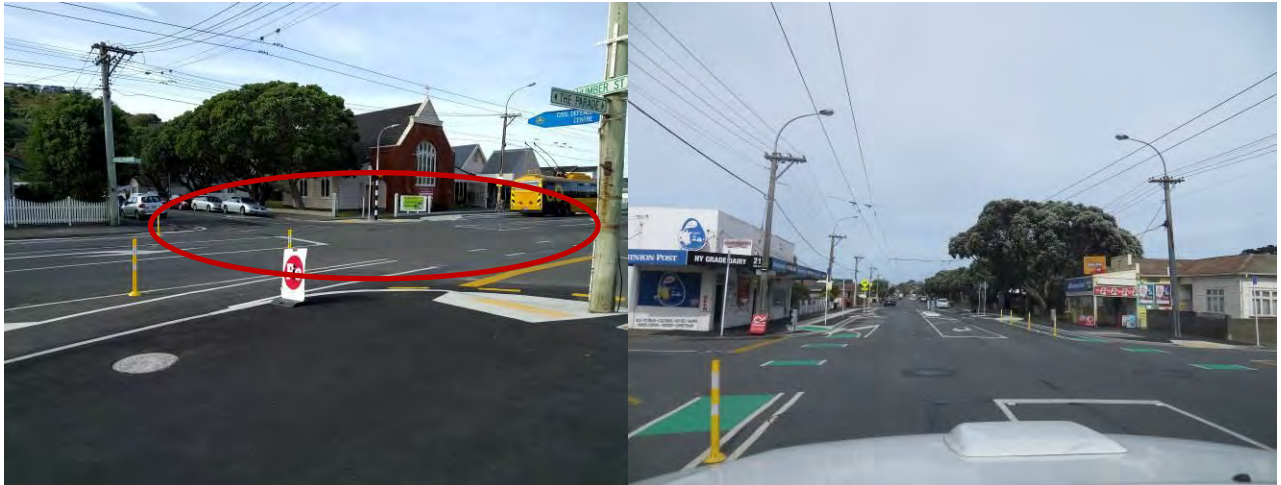
Figure 2-7: Photo showing a lack of green coloured surfacing and cycle symbols across the Humber St Intersection

Figure 2-8: Photo showing green coloured surfacing across the Mersey St intersection, however there are no cycle symbols provided

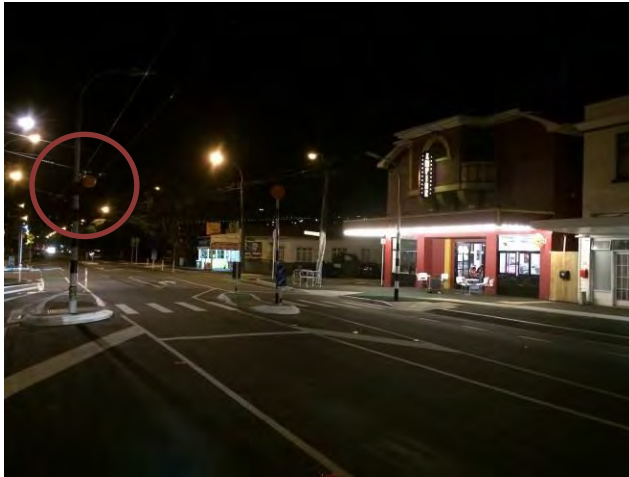
The SAT noted during the night inspection that a number of Belisha beacons at pedestrian crossings along the route were not operational, refer Figure 2-9 and Figure 2-10 below. Belisha beacons provide additional dynamic advance warning to approaching motorists of the presence of a pedestrian zebra crossing. It is important to ensure that where Belisha beacons are provided that they are operational.

Figure 2-9: Photo showing the eastern Belisha beacon at the pedestrian zebra crossing opposite Empire Cinema was not operational

Ensure that all Belisha beacons and floodlighting at pedestrian zebra crossings along the route are operational and replace or refresh (cleaning, change bulbs etc.) as required.

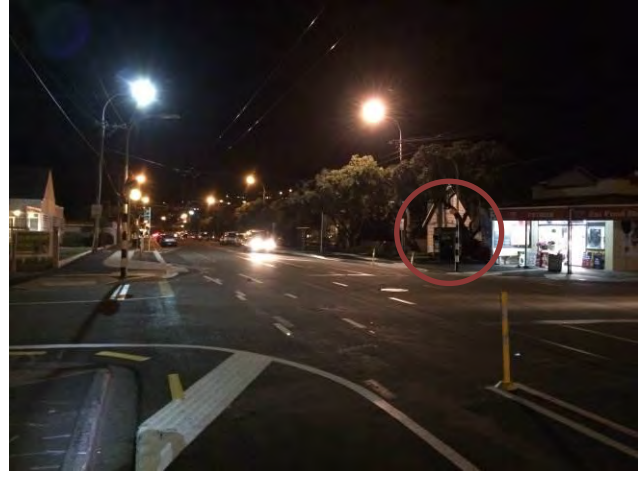
Figure 2-10: Photo showing that the western Belisha beacon at the intersection of Humber St was not operational

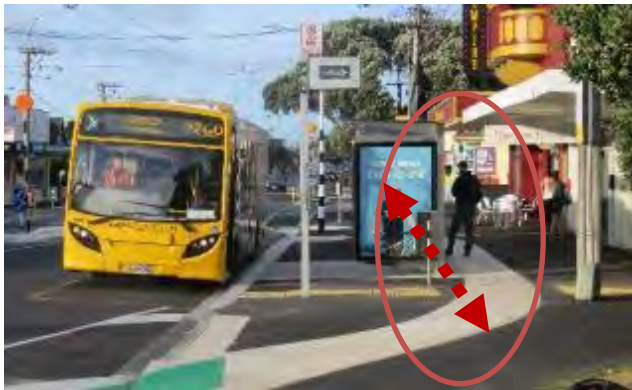
The SAT observed that the bus stop cycleway bypasses generally operate well with regard to separating the high risk cyclist/vehicle conflict; however, a number of cyclist/pedestrian conflicts were noted due to poor intervisibility through the bus shelter, refer Figure 2-11 and Figure 2-12 below. Note that there are some bus shelters which incorporate advertising within their side walls thereby obstructing visibility through the bus shelter to the opposite side.

Figure 2-11: Photo showing a pedestrian waiting on the cycleway bus stop bypass

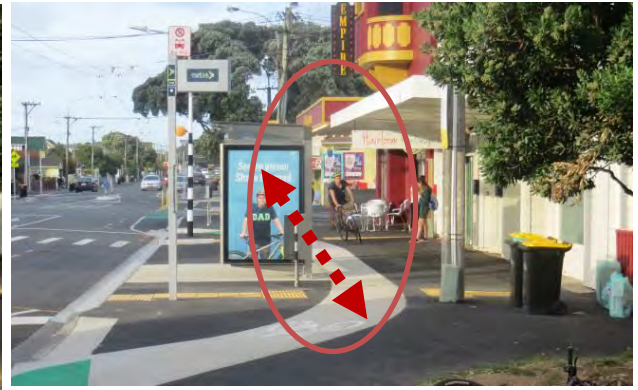
Figure 2-12: Photo showing a cyclist swerving off the cycle lane to avoid a pedestrian

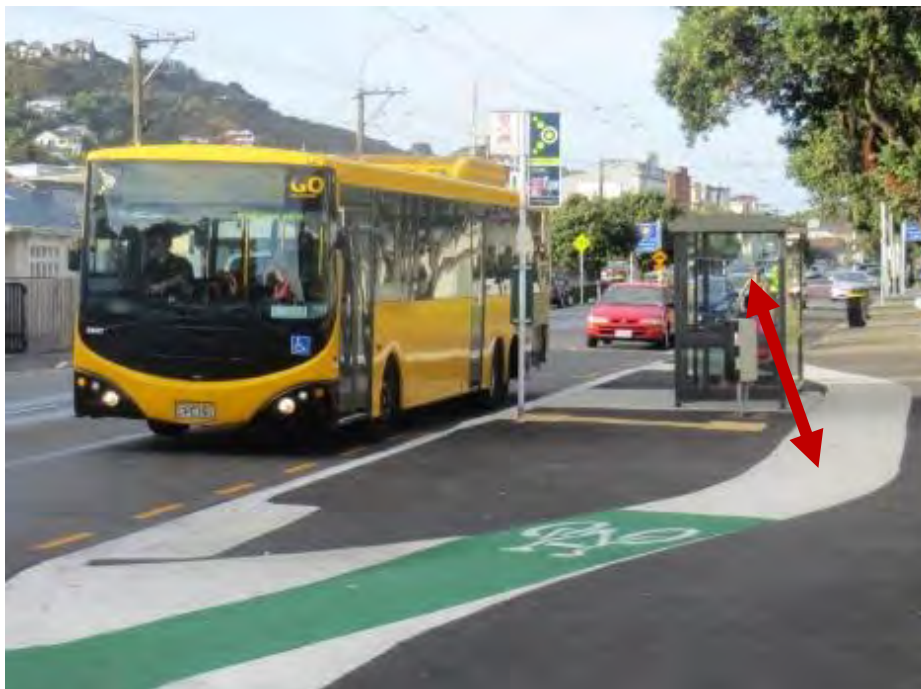
It was noted that the bus shelter north of Avon St had a clear side walls (refer to Figure 2-13 below), this increases inter-visibility between modes and reduces the potential for conflict.

Figure 2-13: Photo showing a clear bus stop shelter, north of Avon St, providing good intervisibility between modes

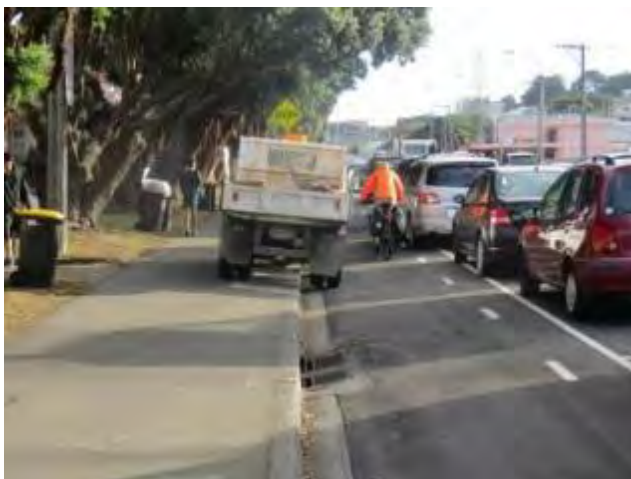
However, the SAT observed a number of vehicles parked well across the buffer zone, refer Figure 2-14 to Figure 2-17. Vehicles parked well across the buffer zone reduce the safety zone space increasing the risk of injuring a cyclist when passengers entering or exiting their vehicle open vehicle doors into the cycleway. Safe-hit posts (or other devices) installed on the corners of the respective parking bays aim to reinforce good parking behaviour to enable the safety zone space / buffer zone to be utilised by the open vehicle doors thereby minimising the likelihood of cyclist/vehicle door collision.

Figure 2-14: Photo showing a combination of vehicles parked across the buffer zone and on the footpath, limiting the width available to the cyclist

To date there has been some education but little enforcement. We will instruct enforcement action to commence with a warning then infringement procedure. We will continue to monitor parking compliance and look to install safe hit posts if required.

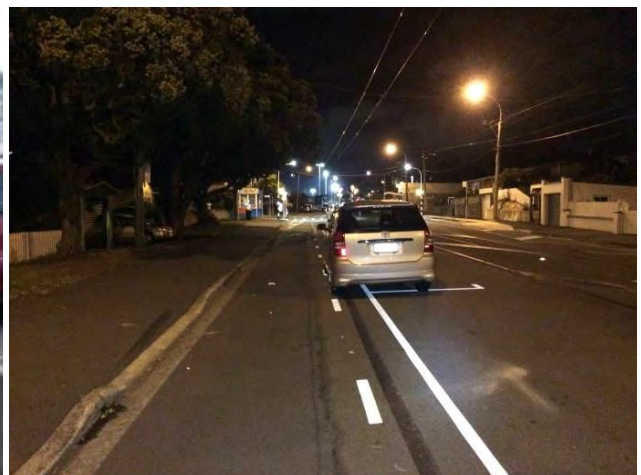
Figure 2-15: Photo showing a vehicle parked across the full width of the buffer zone

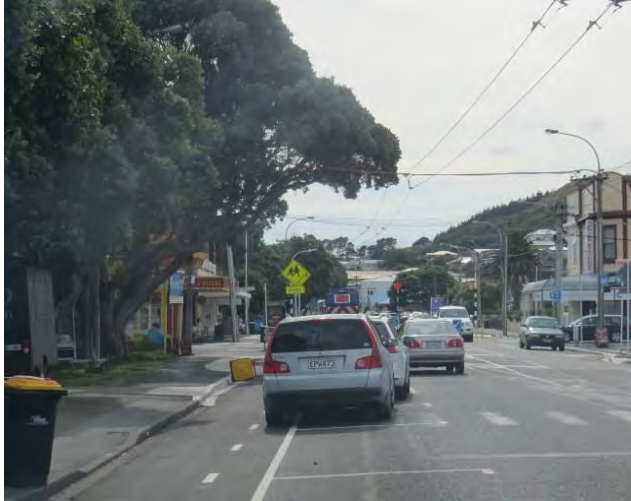
Figure 2-16: Photo showing a vehicle parked well across the buffer zone

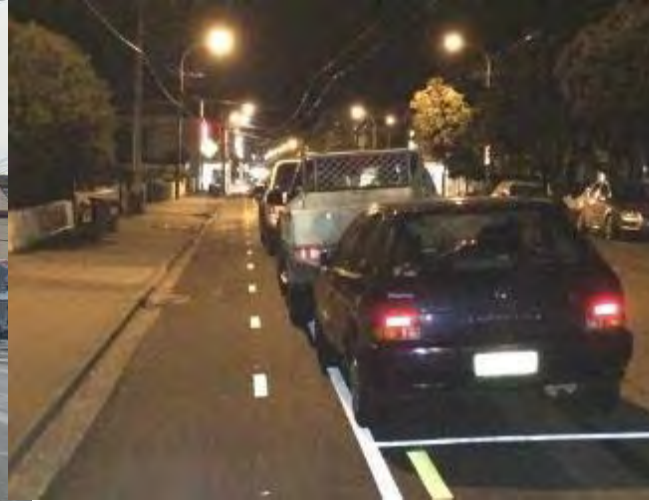
Figure 2-17: Photo showing a number of vehicles parked partially across the buffer zone

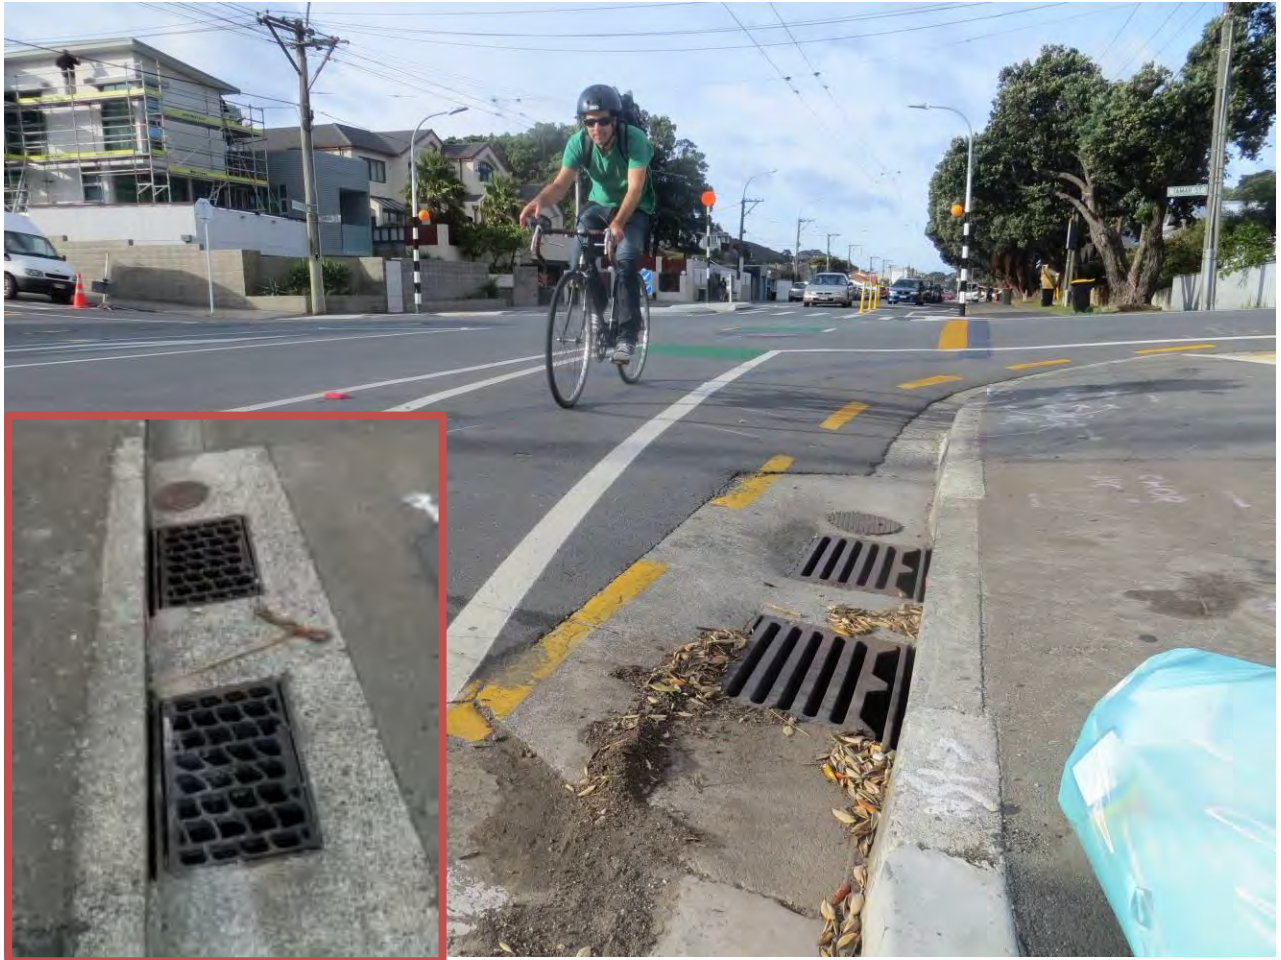
The SAT observed a non-cycle friendly sump at the intersection of Tamar St/The Parade. Although it is noted that this sump is offset from the cycle path, due to the proximity to the intersection, cyclists may prefer to be closer to the kerb, bringing the sump into play. In addition, debris build up at sumps along the project extent should be monitored and cleaned prior to encroaching into the cycleways.

Figure 2-18: Photo showing a non-cycle friendly sump at Tamar St/The Parade (inset photo: example of cycle friendly sumps elsewhere along the route).

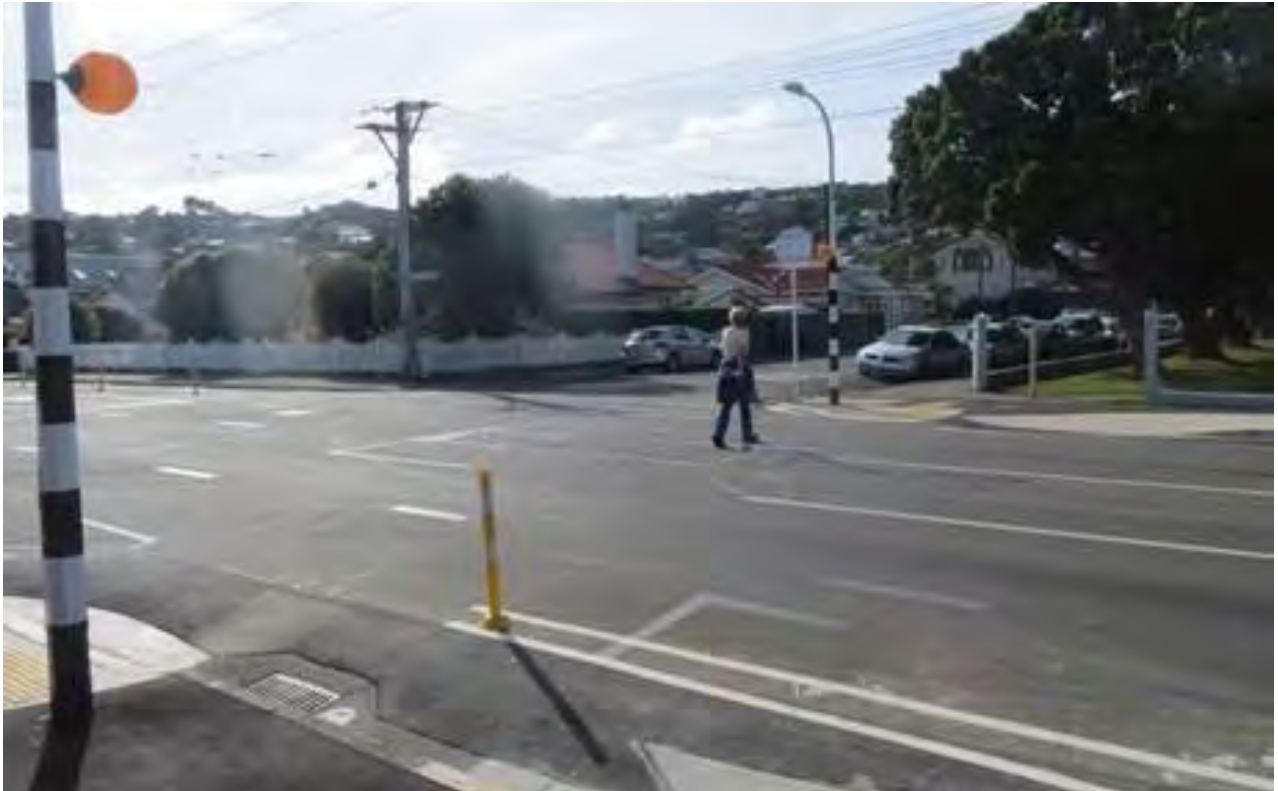
This sends mixed messages to both the pedestrian and approaching motorists. The SAT observed pedestrians utilising the pedestrian crossing even though there are no pedestrian zebra crossing markings provided on the carriageway (refer Figure 2-20 below). Motorists may not give way to pedestrians as they may not be perceived to be on a pedestrian crossing given the lack of zebra markings.

Figure 2-20: Photo showing the partially built pedestrian zebra crossing south of Humber St
Recommendations

This needs immediate action, noting that this issue and the ghost marking issue (Section 2.1.1) were raised with WCC via email the day after the audit (8 April 2016).

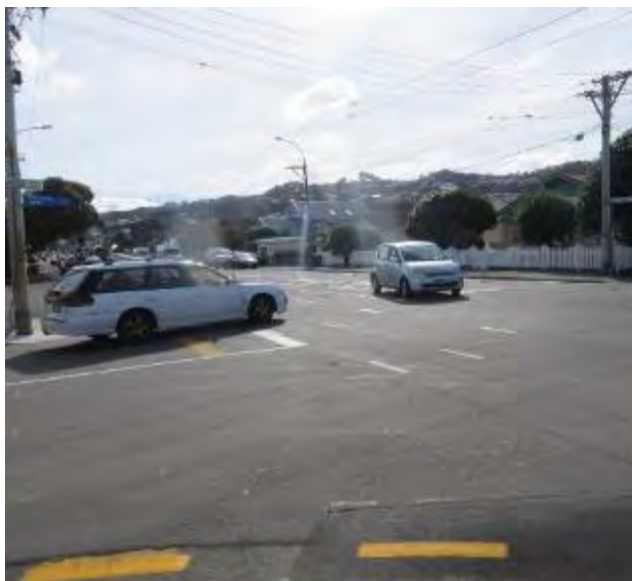
The SAT observed that the safe-hit posts installed at the Humber Street intersections to protect cyclists from vehicles tracking across the cycleway when turning left out (Refer Figure 2-22), are also causing vehicles turning left out of the eastern side of Humber Street to track into the right turn bay (Refer Figure 2-21). The SAT observed a right turning vehicle not being able to use the right turn bay due to being obstructed by a vehicle turning left out of Humber Street onto The Parade. This right turning vehicle was forced to straddle the right turn bay and the southbound traffic lane to avoid the exiting vehicle.

Figure 2-21: Photo showing a vehicle turning left out of the western side of Humber St while another vehicle waits to turn right in

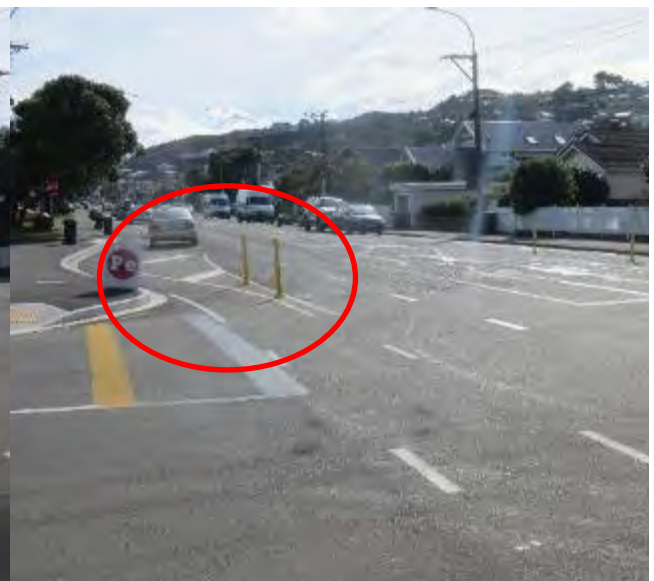
Figure 2-22: Photo showing the safe-hit posts installed at the western side of the Humber St intersection

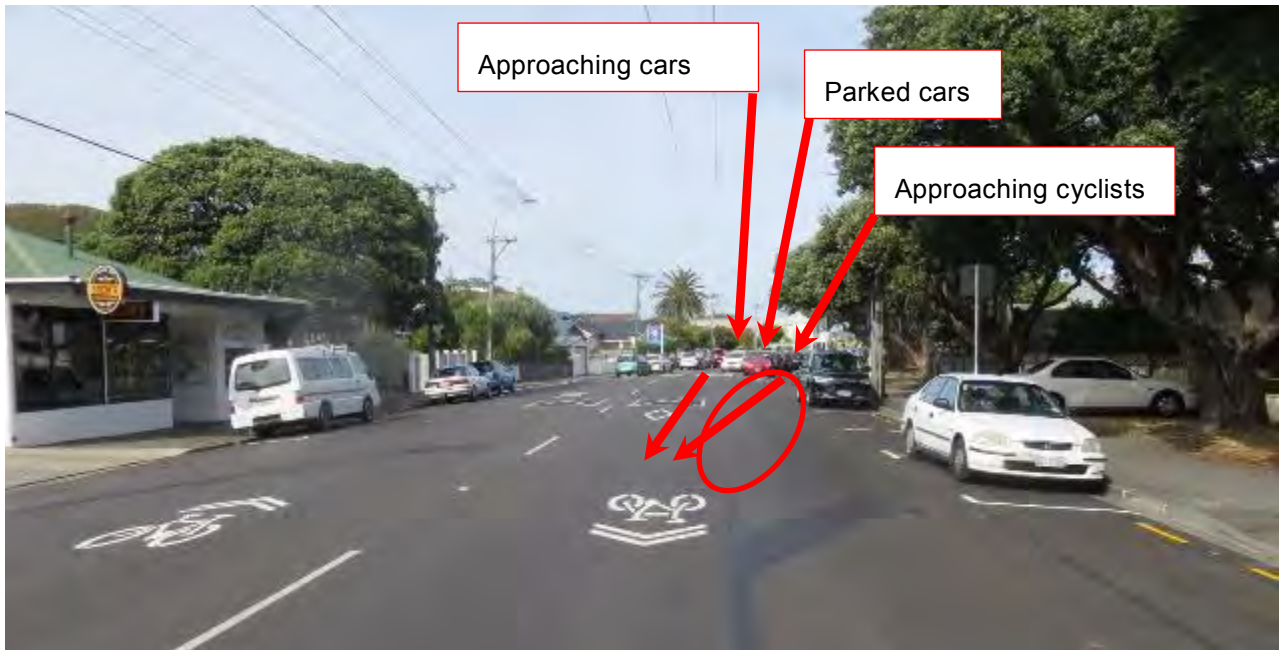
Figure 2-23: View south along the northbound lane on The Parade towards the village. Note the lack of any guidance for cyclists (red circle above) or warning for motorists to expect the presence of cyclists entering the traffic flow.

Consideration should be given to providing an appropriate length of dedicated cycle lane with green surfacing which flares away from the kerb toward the northbound traffic lane thereby providing additional warning of the likely presence of cyclists to northbound motorists approaching the village.

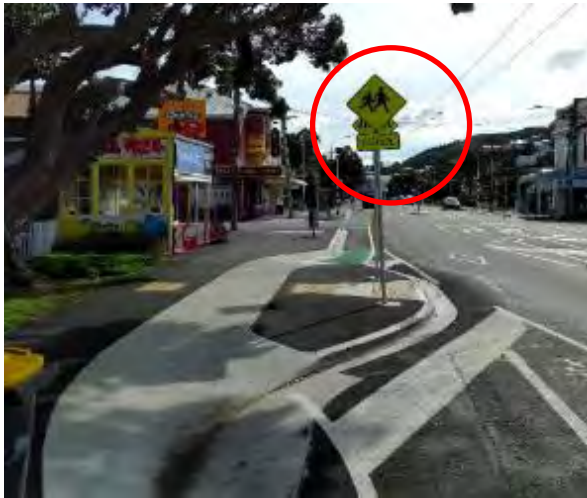
The SAT observed that on the southern approach to the Mersey Street intersection, the school sign combination (PW-32) is obscuring the pedestrian crossing sign (PW-30). This was noted as being an issue from both the cycleway and the traffic lane (where the PW-30 is partially obscured – refer photo

Figure 2-24: View northbound on cycleway approach to the bypass of the pedestrian refuge island. Note the overlapping school and pedestrian crossing signage south of Mersey Street.

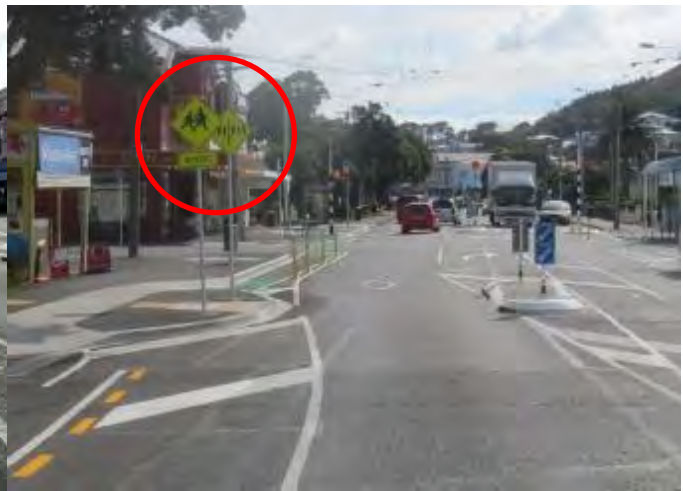
below right). The pedestrian crossing sign is one part of the information disseminated to a road user in advance of a pedestrian zebra crossing therefore it is important that this is not obstructed.

Figure 2-25: View northbound on The Parade approach to the pedestrian refuge island. Note the partially overlapping of the pedestrian crossing signage by the school sign

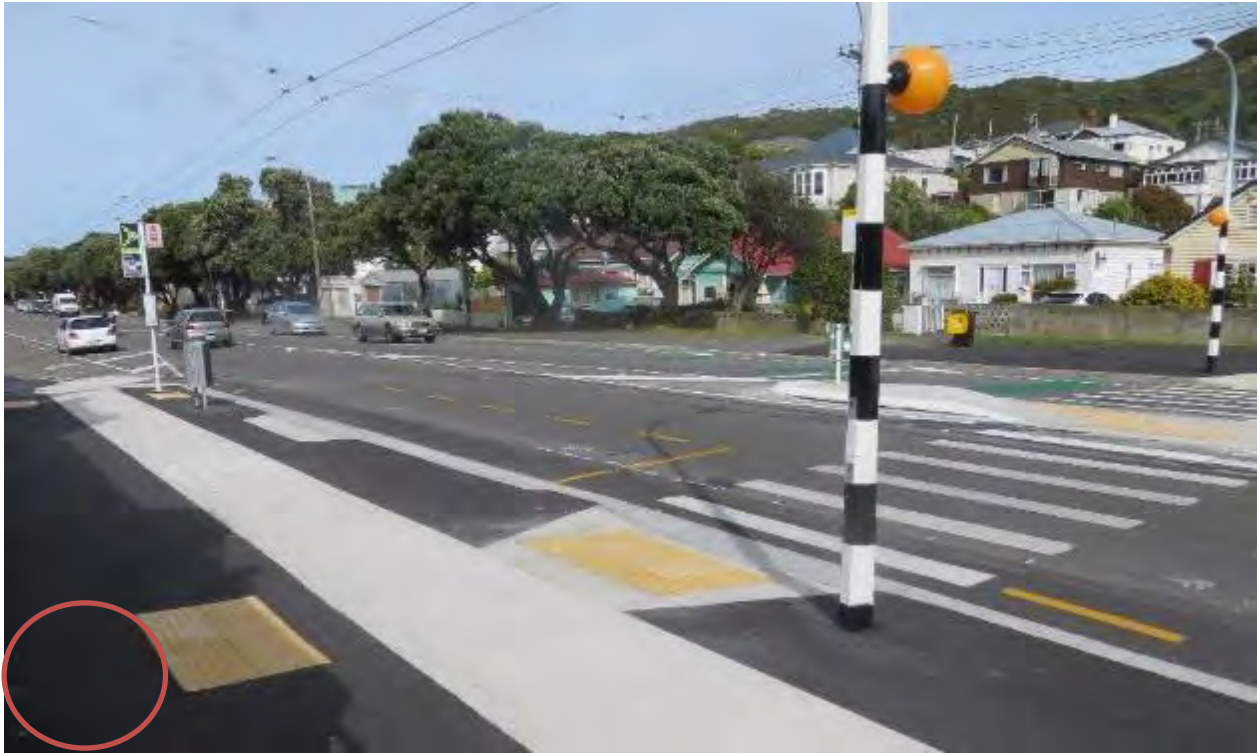
Directional tactile pavers direct visually impaired footpath users towards crossing facilities and public amenities. The SAT observed a lack of directional tactile pavers on the eastern side of the pedestrian zebra crossing located south of Dee Street and due to the width of the footpath, these may be beneficial for visually impaired footpath users at this location, thereby differentiating it from the bus access point located to the south.

Figure 2-26: Photo showing missing directional tactile pavers on the eastern side of the pedestrian zebra crossing located south of Dee Street.

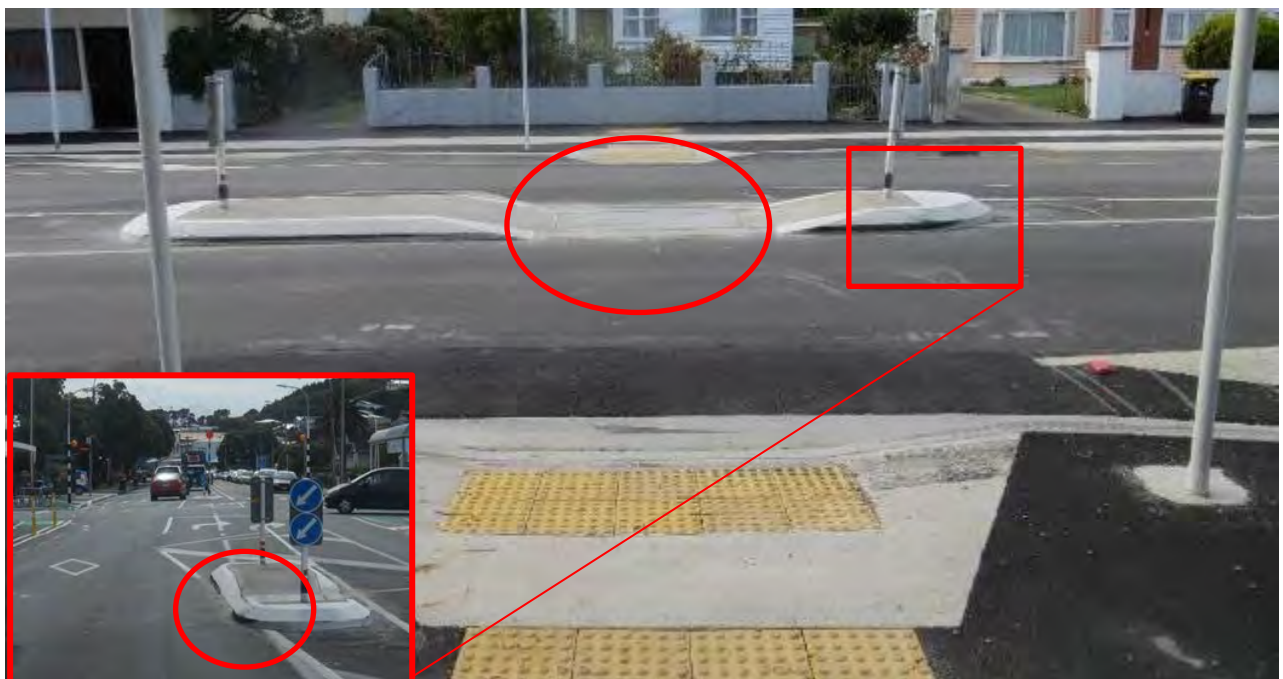
The SAT observed missing tactile pavers at the central island of the pedestrian refuge crossing point (refer Figure 2-27), this may result in visually impaired pedestrians failing to stop at the central island and continuing to cross The Parade, with the potential for vehicle conflict. These were included on the construction drawings but were not installed at the time of the audit site visit.

In addition, the SAT noted that the central kerb build out is sitting outside of the road markings and into the northbound traffic lane (refer Figure 2-27 inset photo). Scuff marks on the kerb confirm this hazard has previously been hit.

Figure 2-27: Photo showing missing tactile pavers at the central island of the refuge crossing south of Mersey St (inset photo: showing the kerb build out sitting outside of the markings)

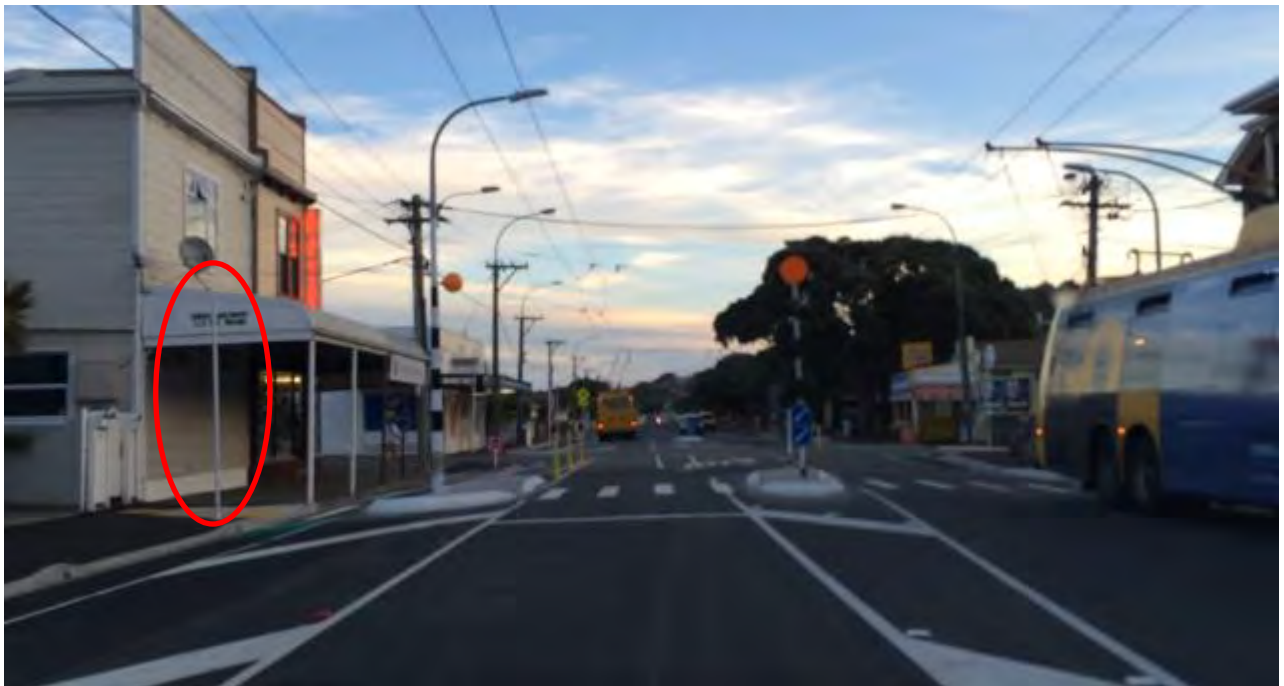
The SAT observed a white pole adjacent to the eastern side of the pedestrian zebra crossing located north of Mersey Street, refer Figure 2-28. There is a pedestrian crossing located between the kerb and the adjacent island which is missing a PW-65 sign and pole. This pole needs to be replaced with a PW-65 incorporating a Belisha Beacon Disk and black and white pole markings which should have been implemented according to the construction drawings provided. The purpose of the Belisha Beacon Disk and markings, at this location, is to provide advance warning to cyclists for the upcoming pedestrian crossing, where cyclists are required to give way to pedestrians.

Figure 2-28: Photo showing a pole without a Belisha Beacon Disk or black and white markings on the pedestrian zebra crossing (eastern side) located north of Mersey Street.

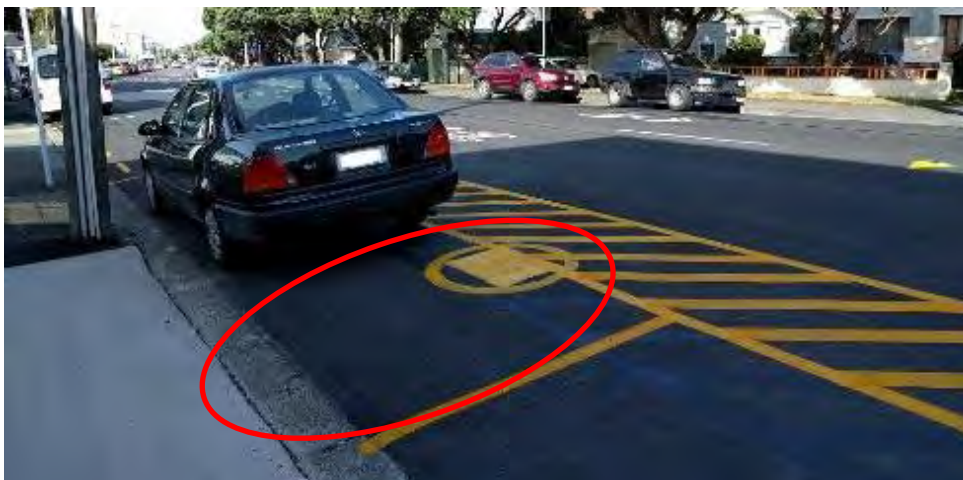
The SAT noted that, following the recent modification to the disabled parking spaces, the fire hydrant is now located within the southern disabled park (rather than just in the buffer area, as previously). There is also no designated area for disabled parking space users to access the footpath and its associated drop kerb from the existing yellow buffer area.

Figure 2-29: Photo showing the length of the southern disabled parking space (note the vehicle parked at the southern end of the space) and the fire hydrant located between the two parking spaces (currently located inside the southern disabled parking space), south of Medway Street

There is a likelihood of vehicles parking over the fire hydrant in its current layout. Therefore, consideration should be given to the repositioning of the southern parking space to avoid the fire hydrant. This would enable the accommodation of a yellow hatched access area of appropriate width (refer to red circled area in photo below) between the respective parking spaces to provide a link between the footpath and the existing yellow buffer area for disabled parking space users.

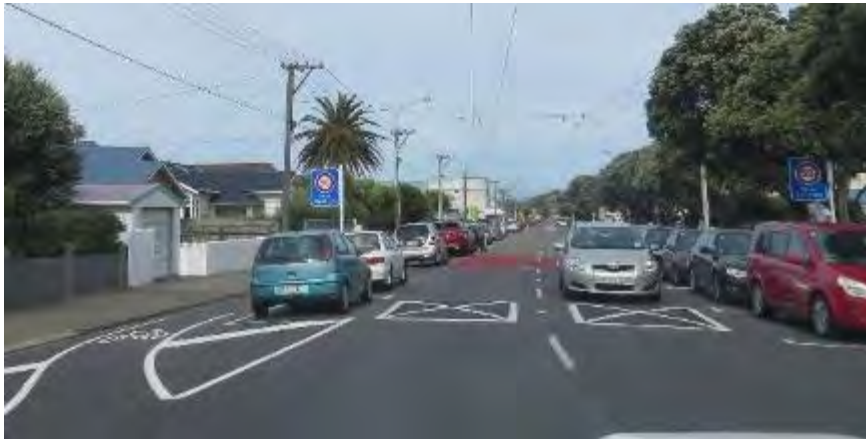
The SAT observed two buses attempting to negotiate the bend simultaneously, which resulted in one bus stopping and waiting until the other had passed.

Figure 2-30: Photo showing the constrained road environment south of Mersey St

Consideration should be given to a review of the bus/heavy vehicle tracking curves on the bend south of Medway St.

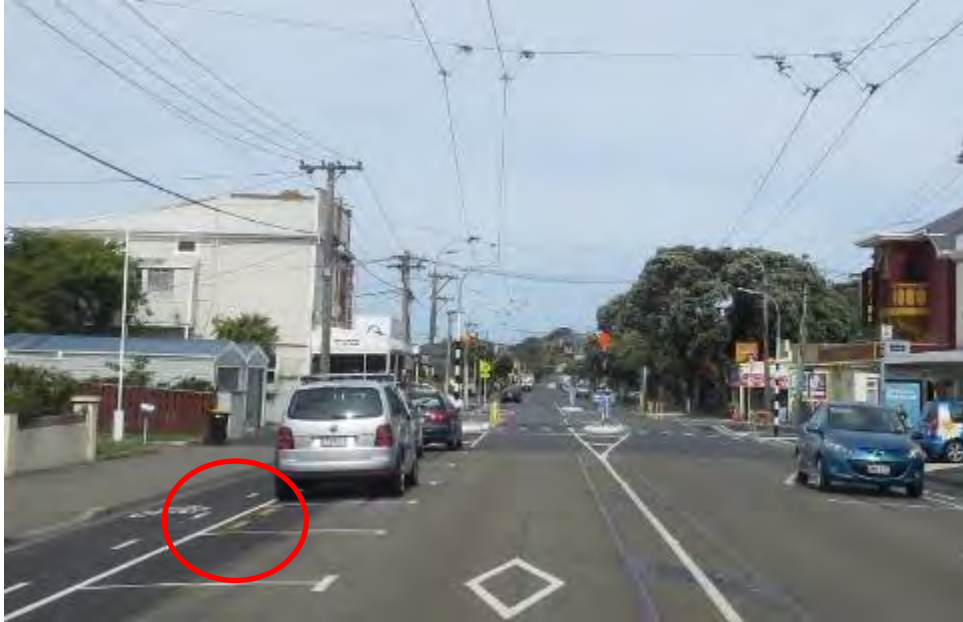
The SAT observed inconsistencies in the application of yellow no-parking line markings across driveways, refer Figure 2-31 and Figure 2-32. In lieu of no-parking markings, motorists may inadvertently attempt to manoeuvre into the space, creating unnecessary potential for conflict and delays with the through traffic. This is exacerbated by the removal of the flush median markings, which would have provided additional manoeuvring width for through traffic.

Figure 2-31: Photo showing no-parking line marking between parking spaces, north of Mersey St

Consideration should be given to applying consistent yellow no-parking line marking between parking bays where driveways are present.

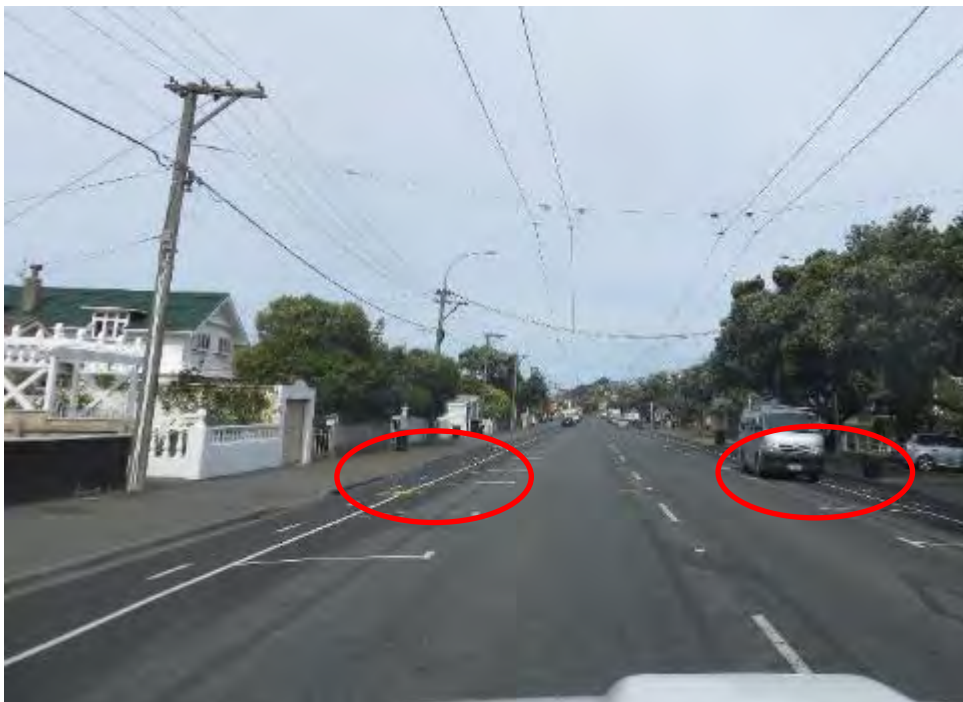
Figure 2-32: Photo showing a lack of no-parking line marking between larger parking spaces

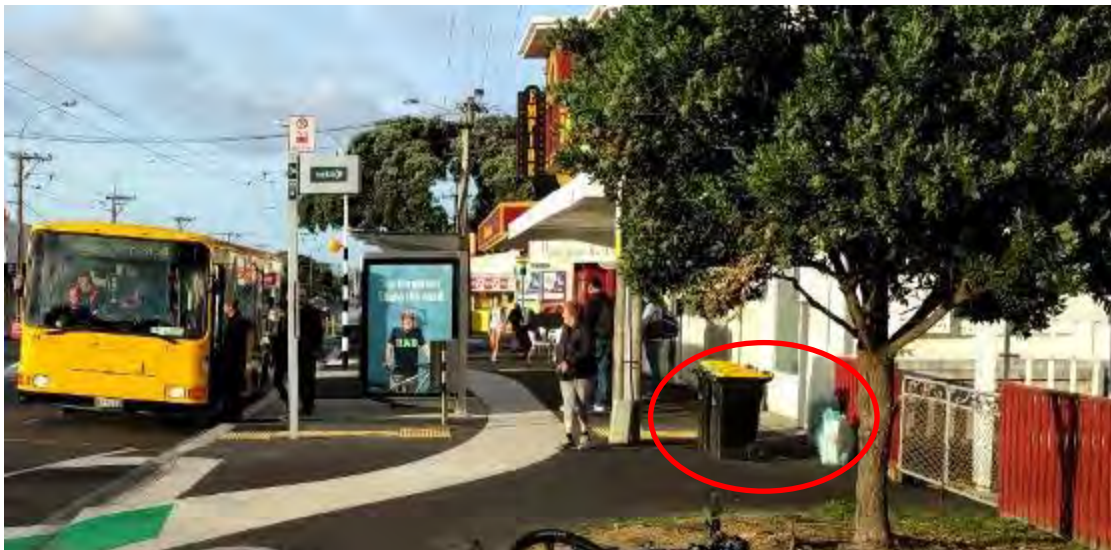
The SAT noted that the placement of the bins by the nearby residents in the vicinity of the Mersey St bus stop bypass, restricts the section of shared space and forces pedestrians into the cycleway section of the bus stop bypass.

Figure 2-33: Photo showing bins obstructing the shared space at the Mersey St bus stop bypass

It is recommended that the owner of the dwelling is encouraged to place the bins closer to the kerb to avoid unnecessarily obstructing the footpath.
