# Aro Valley cycleway audit - safety and accessibility

90% design audit

**Paneke Pōneke**  
Bike network plan

October 2022

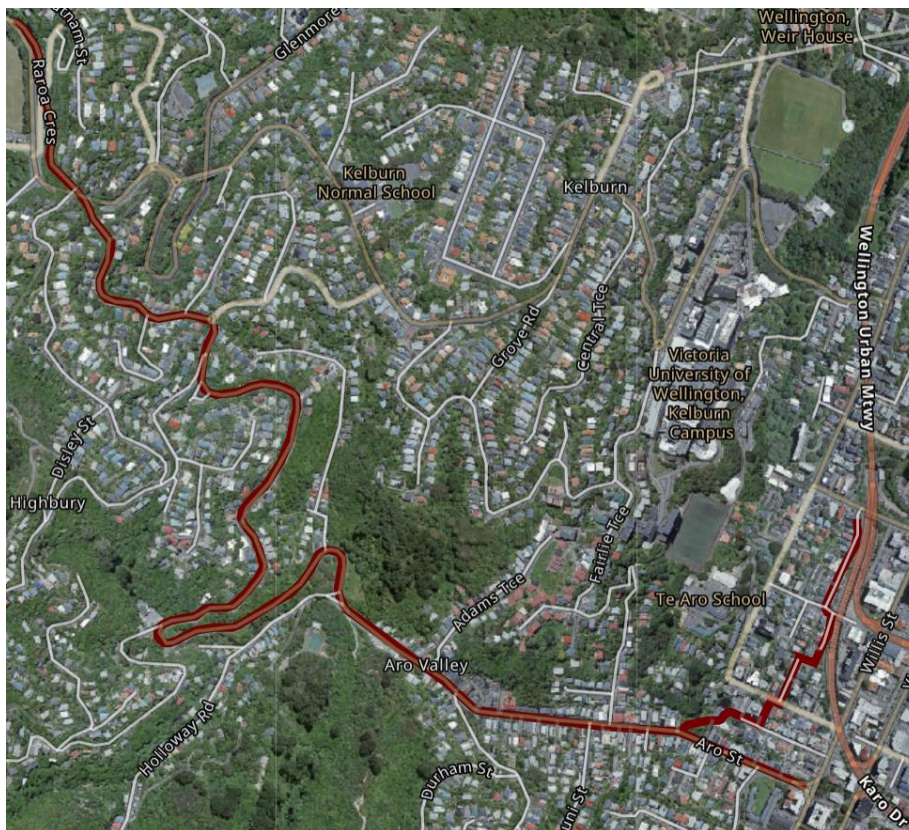
**Figure 1.1-1: Extent of Aro Valley route**

This CASA is for the 90% stage of the Aro Valley route, which links the western side of the CBD at Willis Street to Chaytor Street, which is on the Karori side of the Karori tunnel (see Figure 1.1-1). This CASA refers to two directions of travel along the route: Citybound, which is generally downhill and Karori-bound, which is generally uphill.

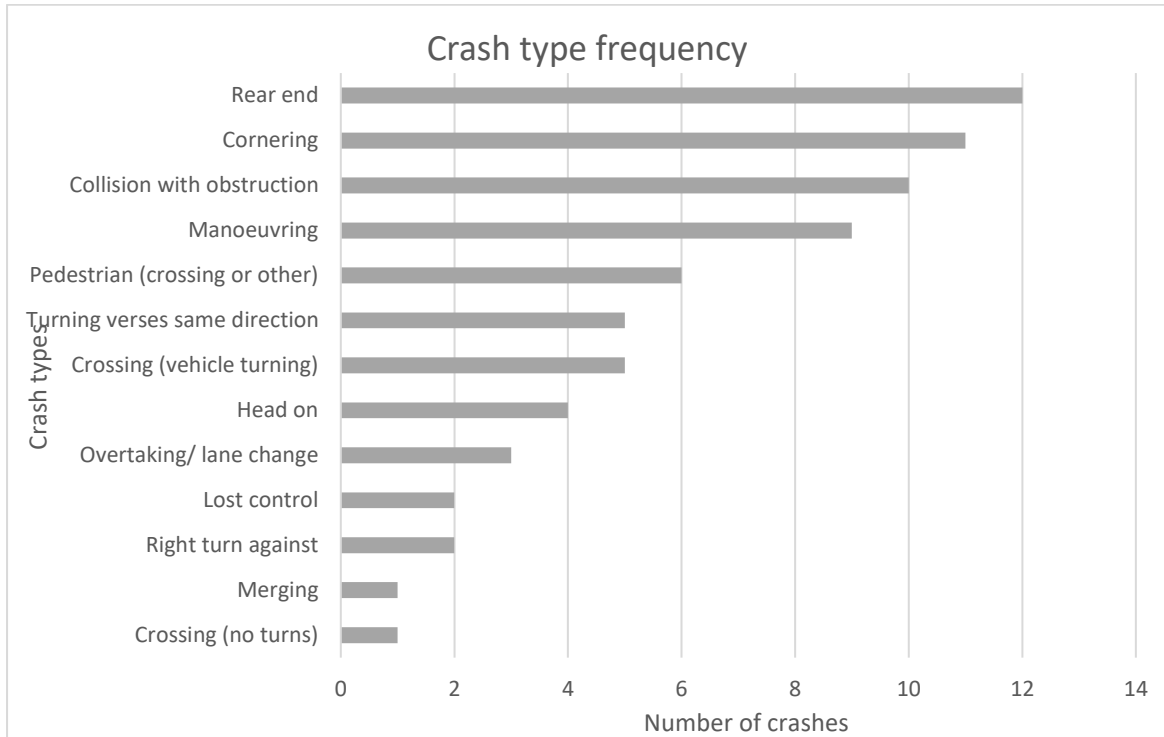
**Figure 1.6-2: Reported crash factors (grouped)**

All crash factors by group are presented in Figure 1.6-2. Each crash may have several factors thus there are more factors at play than just the number of crashes.

The top four crash factors (rear end, cornering, collision with obstruction and manoeuvring) all point to the constricting alignment of the road and amount of traffic on the route. Given the lack of alternative options for alignment and the nature of the corridor these are unavoidable risks that should be minimised through design, including reductions in travel speeds.

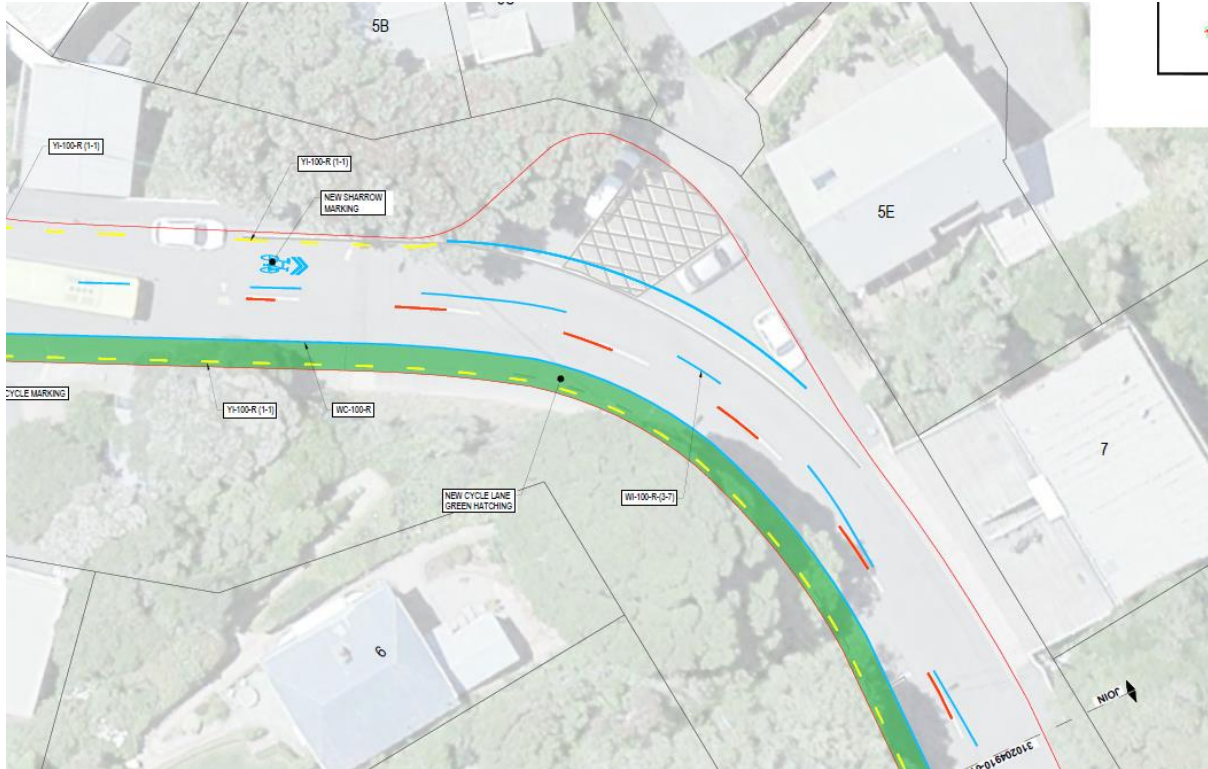
**Figure 2.4-1: Cycle lane on inside of curve, Raroa Road**

There are several sections, particularly along Raroa Road where there is a cycle lane without buffers or separators on the inside of a curve (e.g. Figure 2.4-1). In such locations, motorists are likely to track into the cycle lane while cornering.

This issue was raised in the 30% CASA, with the recommendation to install either flexiposts or audio-tactile profiled (ATP) line-marking leading up to and around a cycle lane on the inside of a curve. The designer noted that buses would need to encroach on the cycle lane around the corners. The decision from the safety engineer and client was to install ATP, but these have not been indicated on the plans.

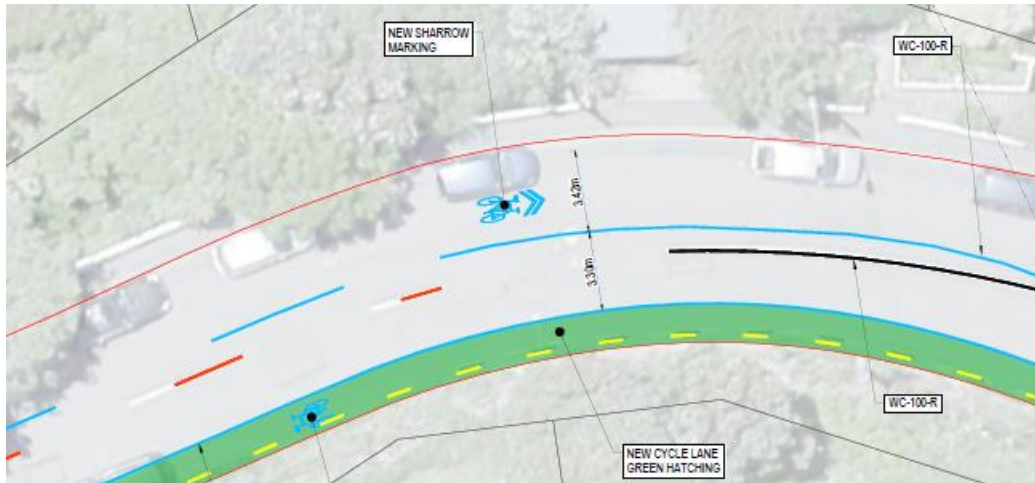
Some sharrows have been marked too close to on-street parking. Locations include:

Figure 2.6-1: Sharrow too close to parking – 25 Raroa Road

This may encourage cyclists to ride in the “door zone” of parked vehicles. If a driver opens their door and a cyclist collides with it, they will likely fall into the path of traffic, which would be very likely to result in serious injury due to the vehicle speeds involved and the vulnerability of cyclists lying on the ground. Given the parking demand along the route, such incidents are expected to be common.

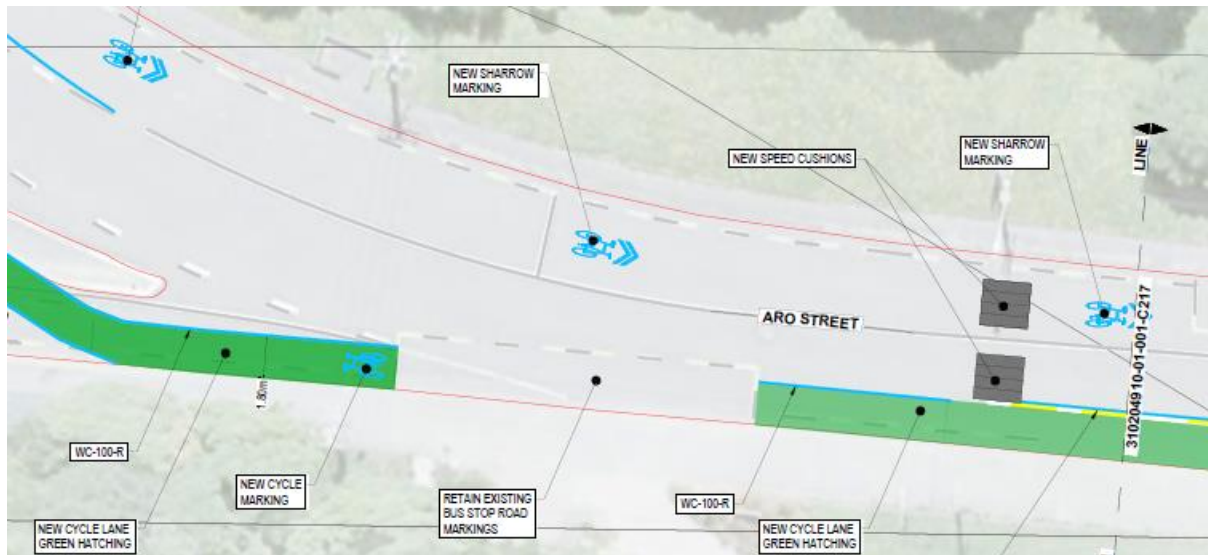
**Figure 3.2-1: Speed cushions near bus stop, east of Holloway Road**

If there is a bus parked in the Karori-bound bus stop on the approach to Holloway Road (see Figure 3.2-1) approaching cyclists will have to wait until passing the speed cushion before entering the general traffic lane to pass the bus. This is a reasonably tight manoeuvre and will be complicated by available gaps in the motor traffic, plus uphill riding.

This is not a high frequency bus route, so it is expected that crashes occurring due the geometry in this location will be infrequent. But the vulnerability of cyclists and speed of motor vehicles means that it is likely to result in serious injury. Therefore, this is a moderate issue.

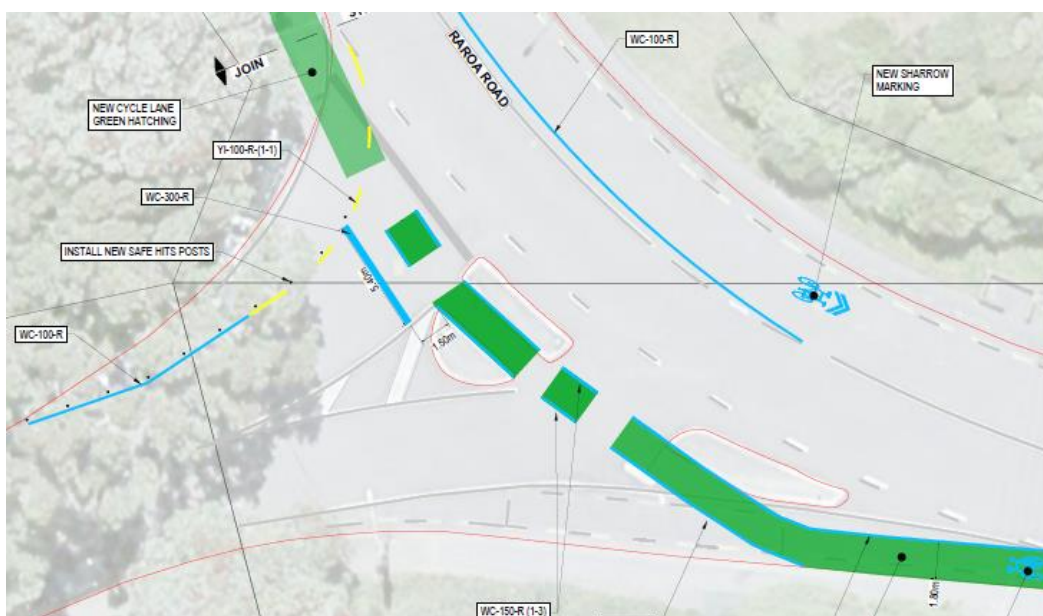
**Figure 3.3-1: Holloway Road intersection design**

This intersection was identified in the 30% CASA for two reasons – the alignment of the Karori-bound cycle lane crossing Holloway Road, and the width of the lane for departing Holloway Road. The 90% design has addressed the width of the lane for turning out of Holloway Road by using safe-hit posts to narrow the lane. The CAT also notes a draughting error showing broken yellow lines across the cycle lane in this location.

The issue with the Karori-bound cycle lane alignment remains. The cycle lane bends behind an existing island – to motorists turning into or out of Holloway it may appear that cyclists are turning into Holloway and not realise they are following the cycle trajectory along Aro Street (see Figure 3.3-1).

In the 30% CASA it was recommended to bend the cycleway out further away from Aro Street (at least one car’s length) with a raised platform and give way line for motorists. However, this was rejected on the basis that the project cannot add another raised platform. If this is not an option, it would be preferable to retain the cycle lane on the main carriageway, so that the trajectory of cyclists is unambiguous to turning motorists.

3.3.1	If the recommendations from the 30% CASA cannot be achieved, retain the cycle lane on the main carriageway.
3.3.2	Rectify the draughting error that shows broken yellow lines across the cycle lane.

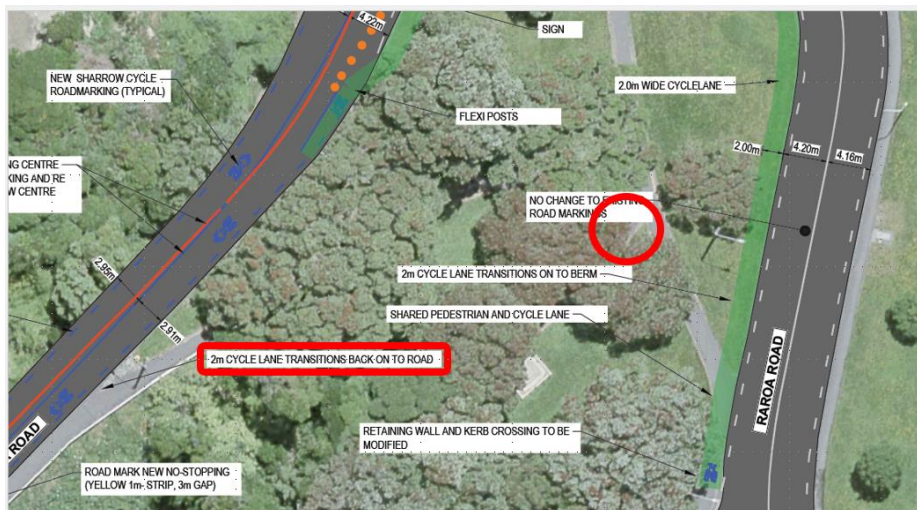
**Figure 3.4-1: E-bike short cut on existing path on Raroa Road loop**

In the 30% CASA (issue 3.13) it was identified that e-bike riders (and very fit/fast unpowered bike riders) are likely to use the existing (steeper) footpath as a short-cut uphill rather than ride the cycleway around the Raroa Road loop near Entrance street. The CAT’s recommendation to provide a kerb cut down at the upper end of the footpath, to enable e-bikers to rejoin the carriageway was agreed upon by the designer and client, but this has not yet been added to the 90% plans.

There are overhanging trees that could hinder e-bikers, plus no kerb ramp from the footpath to the carriageway at the end of the short cut. The former could result in an e-biker falling onto the path, the latter could result in them falling onto the live carriageway and being hit by a motor vehicle. Both are expected to be infrequent occurrences, as e-bikers would generally anticipate and avoid the hazards, but falling onto the live carriageway would be likely to result in serious injury.

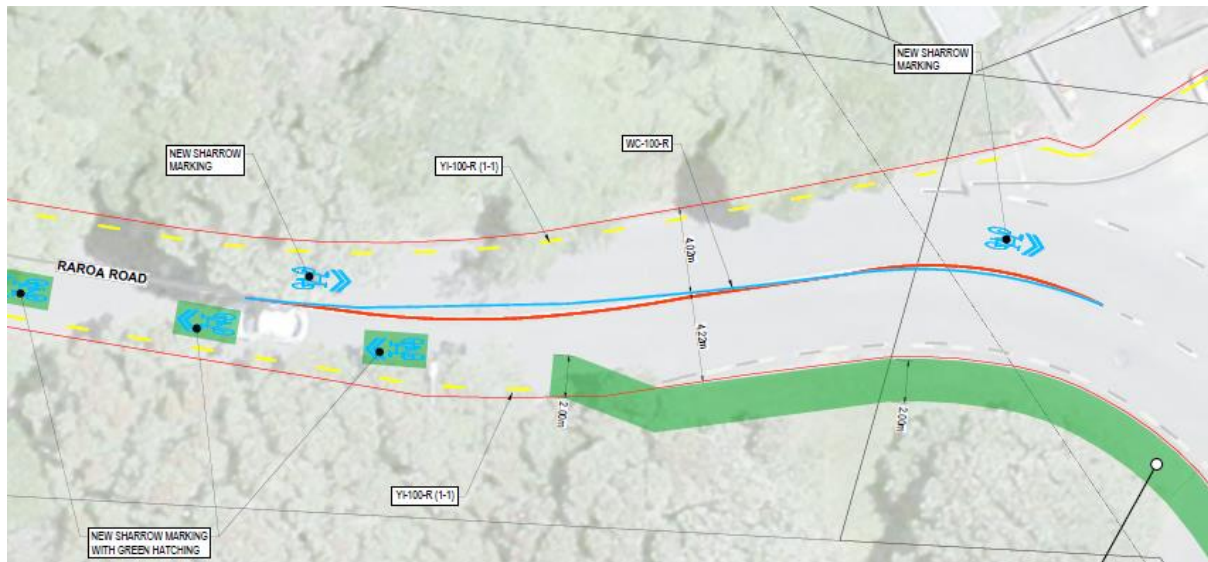
**Figure 3.5-1: Off-road cycleway transitions to mixed traffic on Raroa Road**

The 30% CASA identified an issue with the transition of the Karori-bound off-road cycle path to mixed traffic on Raroa Road, which involved safe-hit posts that appeared to result in a traffic lane narrower than the legal minimum width of 2.5 m. The 90% design (see Figure 3.5-1) has removed the flexiposts but still appears to have a short section of on-road cycle lane which would result in a section of the general traffic lane being approximately 2.3 m wide.

Furthermore, without the safe-hit posts, the cycle lane creates an unacceptable taper on the general traffic lane.

This could result in cyclists thinking they have a dedicated lane as they enter the carriageway, without there being sufficient space for motorists to pass them. Given the ambiguity, resulting crashes are expected to be occasional, and, given the speeds involved and vulnerability of cyclists, likely to cause serious injury.

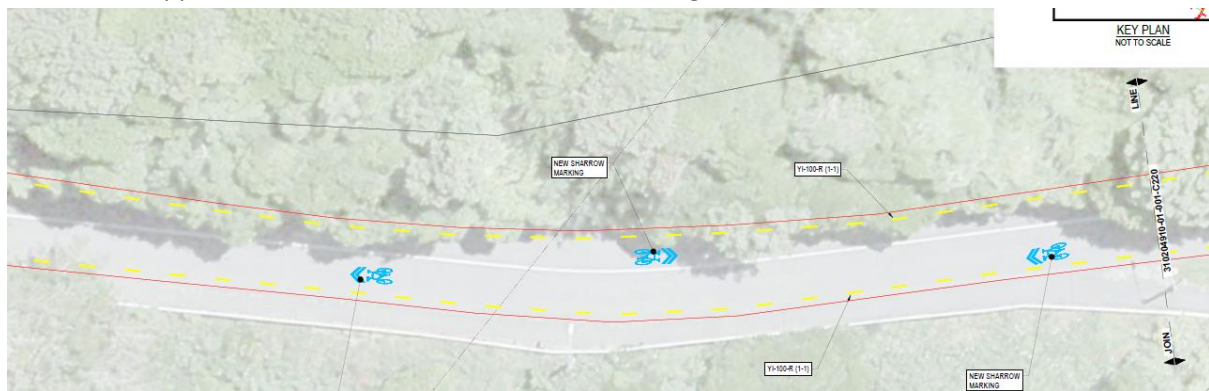
**Figure 3.6-1: Narrow sections of Raroa Road in city-bound direction**

There is a section of Raroa Road east of Entrance Street (sheet 21 of the 90% plans) where the city-bound lane appears to be narrower than the minimum legal lane width of 2.5 m.

This is located in a hilly, winding section of road where people cycle in mixed traffic. Having a lane that is too narrow, in combination with these other factors, could result in conflict between cyclists and motor vehicles in either direction.<sup>1</sup>

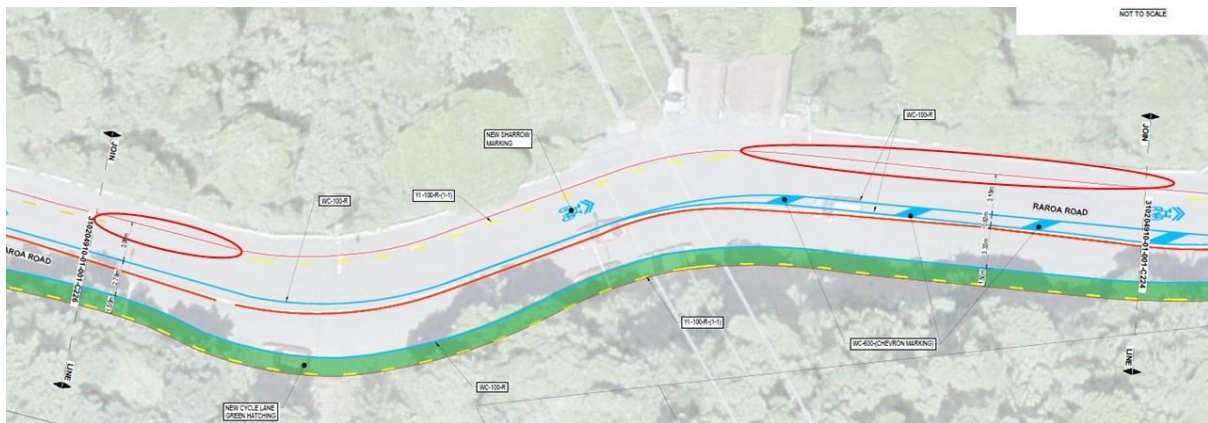
**Figure 3.7-1: No-stopping in the vicinity of 166 Raroa Road**

Raroa Road forms a hairpin bend at Mount Pleasant Road and has a steep gradient. Near 166 Raroa Road, some no-stopping restrictions have been added to accommodate the new cycle lane and flush median. However, the CAT suggests that it would be preferable to also add no-stopping in the sections circled in red in Figure 3.7-1, to provide a consistent stretch of route.

If vehicles are parked in the sections circled in red in Figure 3.7-1, the available lane width will be too narrow for moving vehicles to stay in their lane while passing the parked vehicle. Drivers may be too overloaded thinking about avoiding hitting the parked car, watching for oncoming traffic, negotiating the gradient and bends etc to also remember to look out for cyclists travelling in the mixed traffic lane.

3.7.1	Continue the broken yellow no-stopping lines in the sections circled in red in Figure 3.7-1 in the vicinity of 166 Raroa Road.
-------	--

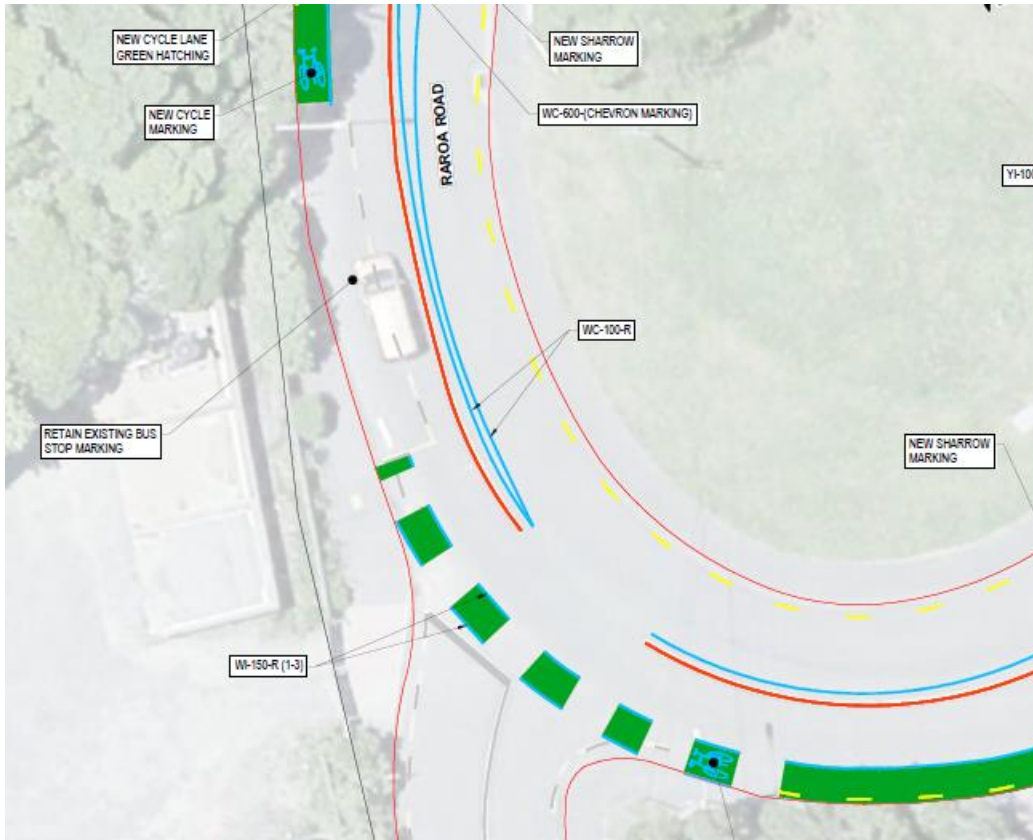
There is an in-lane bus stop in the Karori-bound cycle lane soon after it crosses Mount Pleasant Road – see Figure 3.8-1.

Figure 3.8-1: Cycleway across Mount Pleasant Road, approaching in-lane bus stop

The proposed design extends the green blocks for side street crossings past the side street, resulting in a small block prior to the bus stop. It would be preferable to have a longer section of cycle lane with solid colour prior to the bus stop, to distinguish the bus stop from the side road, particularly for cyclists and motorists turning left out of Mount Pleasant Road.

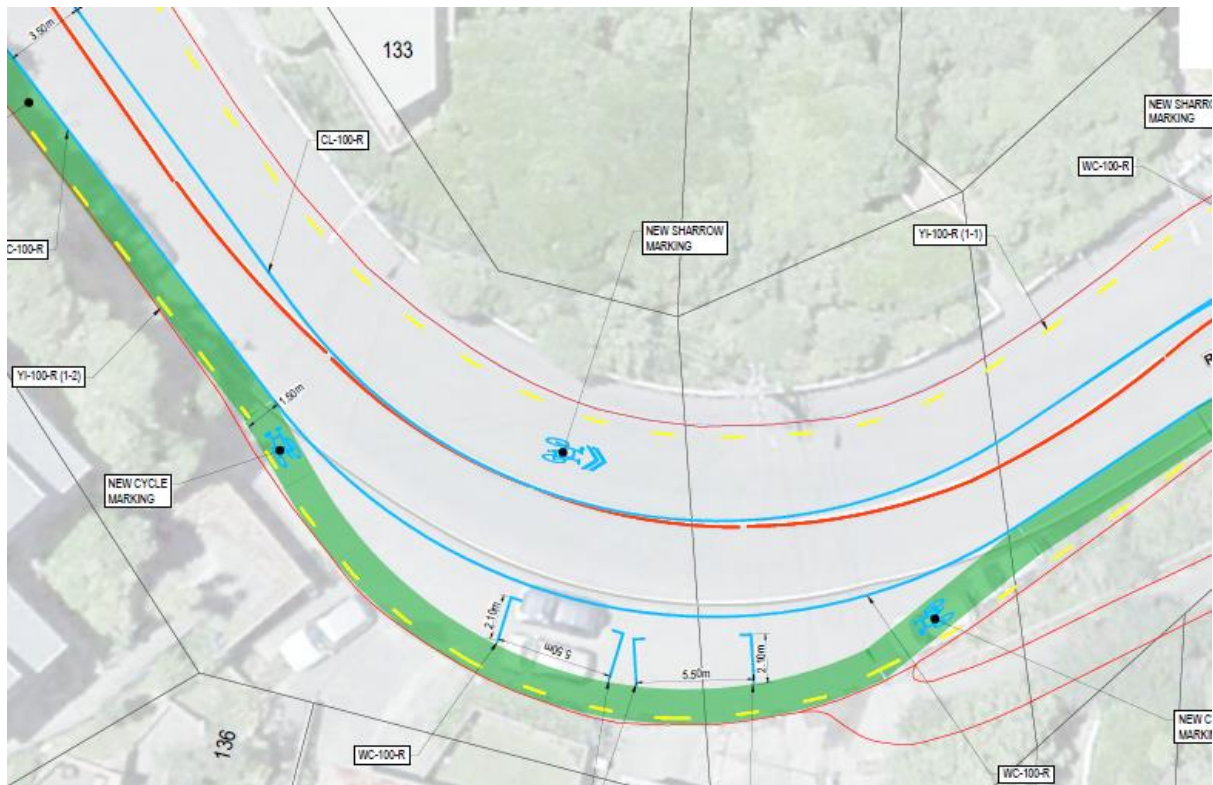
**Figure 3.9-1: Marked parking spaces adjacent to cycle lane**

The design shows two marked parking spaces adjacent to the Karori-bound cycle lane in a bend on Raroa Road – as shown in Figure 3.9-1:

There is no physical measure to stop cars encroaching on the cycle lane here. The aerial photos show two cars parked side-by-side – this suggests a high parking demand which may make it likely drivers will park a little over the cycle lane. It also shows that drivers are not concerned about parking close to the general traffic lane, and therefore it could be acceptable to move the proposed parking spaces slightly away from the cycle lane to accommodate a physical barrier, which will also help prevent passenger dooring incidents.

Cars encroaching on the cycle lane will cause a pinch point for cyclists and, in extreme cases may cause cyclists to leave the cycle lane and enter the general traffic lane – if this occurs suddenly it may result in a crash with motor vehicles. Such crashes would be infrequent but likely to result in serious injury.

There is also the question about the legality of providing a marked parking space to the right of a broken yellow (no-stopping) line).

3.9.1	Provide a physical barrier (e.g., wheel stops) between the cycle lane and marked parking spaces – move the parking spaces slightly to accommodate this.
3.9.2	Do not mark broken yellow lines adjacent to the car parking spaces.

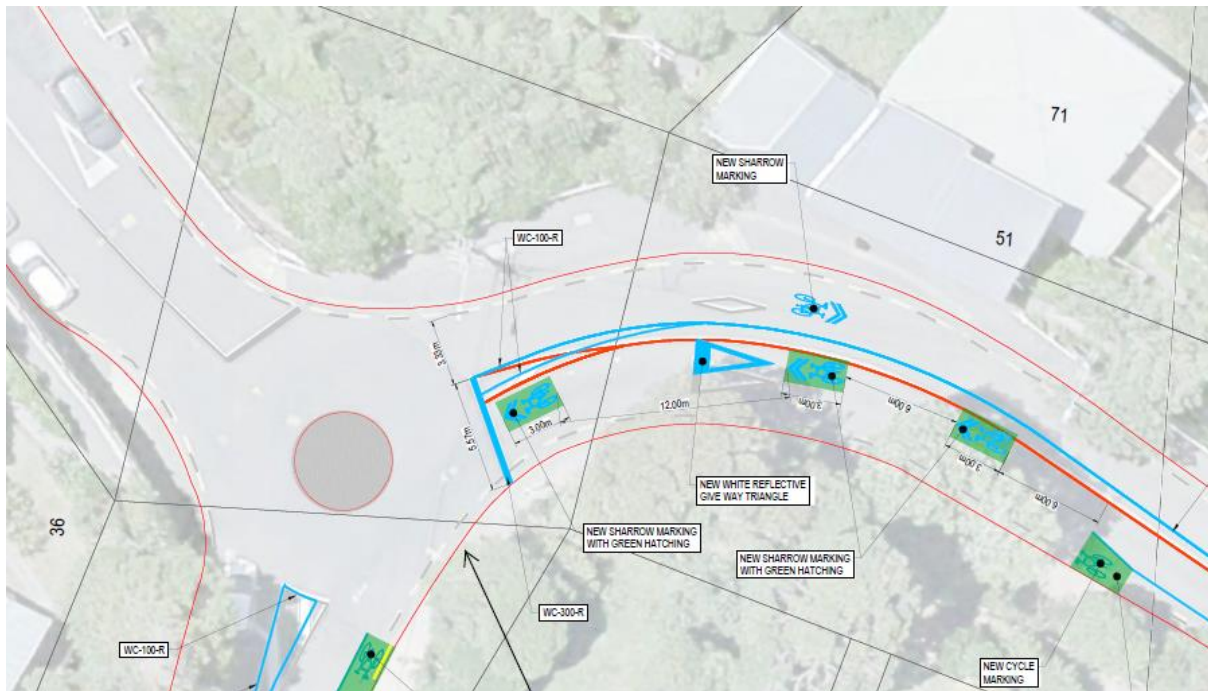
**Figure 3.10-1: Plunket Street roundabout**

As per the 30% CASA (issue 3.16) the Karori-bound approach to the Plunket Street roundabout has been modified to transition to mixed traffic rather than have a kerbside cycle lane up to the limit line – see Figure 3.10-1.

However, there are some concerns with the way this has been implemented. Firstly, the sharrows are too close to the centreline – they should be positioned in the centre of the lane.

Secondly, the approach lane is wide enough that drivers might form two approach queues. This could make it difficult for cyclists to manoeuvre and cause conflict on the approach, or if they get stuck on the wrong side of motor vehicles, conflict travelling through the roundabout.

These issues are expected to be occasional sources of crashes, which would be likely to cause serious injury.

<b>Designer</b>	3.10.1 – agree, design to be updated. 3.10.2 – agree, design to be updated.
<b>Safety Engineer</b>	Agree with CAT and Designer.
<b>Client</b>	Agree
<b>Action</b>	Update designs as per CAT recommendation.

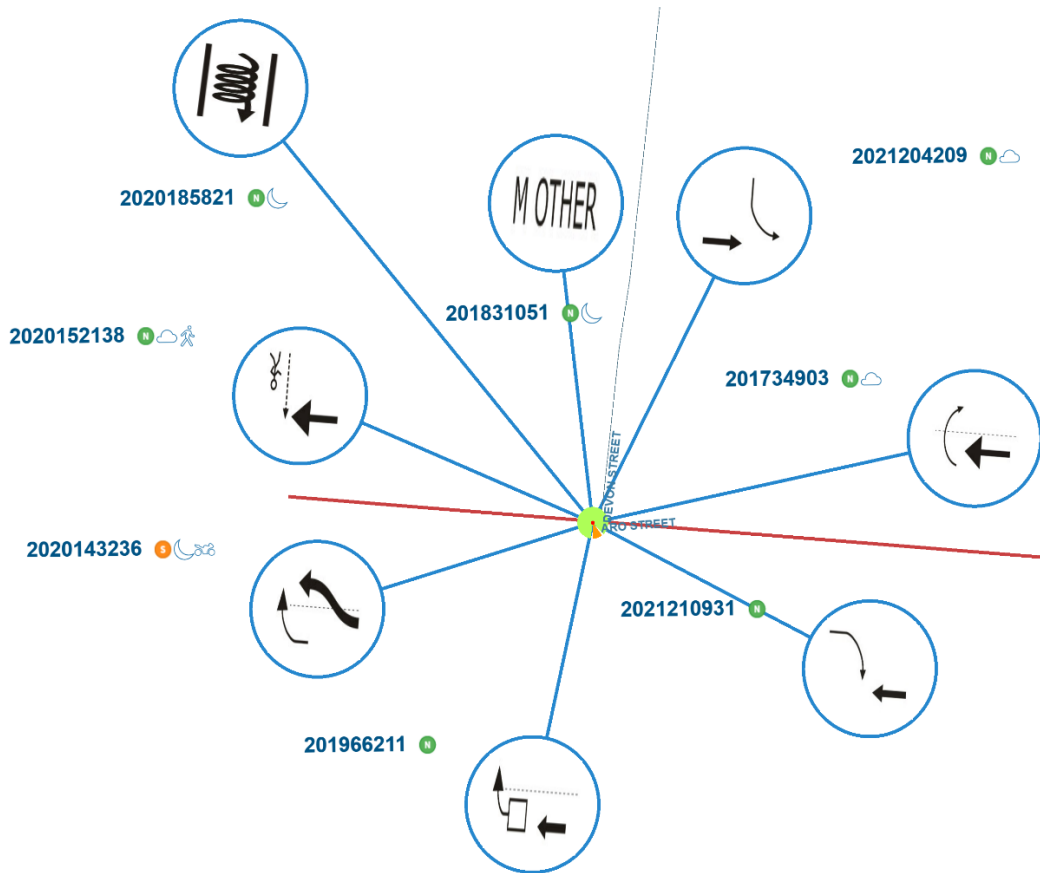
**Figure Appendix A-1**

Crash data for the Devon Street intersection indicates that:
