# Ngaio cycleway audit - safety and accessibility

90% design audit

This CASA is for the 90% design stage of Wellington Transitional Cycleways, Ngaio Gorge section.

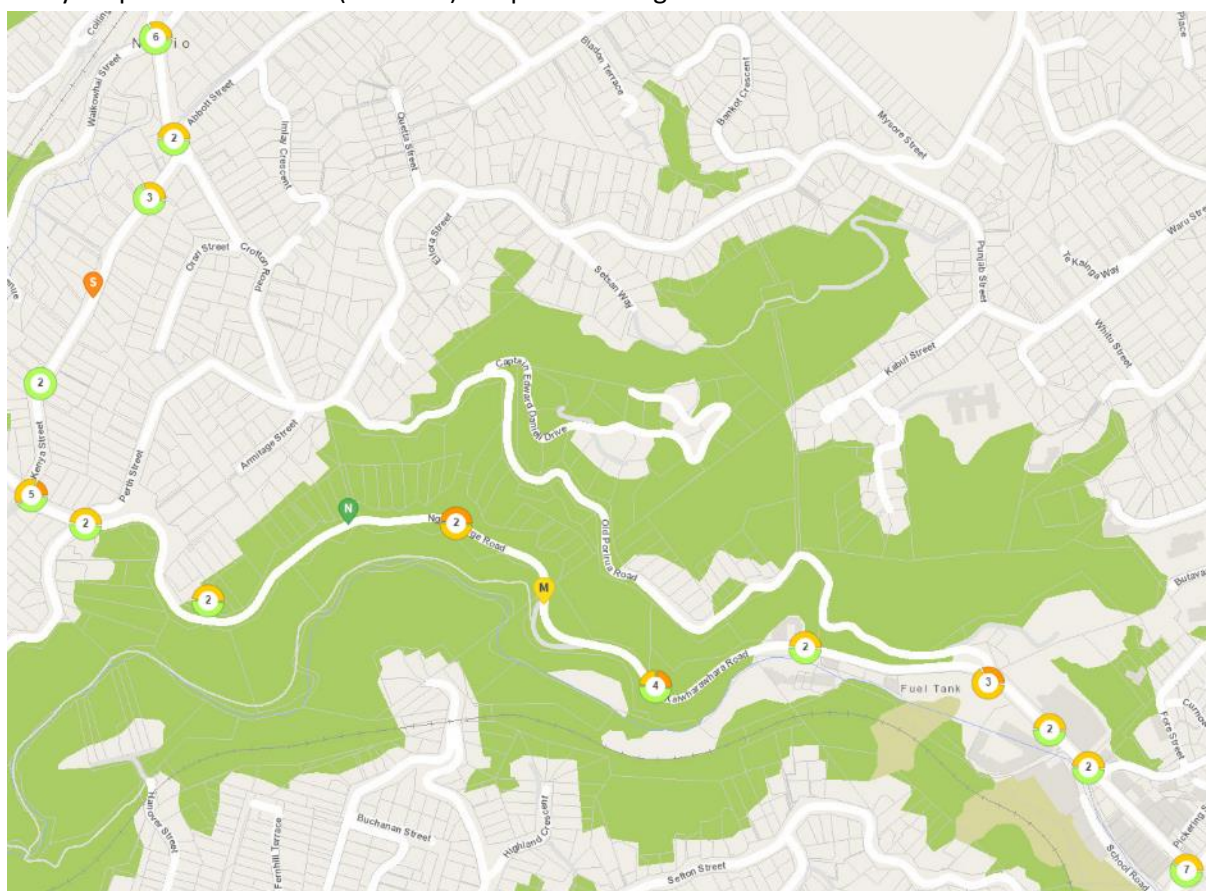
**Figure 1-2: all crashes reported in the proposed Ngaio corridor**

A total of 47 crashes were reported along the proposed Ngaio project corridor over the five-year period. Five of these were serious (four involving cyclists), 22 minor (six involving cyclists) and 26 noninjury (all involving motor vehicles). Of those involving cyclists, two were at the Hutt Road intersection (both causing minor injury), two more were at the intersection with Old Porirua Road (one serious and minor injury), two occurred between this intersection and Trelissick Crescent (both causing serious injury), one at the western Trelissick Crescent intersection (causing serious injury) and one at the Waikowhai Street roundabout (causing minor injury).

Crashes are slightly clustered near Hutt Road, at Trelissick Crescent intersections, and the Waikowhai Street roundabout. While there are clustered no predominant crash pattern or black spots present

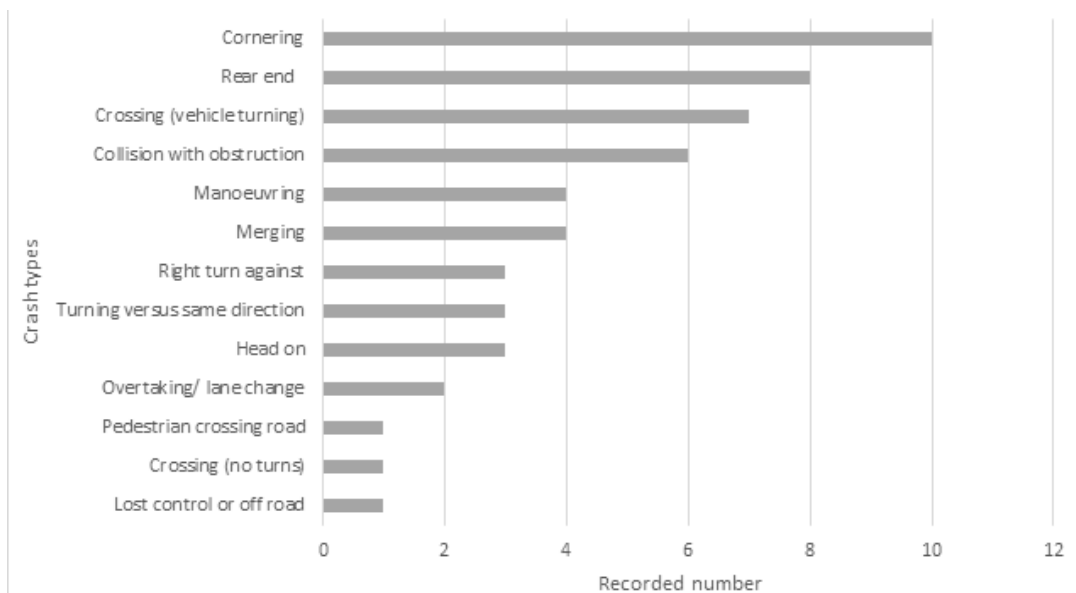
**Figure 1-3: reported crash factors (grouped)**

The top four crash factors (cornering, rear end, crossing (vehicles turning), collision with obstruction) all point to the constricting alignment of the road. Given the lack of alternative options for alignment and the nature of the corridor this is an unavoidable risk that should be addressed through design.

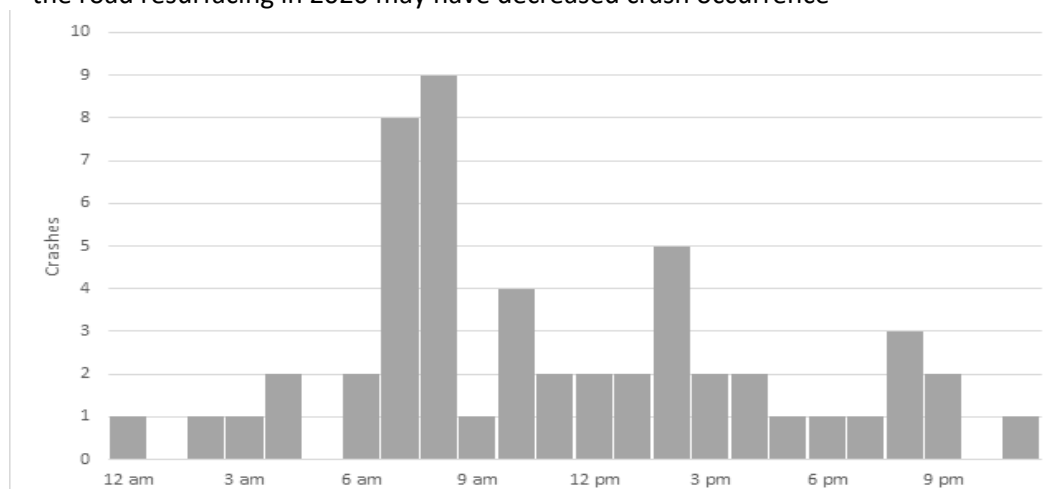
**Figure 1-4: crashes over time of day**

- crashes most commonly on Tuesday, Wednesday and Friday
- crashes peak with some traffic volume peaks (Figure 1-4)
- crashes resulting in serious injury often involved cyclists
- crashes were more frequent in winter
- the road resurfacing in 2020 may have decreased crash occurrence

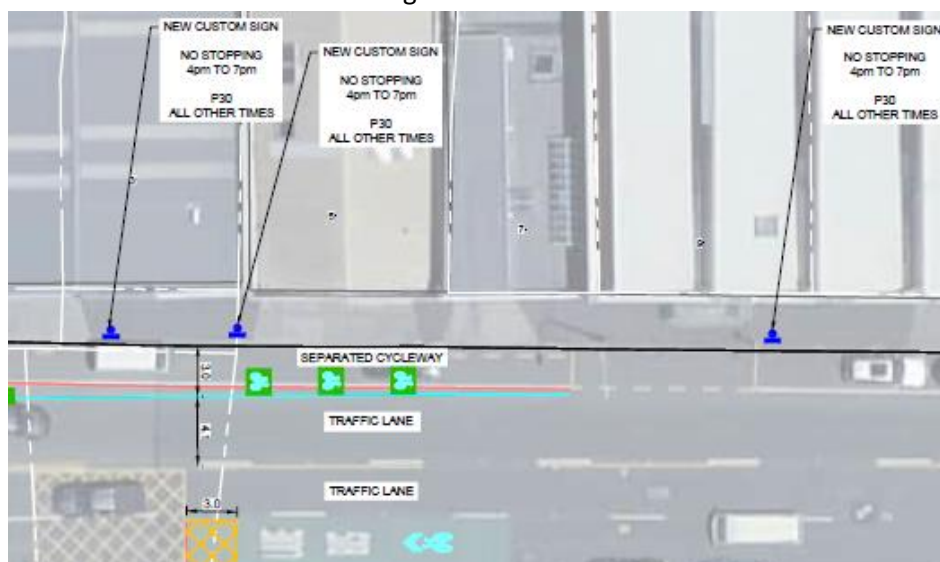
Figure 2-1: Plan showing proposed off peak parking lane and peak time cycle way

Kaiwharawhara Road is proposed to have the transitional cycleway completed over three stages, these three stages involve different level of implementation. Stage 1 restricts parking on the Ngaio bound lane during the evening peak. Outside of the evening peak the cyclists are expected to travel along the traffic lane, popping in and out of where the parking lane is occupied. The CASA does not believe this is a safe option and suggests not completing stage 1 and 2 of the implementation stages. Once able to complete Stage 3 as per the decisions report, then it is safe to do so. Cyclists travelling outside of the hours of 4-7pm will experience an unpleasant feeling of being in between the parking lane and traffic lane. The southern side of Figure 2-1 shows the shared bus lane.

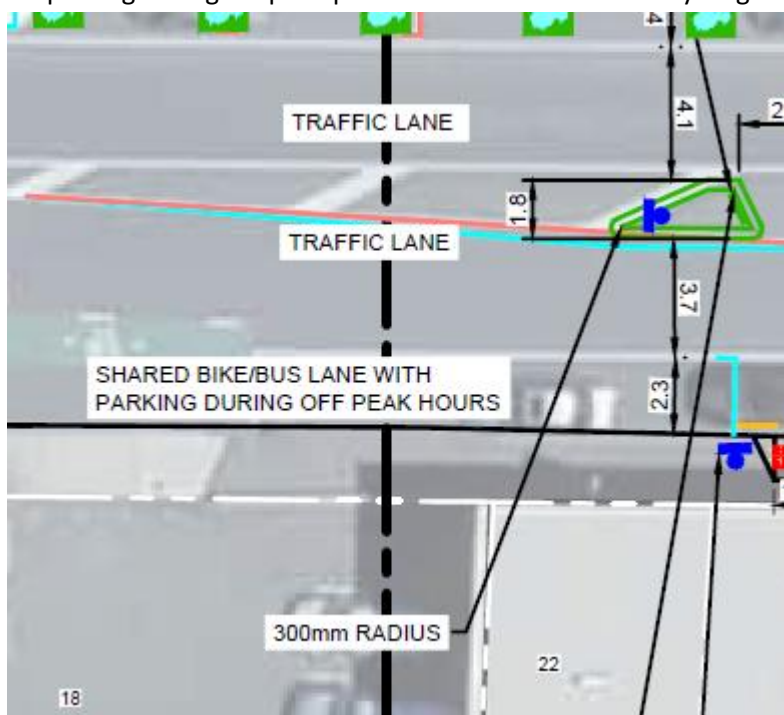
Figure 2-2: Plan showing proposed 2.3m wide shared bus / bike lane and off peak parking lane

Similarly to 2.1, the shared bike / bus lane during peak hours does not align with CNG and other guidance. CNG states “Wide bus lanes can be part time, ie allow parking during non-bus lane hours. Narrow bus lanes must be permanent (ie no parking), because when parking were to be permitted, people on bikes would be forced to ride within the door opening zone. Best practice in NZ is that bus lanes should be either: wide enough for cyclists to ride adjacent to buses, 4.2 m or wider, narrow enough that cyclists and buses must travel in single file, 3.2 m or narrower.” Plans show a part-time bus lane <3.2m with parking during off-peak periods – this is not safe for cycling then.

<b>Designer</b>	<p>For Recommendation 2.2.1 refer to response to Finding 2.1</p> <p>The design shows the existing bus lane markings generally being retained for Stage 1 prior to the shared bike/bus lane being increased to 4.2m wide during Stage 3. There is insufficient width to provide this 4.2m width in Stage 1 due to off-peak parking remaining on the south side of Kaiwharawhara Road. The pedestrian refuge at Cameron Street also constrains lane widths.</p>
-----------------	---

Given these constraints the length of lane less than 3.0m that could be widened to 3.2m in Stage 1 is around 70m outside 36 Kaiwharawhara Road (current shared bus/bike lane width is 2.6m). We feel this provides limited gains while introducing additional ghost markings, and recommend it is delayed until Stage 3 or when the road is resealed.
<b>Safety Engineer</b>	Agree with Designer. Monitor behaviour outside of pm peak and modify as necessary.
<b>Client</b>	Agree with designer
<b>Action</b>	Continue with staged approach and add to monitoring plan.

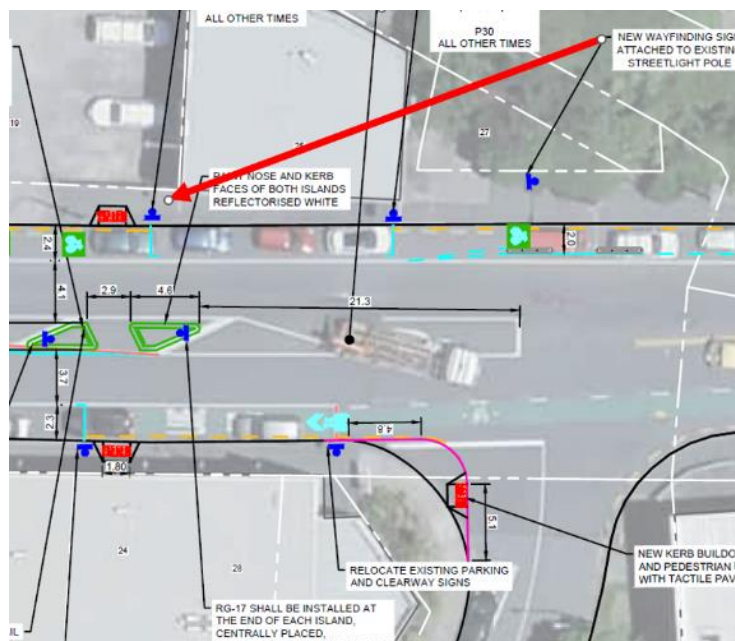
**Figure 2-3: Plan showing proposed extra location for wayfinding signage**

New wayfinding signage is proposed to be installed at Kaiwharawhara Road and Cameron Street intersection. Signage is proposed at the top of the intersection; a crossing point has been provided on the approach to the intersection and the CASA believes the wayfinding needs to be provided at crossing point. Cyclists using Cameron Street and following wayfinding signage are required to use the turning bay.

**Designer** Agree with the CAT recommendation. This also aligns with other feedback received for the 90% design reviews.

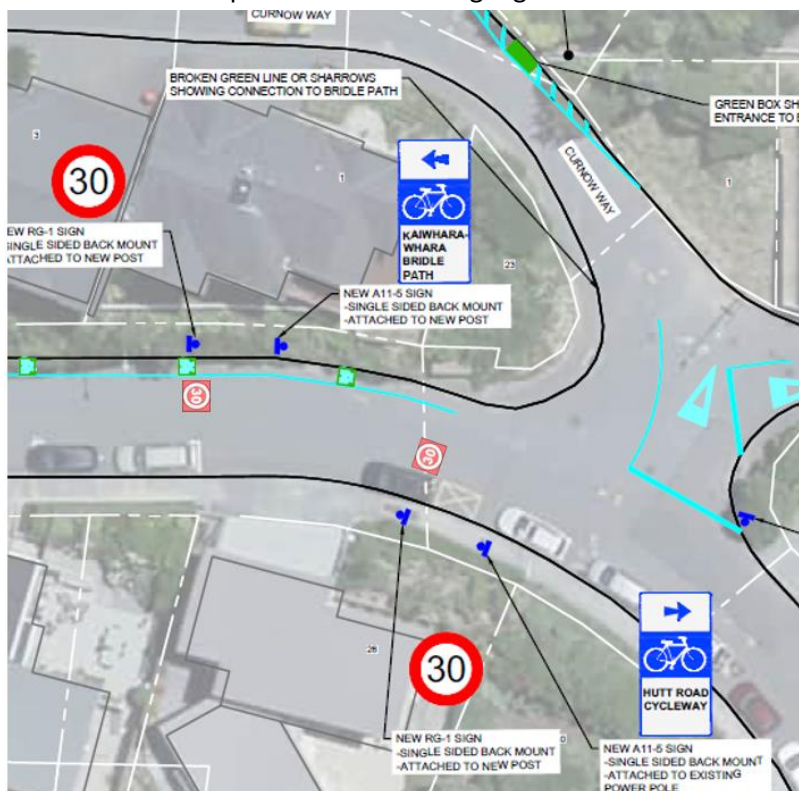
Figure 2-4: Plan showing road marking option for speed repeaters along Cameron Street

Cameron Street is proposed to have a speed reduction to 30 km/h. Repeat signage is proposed throughout the length of Cameron Street. The *Setting of speed limits 2022 Rule* no longer requires repeaters to be installed on speeds other than 50 km/h and 100 km/h. The CASA ponders the use of road marking at the locations for repeaters instead of signage.

<b>Designer</b>	<p>Agree with the CAT recommendation.</p> <p>A general theme identified across all feedback received for the 90% design is a desire to reduce the number of signs and reduce clutter in the road environment which aligns well with this recommendation.</p>
<b>Safety Engineer</b>	Agree with CAT and Designer.
<b>Client</b>	Agree with CAT
<b>Action</b>	Use road markings rather than signs for speed repeaters

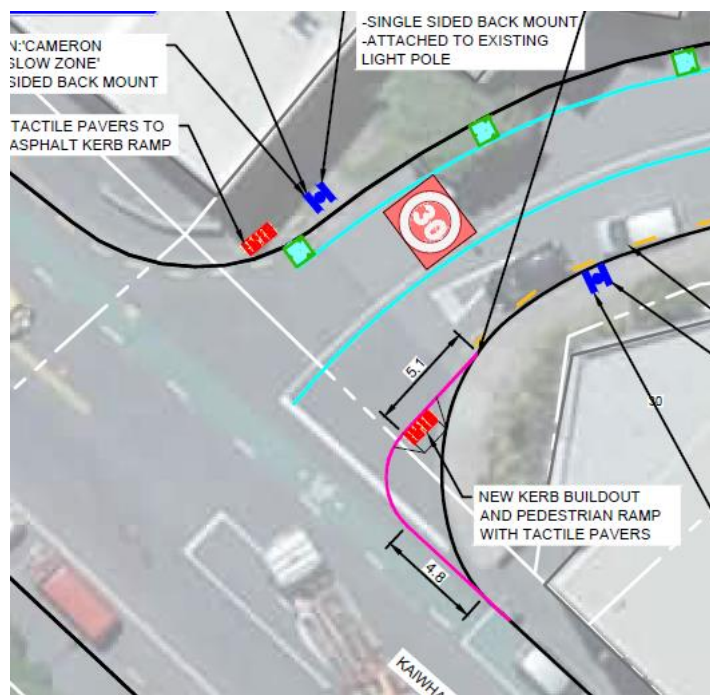
Figure 2-5: Plan showing proposed intersection kerb changes

Cameron Street is proposed to have kerb build-outs installed on the downhill lane. The CASA believes kerb build-outs should be completed on both sides of the road. Reducing the radius of both corners will help reduce the speed into and out of Cameron Street. The pedestrian ramp is proposed within one car length from the give way limit line. The CASA suggests putting the pedestrian ramp one car length back from the limit line. This will allow vehicles to be parked at the limit line and pedestrians to still cross.

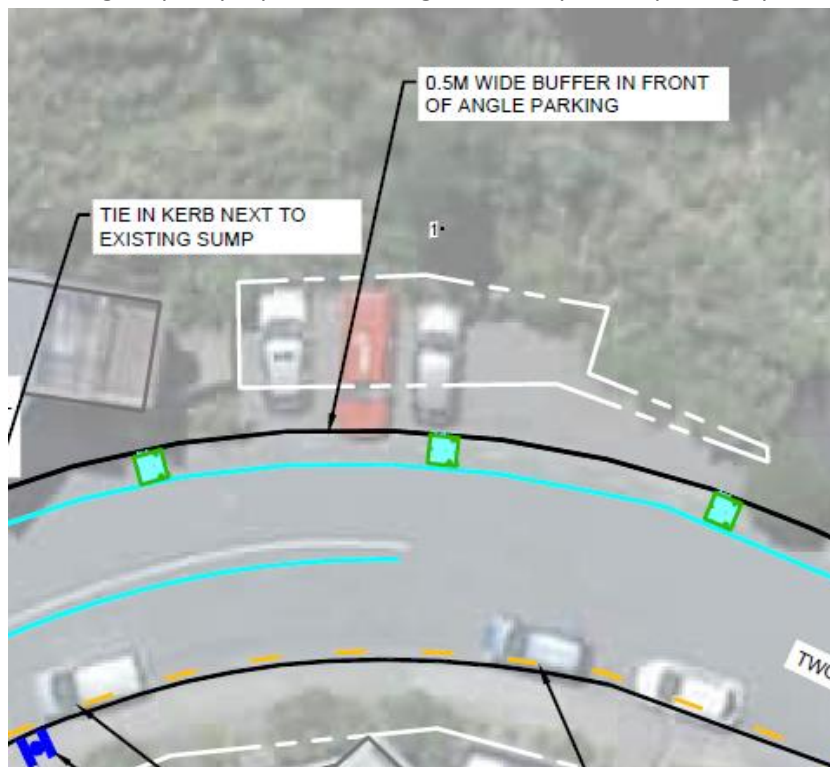
**Figure 2-6: 1 Cameron Street parking location**

We agree with the design report proposal to change these to parallel parking spaces.

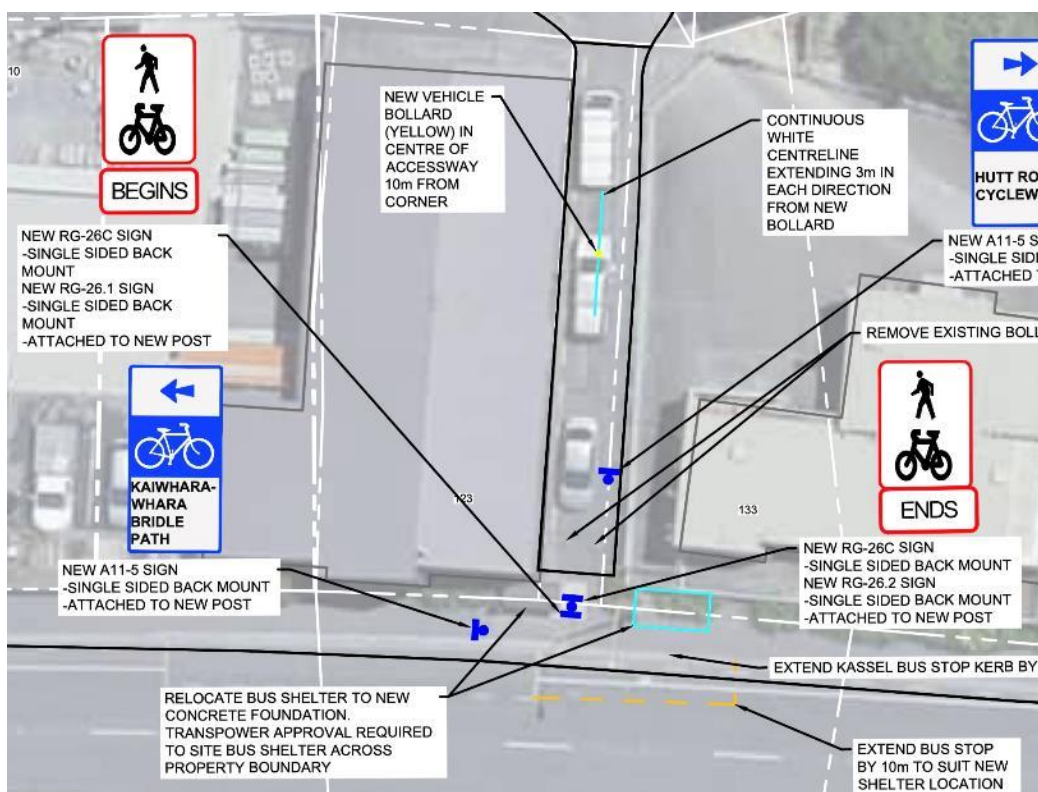
Figure 2-7: 1 Fore Street access signage

- The central bollard should be carefully designed as per [Access control devices on paths](#). For example, the height of the bollard is not specified. For riders who are following other riders, they may not see the bollard until it is too late. The bollard is specified to be 10 m from the corner; however, this would permit up to two vehicles to park in the pathway - why not shift the bollard closer to Pickering Street. *The placement and height of the bollard (if less than a rider height) may occasionally cause a crash resulting in likely serious injury.*

- There does not seem to be provision to cross the full height kerb to access the Hutt Road cycleway. *The full height kerb may occasionally result in riders falling while trying to mount it, resulting in minor injury.*

- The Hutt Road Cycleway sign has the arrow pointing the wrong direction for the majority of the route; preferably this would be a dual headed arrow.
- The bus shelter appears to be placed in conflict with the existing streetlight pole and should be indicated slightly further from the Fore Street path.

<b>Designer</b>	<p>2.7.1 Agree with CAT recommendation. This also aligns with other feedback received for the 90% design reviews. We suggest extending the line markings aligns best with the feedback received.</p> <p>2.7.2 The bollard was located part way down Fore Street to improve the length of lead in for cyclists and provide a T turning area for industrial lanes as shown in Plan R-9-706 in the WCC Code of Practice for Land Development. This also links to Recommendation 2.7.1 (extended markings shouldn't extend across Pickering Street). The distance from Pickering Street could be reduced to 5.5m if WCC accept a turning area for residential streets instead</p> <p>2.7.3 A general theme identified across all feedback received for the 90% design is a desire to reduce the number of signs and reduce clutter in the road environment which aligns well with this recommendation. Design can be updated to show markings rather than a sign</p> <p>2.7.4 &amp; 2.7.5 The footpath along Hutt Road ends just beyond Fore Street, and there is no crossing facility for cyclists or pedestrians across the four lane wide Hutt Road. All users are required to divert approximately 75m to the signalised crossing at Kaiwharawhara Road. We note that the majority of cyclists are travelling south towards the city resulting in minimal delay.</p> <p>2.7.6 Agree with CAT recommendation</p>

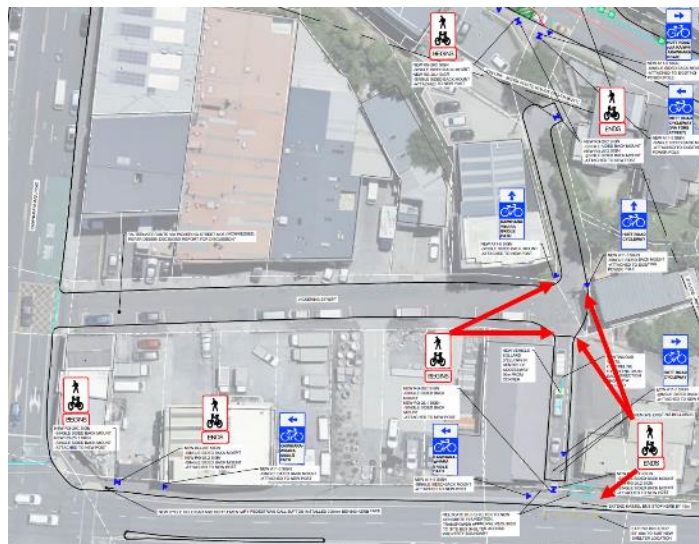
Figure 2-8: Cameron / Pickering Street shared path map marked up with proposed locations for signage

Proposed shared path signage needs reviewing. Figure 2-8 shows the extents of shared path requiring signage to demarcate the start and end of shared path.

<b>Designer</b>	A general theme identified across all feedback received for the 90% design is a desire to reduce the number of signs and reduce clutter in the road environment. This will result in changes to replace some or all of these signs with markings.
<b>Safety Engineer</b>	Agree with Designer.
<b>Client</b>	Agree with designer, however, this section is to be removed from plans.
<b>Action</b>	Remove signs at Cameron/Pickering streets.

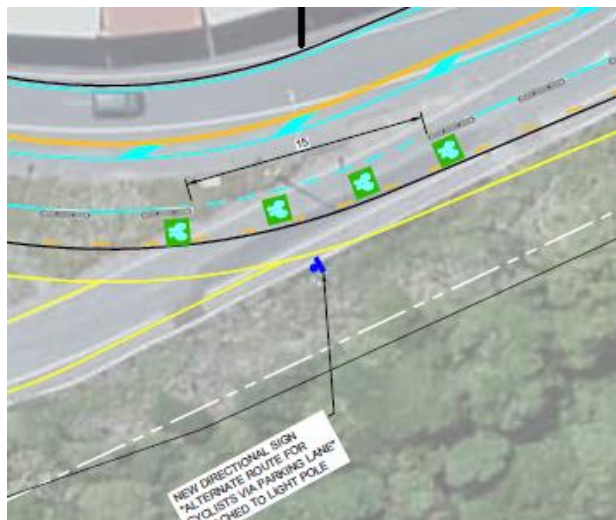
Figure 2-9: Insert of plan showing entry into alternative route

The location of wayfinding signage for the alternative route up Ngaio Gorge diagrammatically looks to be away from the line of sight of uphill cyclists. The CAT suggests moving the alternative route sign to the decision point upstream.

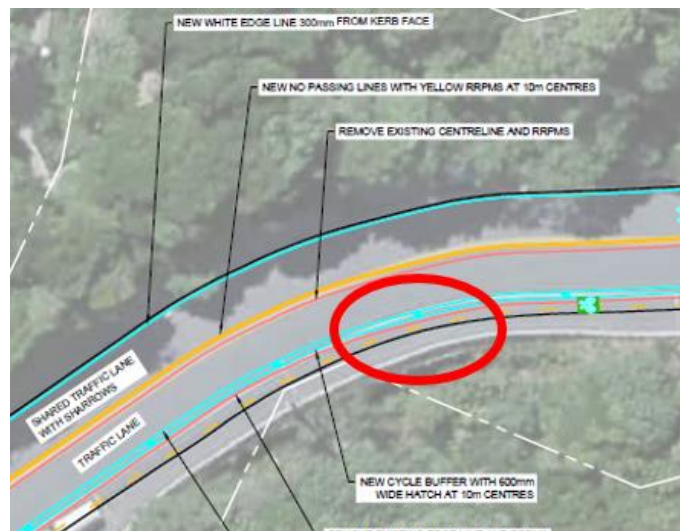
Figure 2-10: sheet 5 extract highlighting narrow cycle lane

A section of the cycle lane uphill on Ngaio Gorge Road shows very narrow lane on the inside of a bend. The CAT suggests altering the type of buffer to allow more space for cycling.

<p>The buffer is painted and has ATP markings, so should not unnecessarily constrain cyclists.</p> <p>We recommend additional green cycle blocks around each corner to further highlight the cycle lane.</p>
<b>Safety Engineer</b>	Agree with Designer.
<b>Client</b>	Agree with designer.
<b>Action</b>	Add green blocks around this corner.

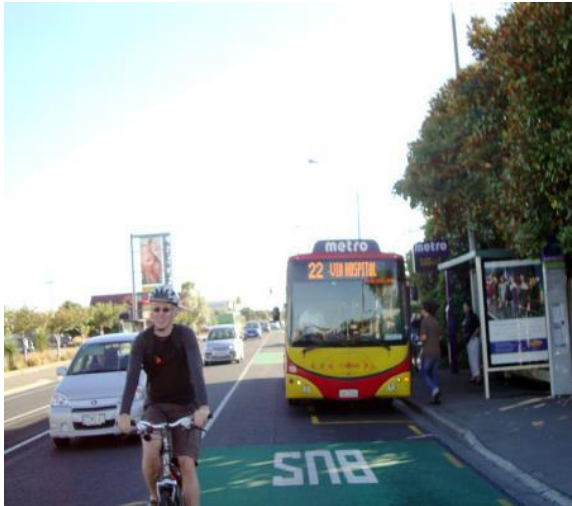
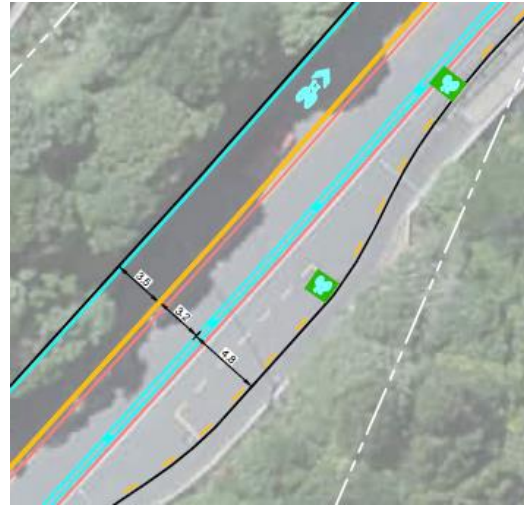
Plans show cyclists are expected to follow the kerb and channel alignment and travel through the existing bus stop. The CAT believes allowing cyclists to continue between the buffer and bus park would be consistent to other treatments throughout NZ.

Figure 2-11: Wide transit lane bus stop treatment

Figure 2-12: Proposed layout for bus stop #5405

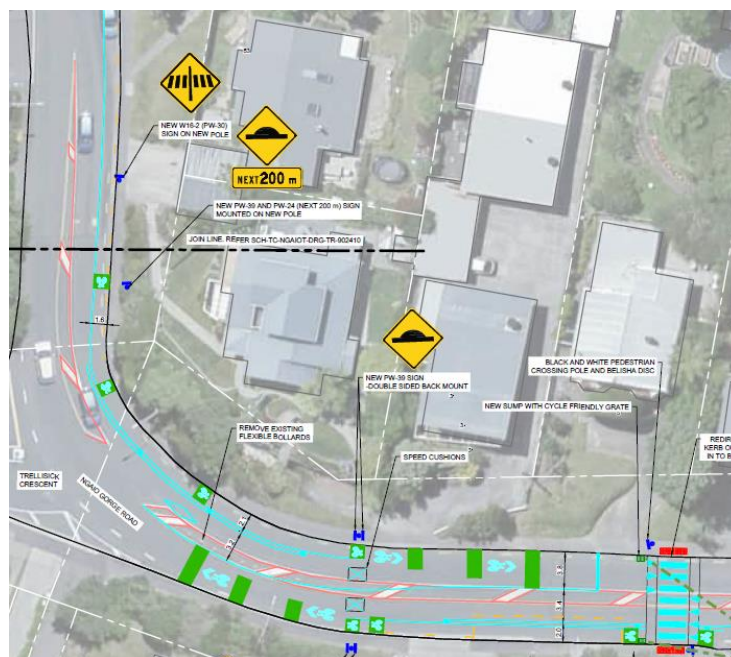
Figure 2-13: Ngaio Gorge Road sheet 8 extract

The pedestrian crossing PW-30 sign is located before the speed cushion signage. Between the distance of this sign to the crossing and the plethora of signs, the CAT considers that drivers may not remember the key message (pedestrian crossing ahead). The CAT recommends that it is shifted to the position of the first hump sign, and that there be only one hump sign at the cushion.

A long as the raised platform is used, the speed of traffic involved in any collisions that do occur is going to be low and therefore the likelihood of serious /fatal injury unlikely.

<b>Designer</b>	Agree with the CAT recommendation.
	A general theme identified across all feedback received for the 90% design is a desire to reduce the number of signs and reduce clutter in the road environment which aligns well with this recommendation.
<b>Safety Engineer</b>	Agree with CAT and Designer.
<b>Client</b>	Agree.
<b>Action</b>	Move signs and add speed advisory sign.

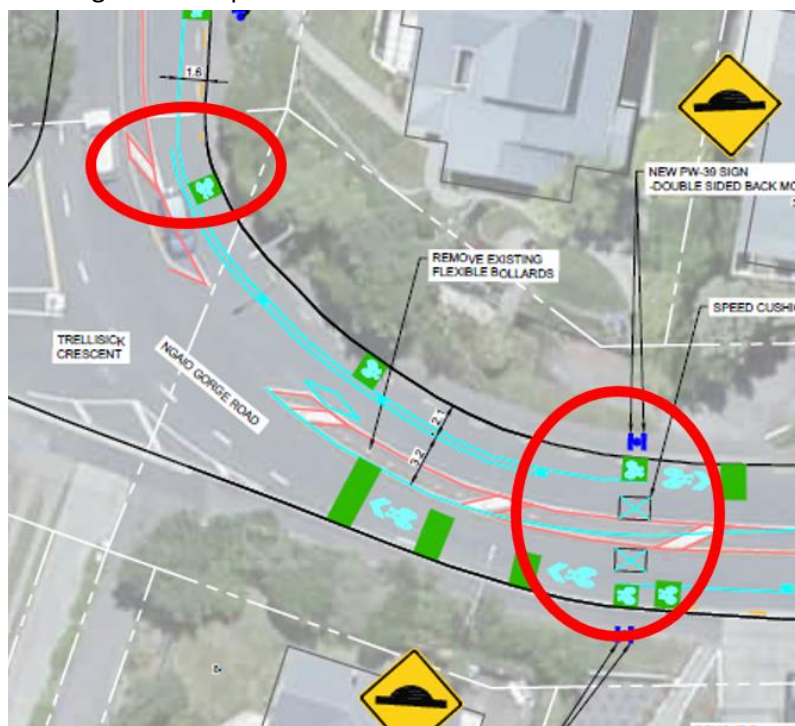
Figure 2-14: Ngaio Gorge Road General arrangement plan sheet 8 extract

90% design plans show cycleway buffer to start at the start of a bend and stop early of speed cushions. The CAT ponders the need for starting the buffer in the bend and not on the approach to the bend. The exit of the buffer before the speed cushions diagrammatically looks to create an easy path for vehicles to skip travelling over the speed cushions.

**Designer** Feedback received for the 90% design recommended extending the buffer along Kenya Street which will be updated on the plans.

Feedback also recommended that the speed cushions are changed to speed humps. Providing speed humps across the full width of the carriageway will address the CAT finding regarding vehicles trying to skip around the speed cushions.

With regard to the markings the width is very constrained in this section, with the combined traffic and cycle lane width in each direction at the speed cushions only 4.4m. Extending the buffer would reduce the cycle lane to 1.0m wide, although we note that the buffer is flush and rideable so wouldn't constrain cyclists. We recommend the

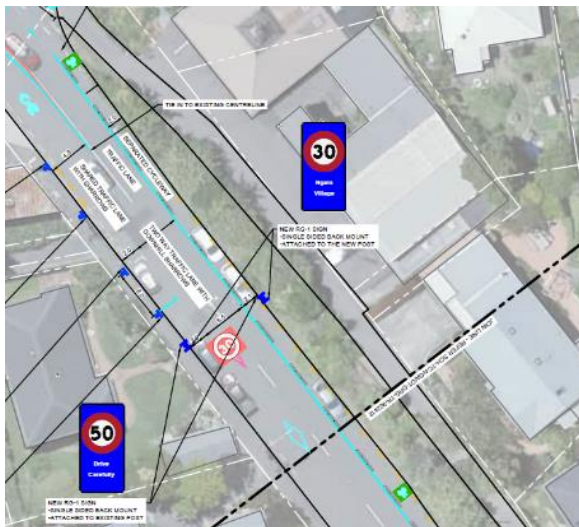
**Figure 2-15: Speed limit change location along Kenya Street**

The 30% audit mentioned extending the 30 km/h speed limit from Ngaio village; from this recommendation the location has been moved back to the Crofton Road shops. This is favourable but the CAT believes speed cushions should be installed to assist with the speed change.

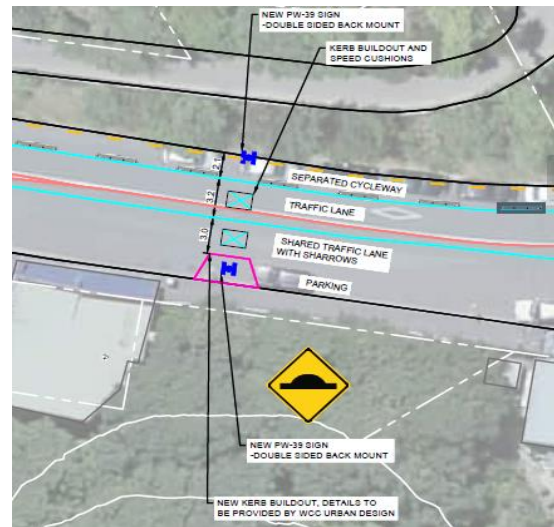
**Figure 2-16: Proposed traffic calming on Crofton Road**

The pedestrian crossing being installed on Ngaio Gorge Road has speed cushions on both approaches but the existing Crofton Road pedestrian crossing only has one; to be consistent and help with the speed limit change it is recommended to install speed cushions on both.

As described in the response to Finding 2.14 feedback received for the 90% design has recommended that the speed cushions are changed to speed humps.

<p>Providing an additional hump in this location was highlighted in the feedback, and addresses positioning issues with the speed cushions.</p> <p>On this basis a speed hump will be added in this location addressing the CAT recommendation.</p>
<b>Safety Engineer</b>	Agree with Designer.
<b>Client</b>	Agree with designer.
<b>Action</b>	Add speed hump.

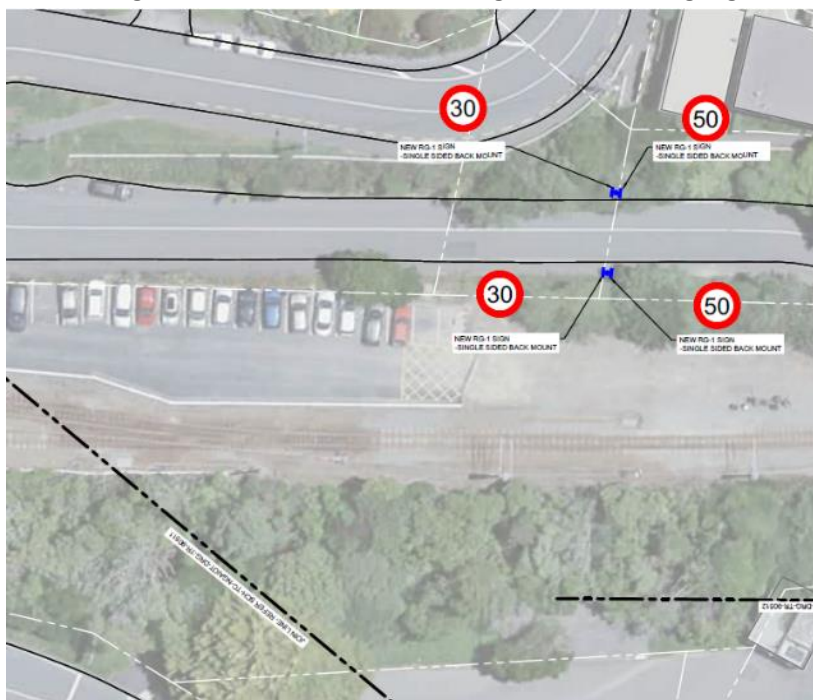
Figure 2-17: Collingwood Road proposed speed limit change location and treatment

Figure 2-17 shows the location of Collingwood Street speed reduction; the CAT ponders if the speed change should occur after the entry into the train station.

No red road marking is included on side roads, the CAT ponders with the speed reduction in these areas that red road marking should be used on each change location to highlight the change in speed.
