POST CONSTRUCTION ROAD SAFETY AUDIT Island Bay Cycleway

Prepared for Wellington City Council

11 May 2016

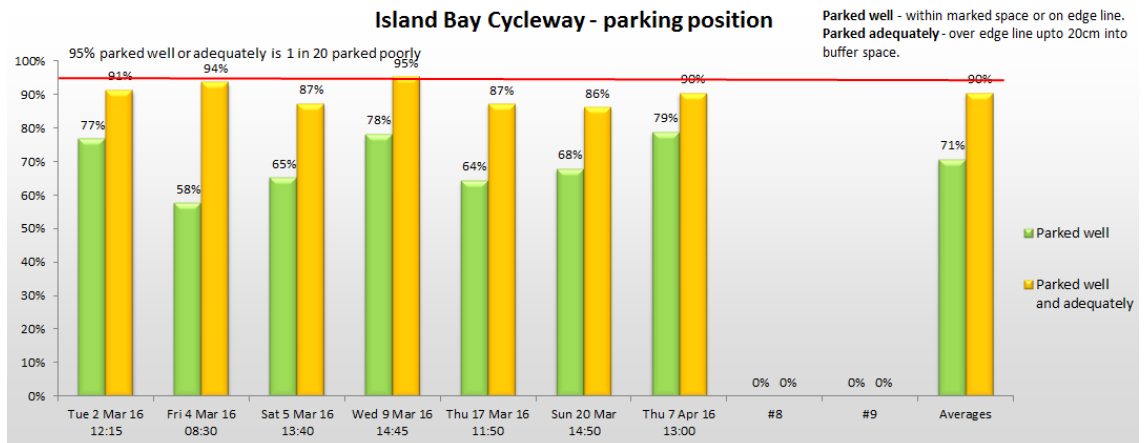
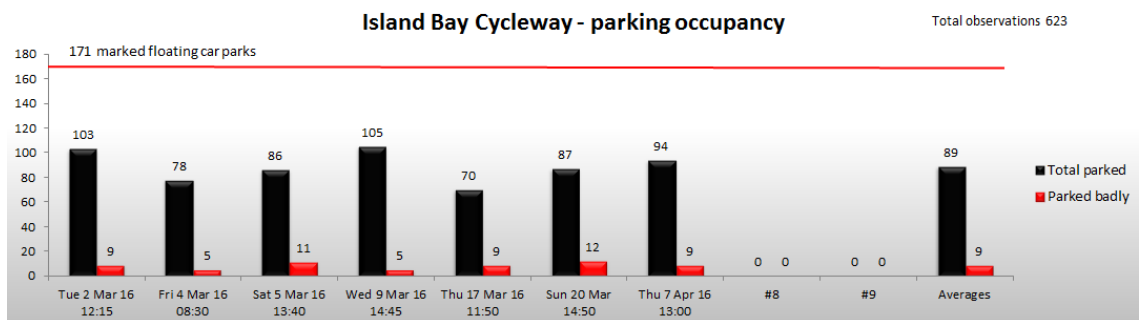
Client decision
 By 7 April 16 we had observed 623 parked vehicles over 7 surveys at various times and days of the week. The surveys showed 71% of vehicles were parked well and 90% parked well or adequately. Badly parked vehicles were observed to range from 5 to 12 with an average occurrence of 9.

To date there has been some education but little enforcement. We will instruct enforcement action to commence with a warning then infringement procedure. We will continue to monitor parking compliance and look to install safe hit posts if required.

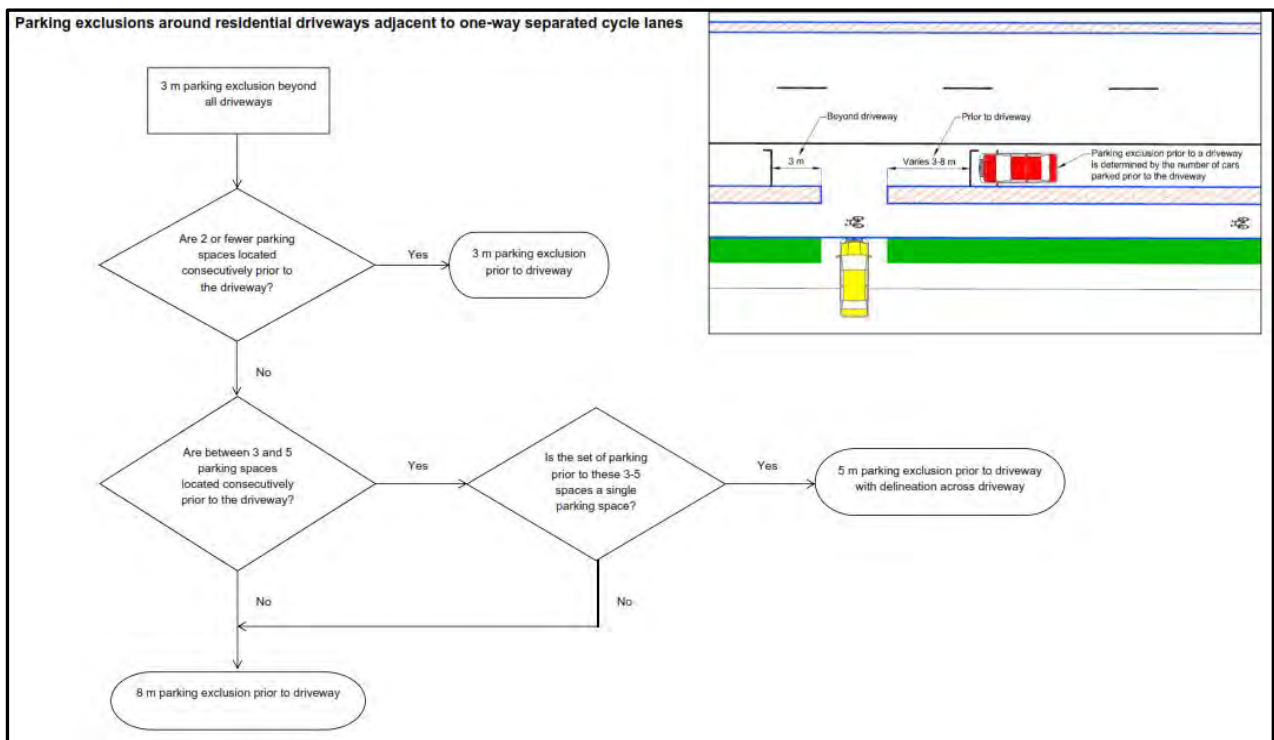
Figure 2-19: Diagram indicating recommended parking exclusions around residential driveways adjacent to one-way separated cycle lanes (Source: “Finding the Right Green Road for Cycle Routes” – IPENZ Transportation Group Conference Paper, Auckland - March 2016).

The SAT observed on site that a new residential driveway was being constructed at No. 84 The Parade directly opposite a marked parking space. The adjacent parking spaces upstream and downstream of this new driveway will need to be remarked appropriately in line with the guidance proposed in Figure 2-19 below.

A recent paper from the *IPENZ Transportation Group Conference Auckland – March 2016*² proposed that a minimum 3m gap should be provided beyond the driveway (i.e. left hand side of driveways for exiting motorists). It was further proposed that the gap prior to the driveway (i.e. right hand side) varies between 3m to 8m depending on the number of vehicles parked prior to the driveway (refer to Figure 2-19 below).

It is recommended that a review of the marked parking spaces is undertaken along the route to ensure that appropriate spacing is provided either side of the driveways. This would provide both sufficient intervisibility between cyclists on the cycle lane and motorists entering and exiting driveways and appropriate manoeuvring space for motorists to carry out their turn movement without encroaching into the opposing traffic lane.
