NEWTOWN TO CITY
TRANSITIONAL CYCLEWAY
90% DETAILED DESIGN ROAD SAFETY AUDIT
PREPARED FOR WELLINGTON CITY COUNCIL
March 2022

Newtown to City Transitional Cycleway 90% Detailed Design Road Safety Audit

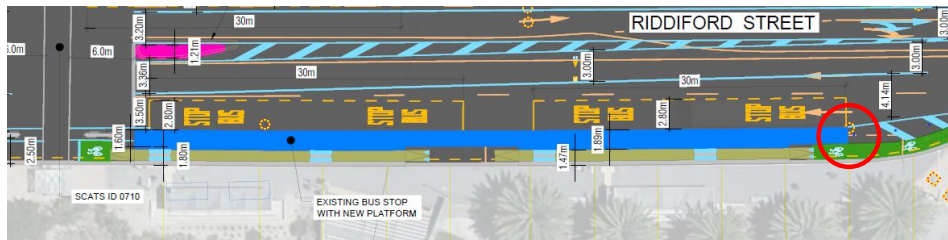
Figure 2-1: Riddiford Street southbound bus stop

In reviewing the design, the SAT noted that the platforms are formed with square end raised ends (circled below). This will result in a vehicle / motorcyclist / cyclist snag point should an errant user impact with the end of the platform. For vehicles, the damage would be predominantly vehicle damage only, however for a motorcyclist and cyclist the injuries could be serious, with a resultant loss of control into the adjacent traffic lane and risk of impact from other traffic.

It is noted that the southbound lane leading into the bus stop is a general lane north of the hospital road intersection but is multiple bus stops following. This could cause late lane changes should a bus stop in the bus stop. It is acknowledged that as a general operation, buses will stop in traffic lanes to onboard / disembark passengers. Predominantly this occurs in the marked bus lane and should have little impact on the general user. In and around the hospital the stopping in the general traffic lane will have a greater impact.

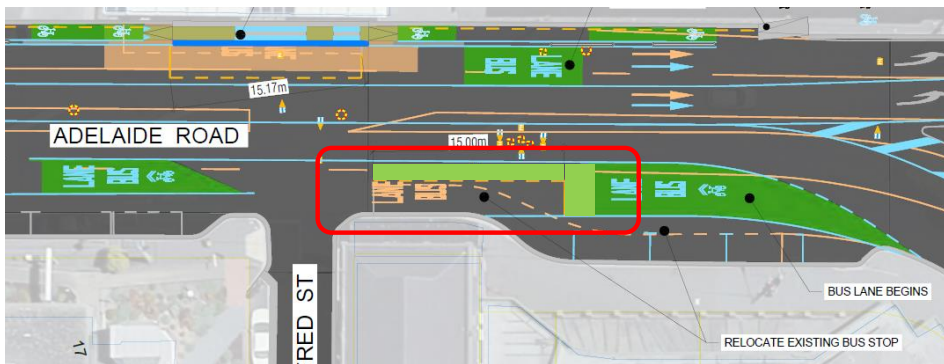
Figure 2-2: Example of additional green markings at bus stops

Green markings have been indicated to be installed at the entry / exit to bus stops. Typically, the bus lane is wider than marked bus stop. The SAT are of the opinion that there is opportunity to use a green surface alongside the bus stop to guide cyclists around stationary bus and also highlight to a driver that cycle passing is possible on their right.

The SAT recommend that the design should apply similar treatments to all bus stops along the project length.

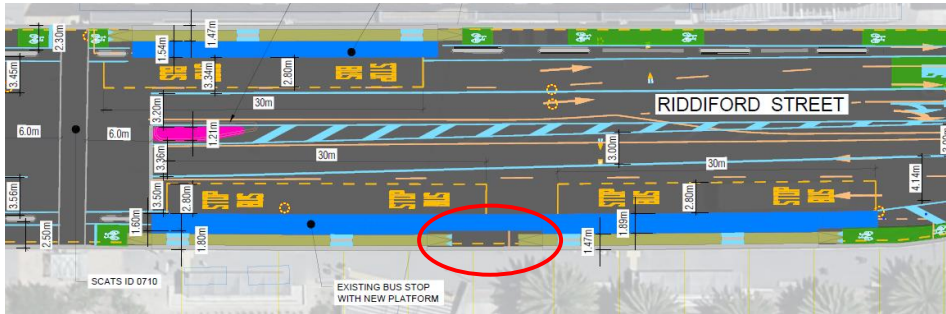
Figure 2-3: Riddiford Street Bus Platform and adjacent cycle lane

the same level as the bus platform, with pedestrian crossing bars over cycle path. An example of the treatment is given in Figure 2-3 below.

The drawings provided are considered indicative of the design intent and lack clarity of the treatments required for the full consideration of the bus stop use.

A feature of the Hospital bus stop is the formation of a ramp down / up midway between the two bus stop facilities (circled in Figure 2-3 above). This will result in a trip / fall hazard, and is considered a significant risk to the elderly, mobility impaired and visually impaired.

Risk of ramp down / up midway between the two bus stops noted but disagree that the risk is significant. The likelihood of a crash should be low given most patrons will walk directly from the bus to the footpath – not along the platform. The additional ramp will help slow cycle speeds which supports the SAT's concerns about 'cyclists impacting with the elderly while the elderly were alighting from the bus'. No change to ramp proposed.

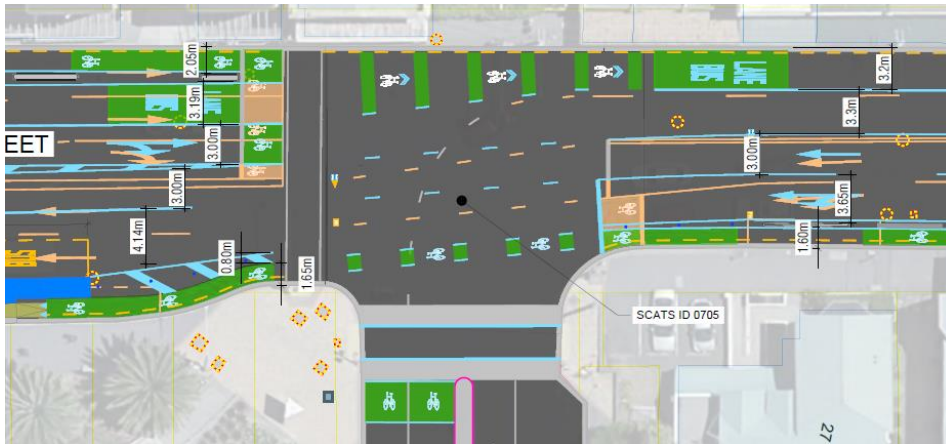
Figure 2-4: Proposed Riddiford Street / Hospital Road intersection design

In reviewing the Riddiford Street / Hospital Road intersection the SAT make the following comments in the absence of any phasing information.

1. Riddiford Street (southbound), left lane is both a through and left movement. Alongside this is the separated cycle facility. The Design Decision Report supplied makes the following assessment:

The separated facility design of the southbound and northbound cycle lanes can lead to an impression by cyclists that under certain conditions (such as the lack of a red signal) that safe through movement is available, when in fact the through movement could be impacted by the adjacent turn / through

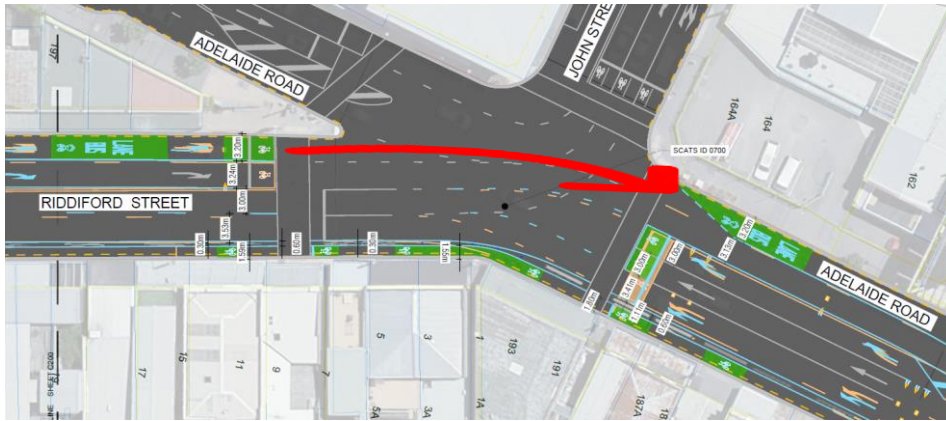
Figure 2-5: Riddiford St / Adelaide Road / Johns Street

Cyclists northbound on Riddiford Street and continuing onward along Adelaide Road to the city will do so from the left-hand bus lane / cycle lane. The design incorporates an advance stop box to assist the cyclist as detailed in Figure 2-5 below.

The bus / cycle lane is marked in accordance with the two user classes; however, the lane markings (left turn arrow) would prohibit a through movement of both a bus and a cyclist unless an exemption is enabled. This has not been detailed.

The SAT are of the opinion that the design, as presented, fails to address significant conflicts between movements. The lack of signal phasing details does not enable the SAT to undertake a full assessment of the impacts of the design.

Frequency Crashes are likely to be common	Severity Death or serious injury is likely	Rating The safety concern is significant
Designer response	As noted in response to 2.1.1 proposed signage (to be included with 100% design) and other markings sufficiently convey allowed movements from the left lane on Riddiford Street. No change proposed.	
Safety Engineer comment	Agree with SAT – signal information should be provided. Key signalised intersections to be reviewed in <i>Safety in Design Workshops</i> .	
Client decision	Road markings updated to include green continuity lines across intersection. Safety in design workshop for signals.	
Action taken	Safety in design workshop for signals. Plans updated.

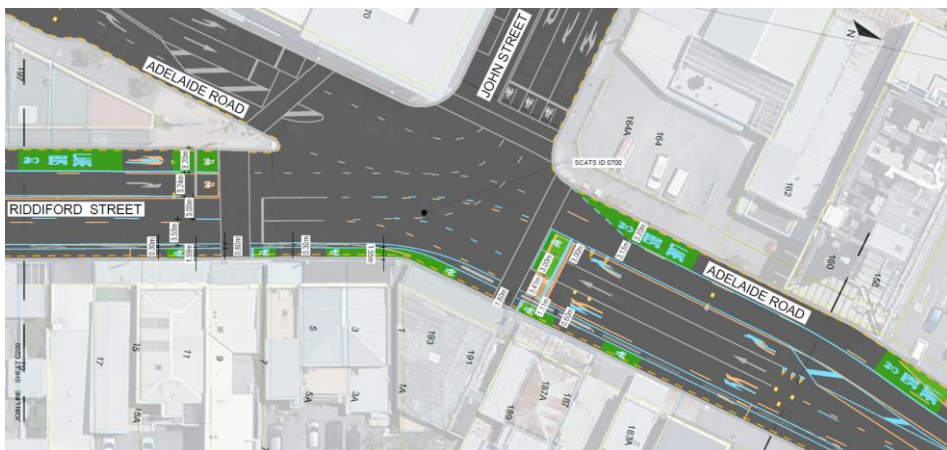
Figure 2-6: Southbound Adelaide Road approach to intersection with John Street and Riddiford Street

The design has provisions of ASB at the head of the through and right turn lanes (southbound on Adelaide Road), as shown in Figure 2-6 below. Separators are formed up to the limit lines for the signalised intersection.

In considering the cycle movement from Adelaide Road, the SAT have identified three possible mechanisms to access the movements required.

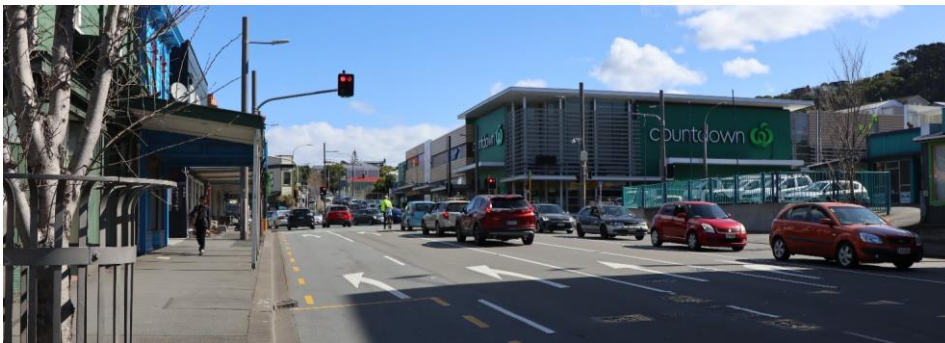
Figure 2-7: Current lane configuration and signal aspects

The current road layout has two southbound veer left lanes at the intersection. The revised design, with the formation of the separated cycle lane removes the kerbside left veer lane, leaving a single lane for this movement. It is noted that the proposed design has a single left veer single straight through movement lanes north of the intersection (southbound), yet it has two departure lanes into Riddiford Street.

The SAT acknowledge that the right hand of these two receiving lanes is to accommodate the right turn movement (southbound) from John Street.

Frequency Crashes are likely to be common	Severity Death or serious injury is likely	Rating The safety concern is significant
Designer response	Agree that there are challenges with cyclists accessing the ASB's as noted by SAT. The current design assumes the third 'mechanism' described by SAT is used by confident cyclists. Less confident cyclists can dismount and use the pedestrian crossing facilities.

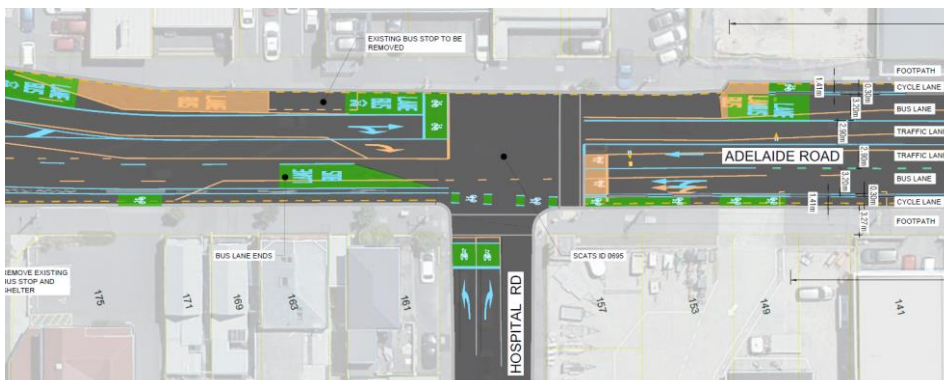
Figure 2-8: Adelaide Road / Hospital Road – southbound lanes shifted right

The SAT noted in the design that the continuation of the lanes through the Adelaide Road / Hospital Road intersection has a noticeable shift to the right (southbound), caused in part due to the differing offset of the kerb line on the west side of the road.

1. Given the lane shift, install lane continuity lines through the intersection to direct drivers into the correct road position,
2. Paint the initial separator formation (currently two lines) with a solid chevron style, providing visual significance to the commencement of the separated facility south of the intersection,

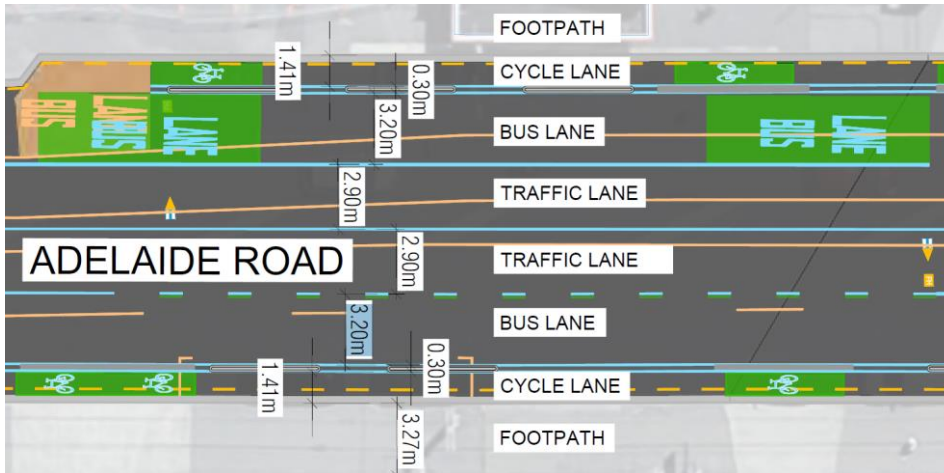
Figure 2-9: Lane widths on Adelaide Road and width of separators

The supplied design drawings indicate that the separator style to be applied along Adelaide Road comprises of a physical buffer, where possible when considering the accesses from adjacent properties.

The road layout dimensions indicate that the physical separator is some 300 mm wide, with a 1.4 metre cycle facility alongside.

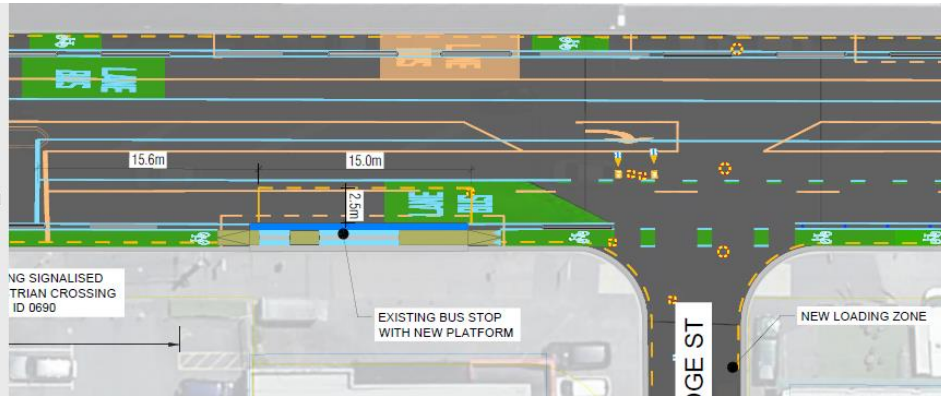
Figure 2-10: Bus stop south of Broomhedge Street

The narrow landing space would result in a passenger stepping from the bus directly into the path of a cyclists, with a risk of being clipped by passing cyclists.

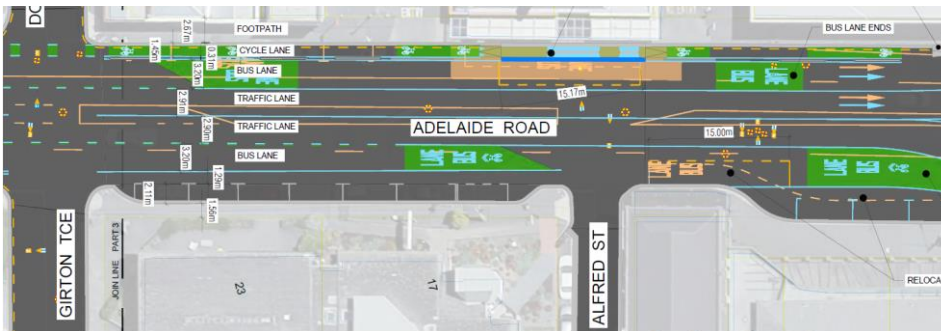
Figure 2-11: Adelaide Road between Alfred St and Girton Tce – parking with adjacent bus lane

The design proposed has kerbside parking alongside the road shoulder between Alfred Street and Girton Terrace. Alongside this is an unmarked buffer, then the bus lane, as shown in Figure 2-11 below.

The supplied design drawings indicate that there are no side road control markings to define the hold point for Girton Tce. A review of previous site photos, and the aerial plans indicate that there is a current Give Way control. The SAT have assumed that the lack of side road control details is a draughting error, and that the current control will remain.

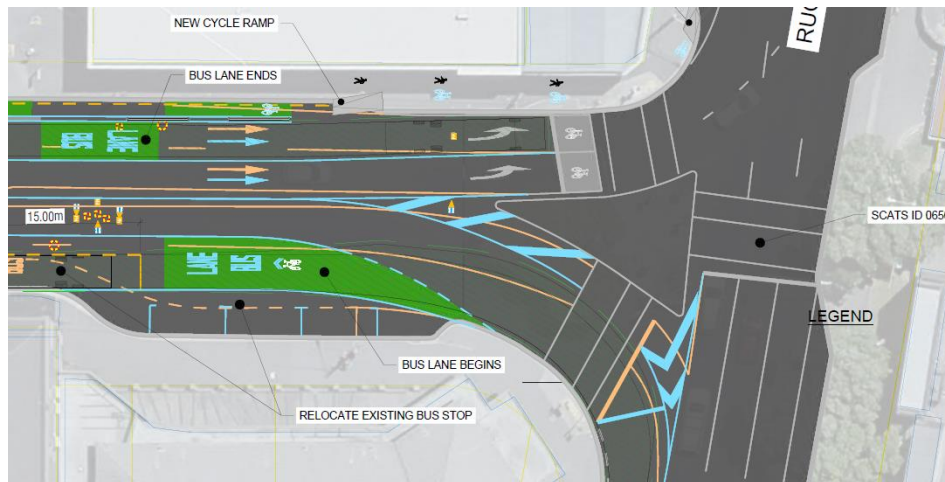
Figure 2-12: Adelaide Road / Rugby Street Intersection

The SAT acknowledge the changes to the lane entry from Rugby Street into Adelaide Road and the inclusion of enlarged advance flush median chevrons, as detailed in Figure 2-12 below.

The tracking path for the bus has been supplied and demonstrates that the bus left turn can be accommodated within the provided lane. The SAT commend the solution provided.

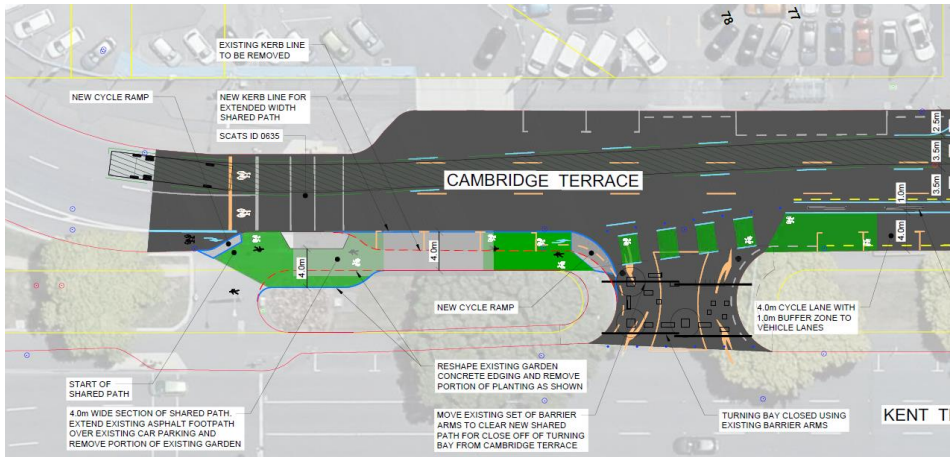
Figure 2-13: Cambridge Terrace southern end of cycle lanes.

The SAT note that for the southbound movement (towards Basin Reserve), there is no guidance into a suitable facility, which could lead to cyclists in conflict with other footpath users either on the central path, or on the footpath on the Kent Terrace side.

The impact of a cyclist with vulnerable users such as the elderly and blind low vision people could result in higher severity injuries. As detailed, the elderly generally has a lower capacity to recover from high trauma injuries, with the resulting injury severity being serious.

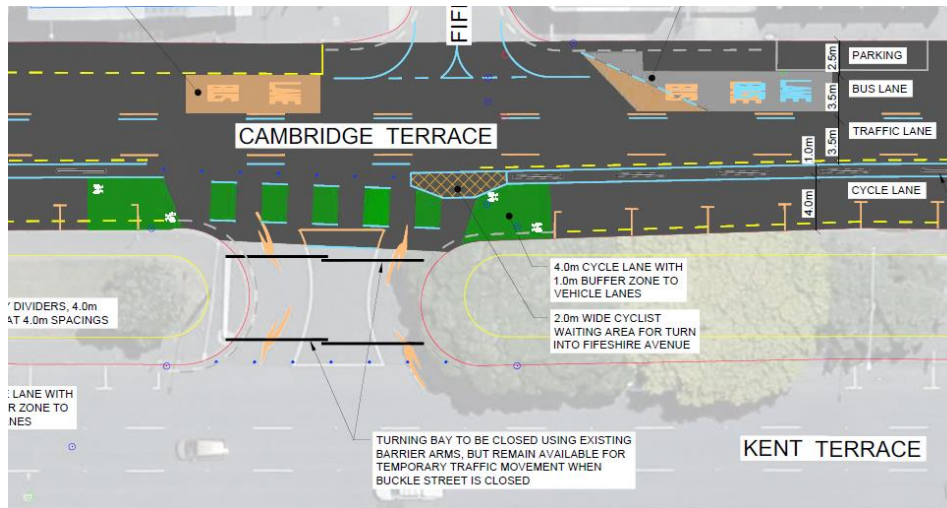
Figure 2-14: Typical U-Turn closure detail

The use of vertical bollards will initially be effective due to their clean and new visible nature, however over time they will typically degrade and become ineffective. The vehicle movement alongside the bollards will result in wheel splash and covering in road grime. The SAT comment that a high level of maintenance intervention will be required to ensure that the bollards are fit for purpose and remain effective.

The SAT consider that the following elements require addressing at this stage to ensure that proposed use, and temporary traffic management use is undertaken in a safe manner.

Frequency Crashes are likely to be occasional	Severity Death or serious injury is likely	Rating The safety concern is moderate
Designer response	Agree with SAT – noting that some of these recommendations are already included in the design (e.g. item #2)/ and or currently exist (e.g. item #4).	
Safety Engineer comment	Agree with SAT and Designer.	
Client decision	Agree with above	
Action taken	No action required

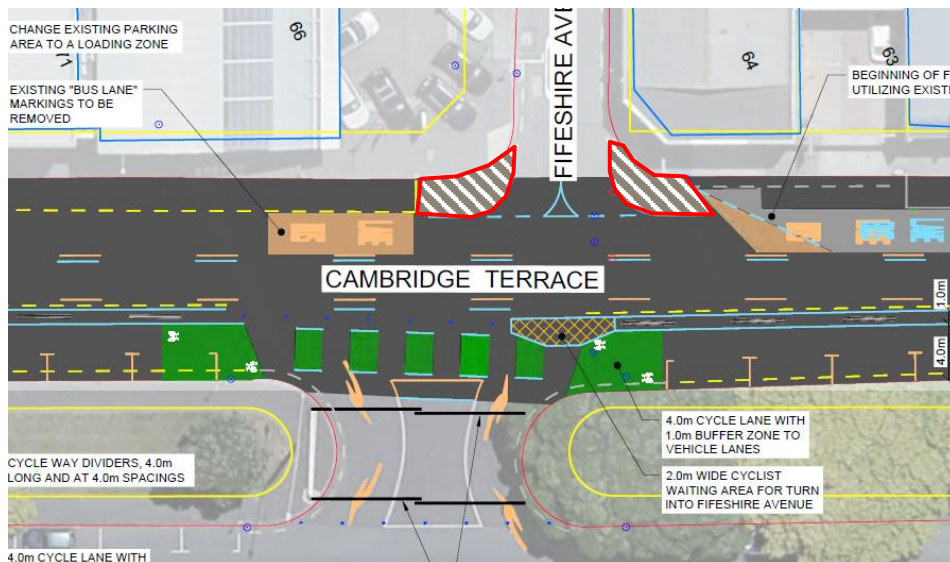
Figure 2-15: Cambridge Tce and Fifeshire Ave intersection

The SAT have identified a number of issues as a result of the proposed intersection and cycle facility layout relating to Fifeshire Ave.

It is noted that the existing parking on the west shoulder is to be converted to a loading zone. The SAT commend this move as it may, in part, reduce the observed effect of car delivery vehicle parking in the traffic lanes unsafely as previously noted in the 30% design RSA. This is to be commended.

The SAT however do note that the design provides edge lines that commence on the traffic lane side of the loading zone, and turn into Fifeshire Ave, both sides. The current markings could be identified as a parking area. The SAT recommend that shoulder chevrons and no-stopping lines are installed to maintain the intervisibility sight line at the intersection (marked on Figure 2-15 above).

The revised design as presented in the 90% design drawings indicates that the kerb line (southbound, west side) has been adjusted to enable the passing of the bi-directional facility past the hook turn for Fifeshire Ave. The design fails to detail the provisions for pedestrians along the north / south route. The SAT note that with the closure of the U-Turn facilities, the central median route could become more attractive for pedestrian movement north and south as it eliminates the need to cross minor side roads.

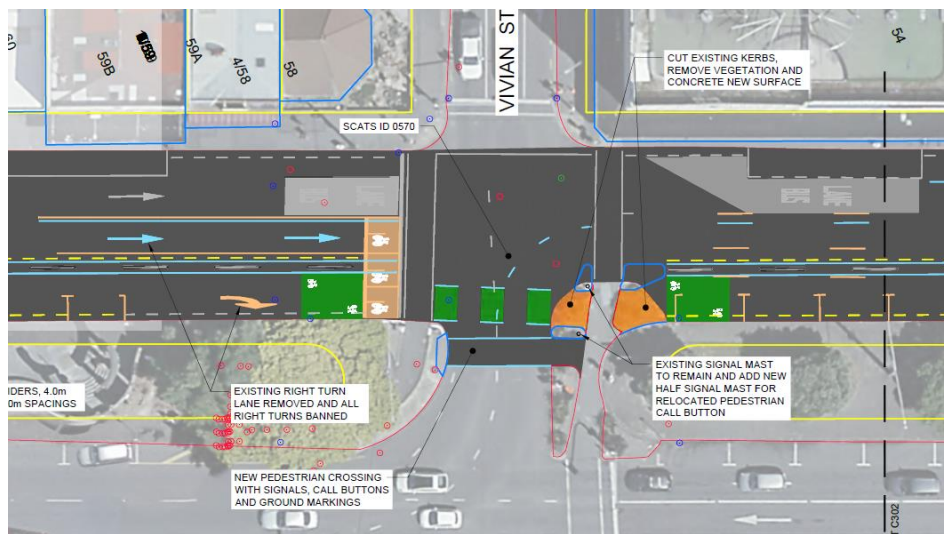
Figure 2-16: Cambridge Tce / Vivian Street intersection

The cycle facility crosses over the pedestrian movement north of the Vivian Street intersection. This crossing does not indicate who has priority – pedestrian or cyclists. The pedestrian will be waiting at the edge of the crossing on the Cambridge Tce side, and depending on user and numbers, would result in pedestrians straying across the cycle path. The SAT recommend that pedestrian crossing bars, with all signs and markings being installed. This crossing requires tactile pavers for the pedestrian movement over the cycle facility.

The SAT consider that given the risk of the pedestrian / cycle conflicts, it is imperative that red pavement markings are installed at the conflict zone.

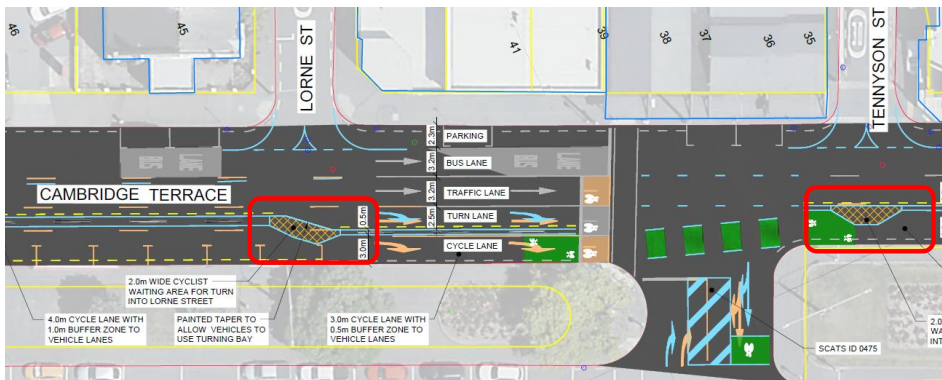
Figure 2-17: Cambridge Tce turning pockets for cyclists

A similar feature is provided at the Tennyson Street intersection, as detailed in Figure 2-17 below.

The hatched zone will be required to accommodate cyclists who not only turn in, but also turn out of Lorne Street and Tennyson Street. The SAT are of the opinion that the marked space is insufficient to allow cyclists to safely depart from the through movement, or wait safely to join the through movement, without their wheel being exposed to passing traffic. This waiting space impedes on the safe movement of cyclists along the bi-directional facility. The SAT acknowledge that the cycle turn volume at these locations may be low, however the risk remains.

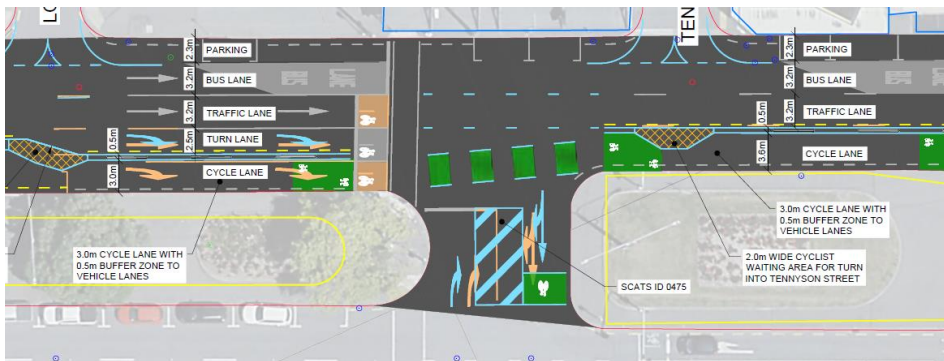
Figure 2-18: Cambridge Tce ASB at Elizabeth St intersection

The proposed design incorporates an ASB at the Elizabeth Street Intersection, as detailed in Figure 2-18 below. It is understood that this layout would have a cyclist undertaking a right turn (in conjunction with the cycle through movement and separated from the right turn movement) traversing into the ASB while the southbound movement on Kent Terrace is occurring.

The current signal layout does not have any aspect that would control the movement proposed for motorists or cyclists in this location. The absence of signal location and phase diagrams result in the SAT being unable to comment on the impacts that the various movements would have.

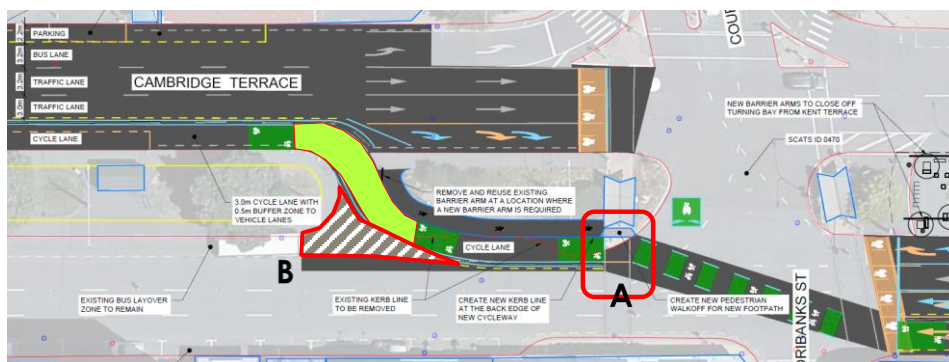
Figure 2-19: Cycle Path transition through Courtenay Place / Majoribanks St intersection to Oriental Parade

The commencement of the movement to the new route on the east side of Oriental Parade is characterised by a chicane movement from the west side of the central median, through to a cross-over facility over the Courtenay Place intersection, then along the east side of Oriental Parade.

In reviewing this new design, the SAT have considered the interaction between bi-directional cyclists, and pedestrian movements at the chicane. The design currently has minimal green marking on the new cycle lane surface, especially in the path of the pedestrian movement.

In addition to the green markings, it is noted that there appears to be no detail on the required hold lines and signal aspects for the north / south movement. Refer to position A on Figure 2-19 above.

The SAT consider that the full chicane movement should be green, with a high friction surface that prevents slipping in wet conditions. This will achieve the following:

Frequency Crashes are likely to be common	Severity Death or serious injury is likely	Rating The safety concern is significant
Designer response	<ol style="list-style-type: none"> 1. Disagree that high-friction surfacing is required, there is nothing to suggest that the current asphalt surface will become slippery in wet conditions when traversed at an appropriate speed. Pedestrian demand across this path is very low and cycle speeds should be low. The cycle separators include vertical delineators at either end which will provide a visual screen especially given the approach angle of vehicles. Current crossing facility has no tactiles or drop-kerbs, layout of this area is likely to change multiple times over the coming few years (including as part of the Golden Mile project) suggest improved pedestrian facilities are provided as part of a more permanent design. 2. Agree with SAT 3. Agree with SAT 4. Agree with SAT – signal information should be provided.

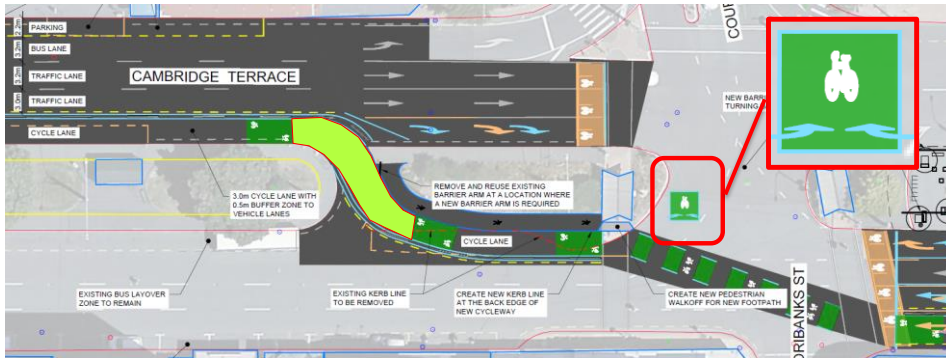
Figure 2-20: Cycle hook turn box located within intersection

The design has a hook turn box positioned in the departure lane from Courtenay Place, as indicated in Figure 2-20 below.

The SAT have significant concerns that this hook turn movement appears to occur in the right hand out bound lane from Courtenay Place and is in direct conflict with this movement. As stated previously, traffic signal phase diagrams were not supplied for this project. The SAT consider that the hook turn box is not in a safe position given the complex movements observed at the intersection.

- ⌘ Cyclists could potentially use the existing footpath crossing (signalised) over Cambridge Terrace, however the shelter in the central median would significantly impact on safe movement and would cause conflicts between cyclist / pedestrians. This risk is present for both the north bound and southbound cycle movements wishing to access Courtenay Place.

- ⌘ It would be unsafe for a cyclist to drop from the separated cycle facility and cross multiple lanes to access Courtenay Place

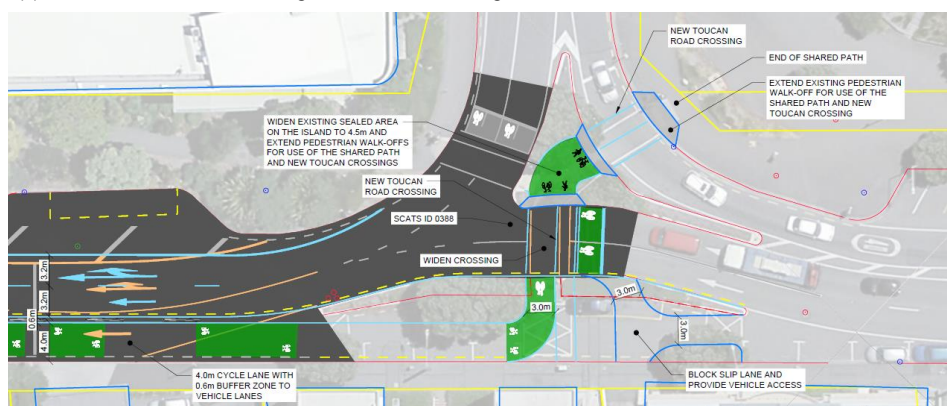
Figure 2-21: Proposed Oriental Parade Crossing point

The new bi-directional facility follows the existing kerb line, traversing through a 90-degree curve to approach the Oriental Parade signals, as detailed in Figure 2-21 below.

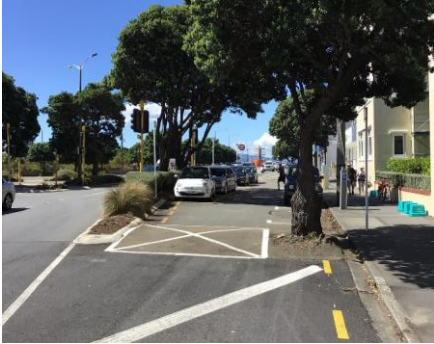
Figure 2-22: Existing speed hump and tree

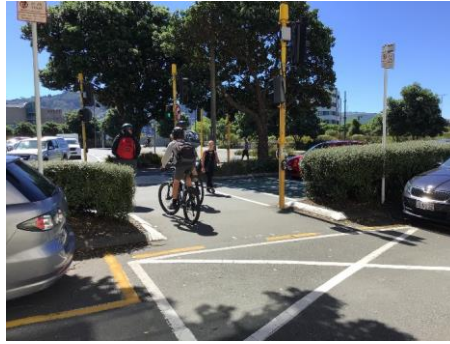
Figure 2-23: Note vegetation blocks sight of car stopped at lights

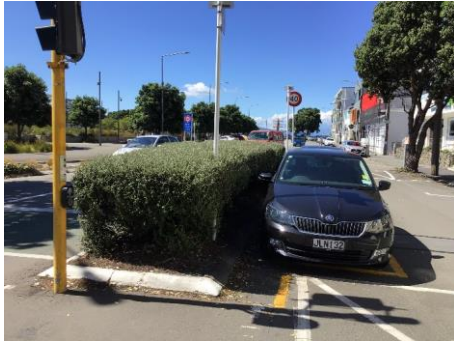
Figure 2-24: Vegetation height masks car

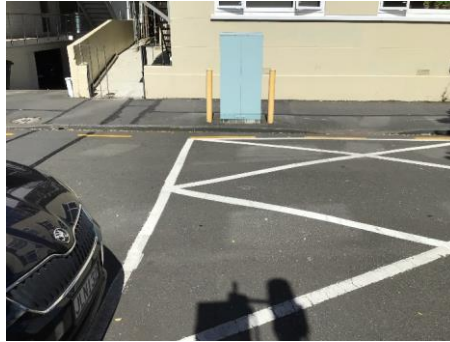
Figure 2-25: Utility kiosk located at proposed crossing point

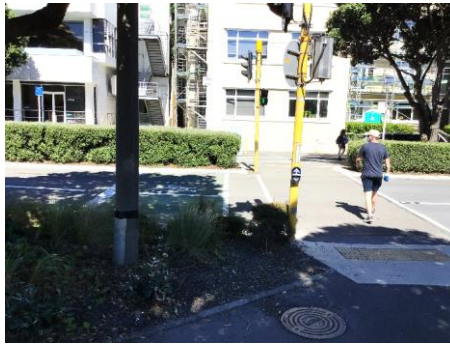
5. The SAT observed existing manholes that would be within the movement zone of the new crossing points either side. The manhole tops are of a smooth steel surface and present a slip risk to cyclists, especially in wet conditions.

Figure 2-27: Service covers within proposed crossing point

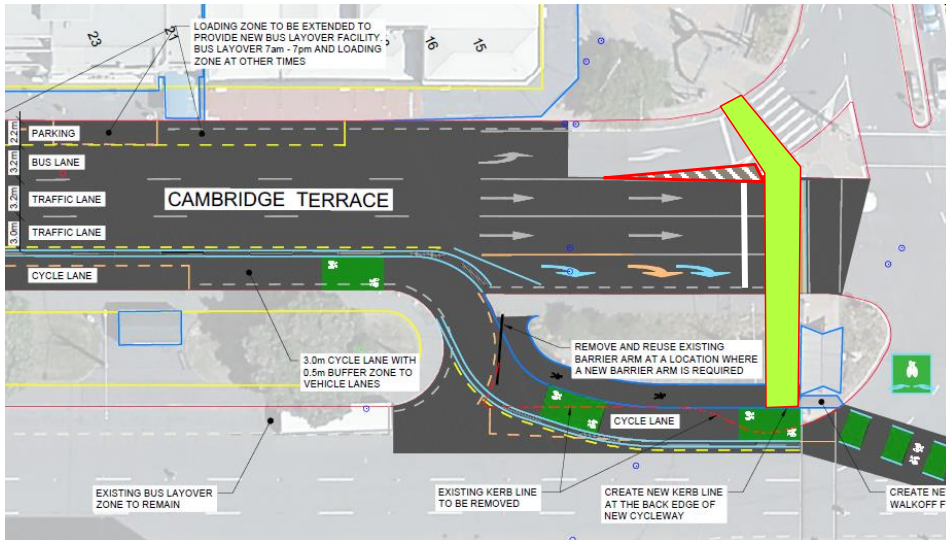
Figure 3-1: Alternate cyclist linkage to/from Courtenay Place

The current pedestrian crossing south of the intersection has a suitable level of service for pedestrians, however this would not be suitable to incorporate cyclists as part of the crossing movement on the current crossing point. Access to the existing path through the central median also occurs immediately adjacent to the lane shift of the new facility.

This could be achieved through the formation of a new path through the central median, with porous pavers over the garden to maintain tree health. The limit line of the northbound movement can be moved back to facilitate the inclusion of a new crossing feature, ASB for through movements, and inclusion of a longer splitter island.

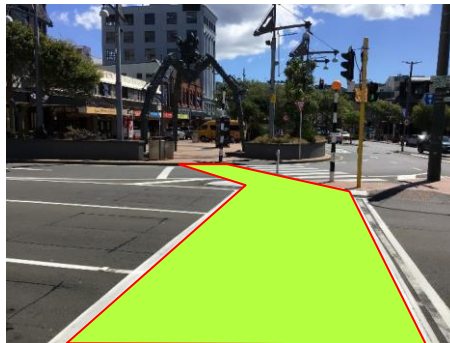
Figure 3-3: View of alternate cyclist connection utilising existing ASBs.
