Appendix G

Bus Stop Rationalisation

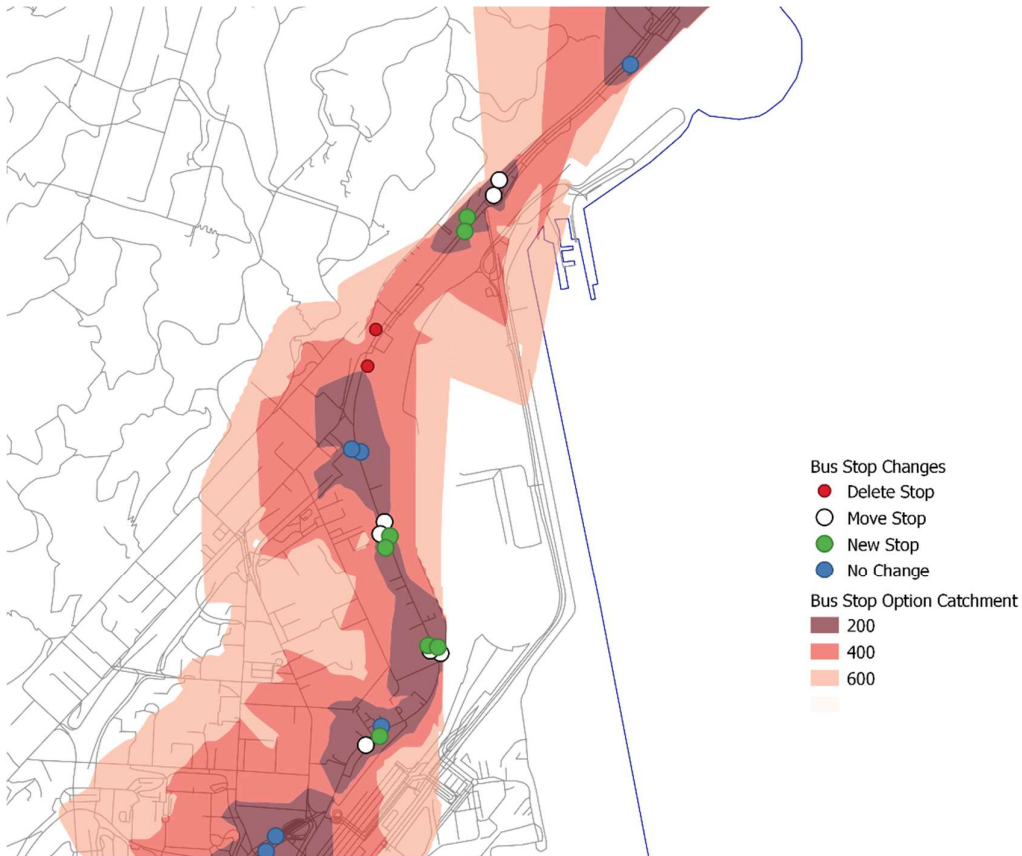
Figure 4 Proposed Bus Stop Catchment Areas

Figure 4 shows the revised catchment areas of the proposed bus stop locations. The revised stop locations will achieve an overall better balance between stop provision and catchment area served.

The main changes proposed are at the southern end of Hutt Road near Tinakori Road, where bus stops are proposed to be removed. This area has a very small catchment, and the removal is unlikely to have a significant effect on many existing bus users.

It should be noted that further refinements were made to bus stop locations in the preliminary design stage which are not shown in Figure 3 and Figure 4. The main changes made were as follows:
